KLEINFELDER

APPENDIX B – PHOTOGRAPHS

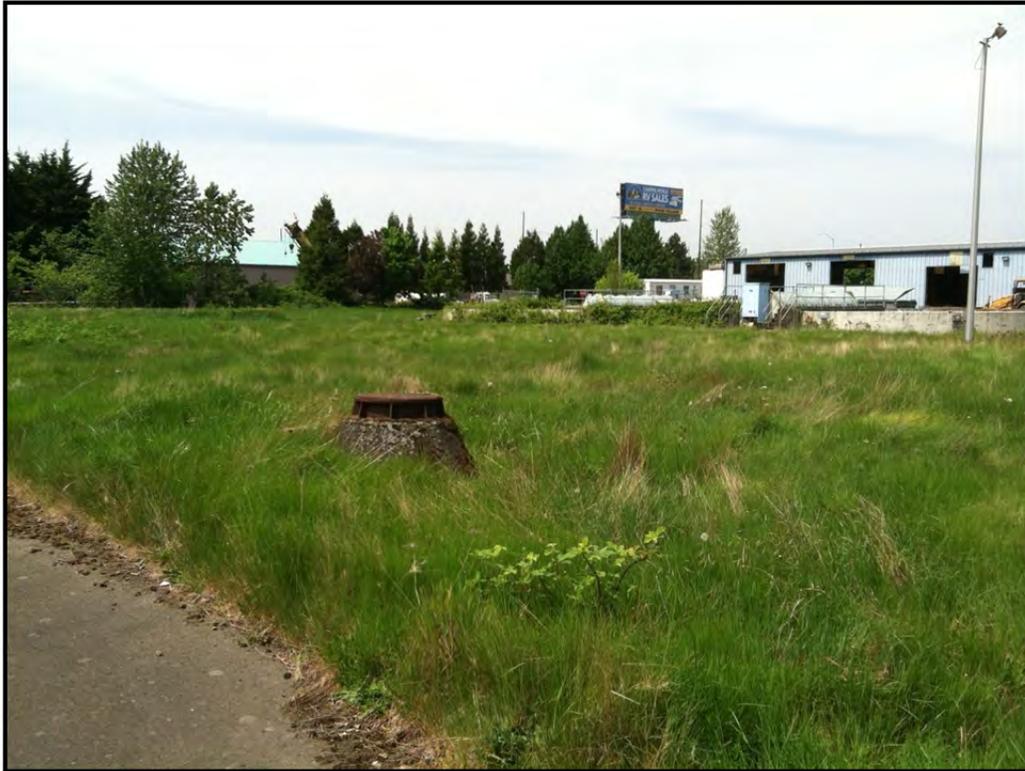
PHOTO #1: INFLUENT MANHOLE WHILE FACING A NORTH WESTERLY DIRECTION

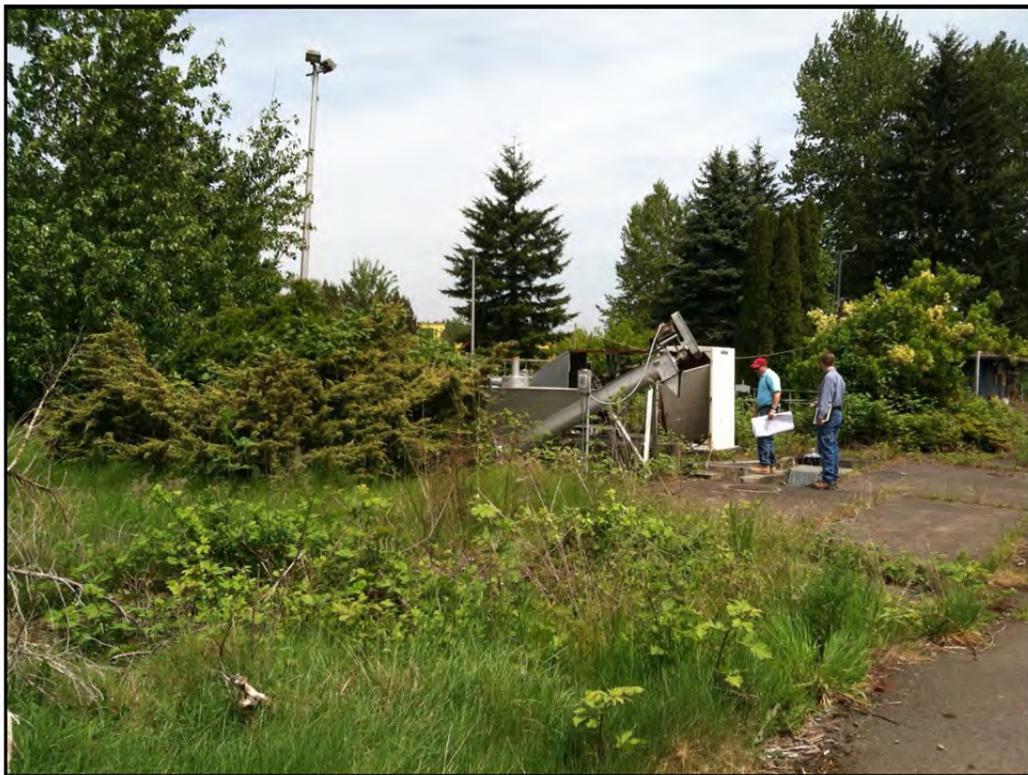
PHOTO #2: EXISTING HEADWORKS FACILITY WHILE FACING IN THE NORTHEAST DIRECTION

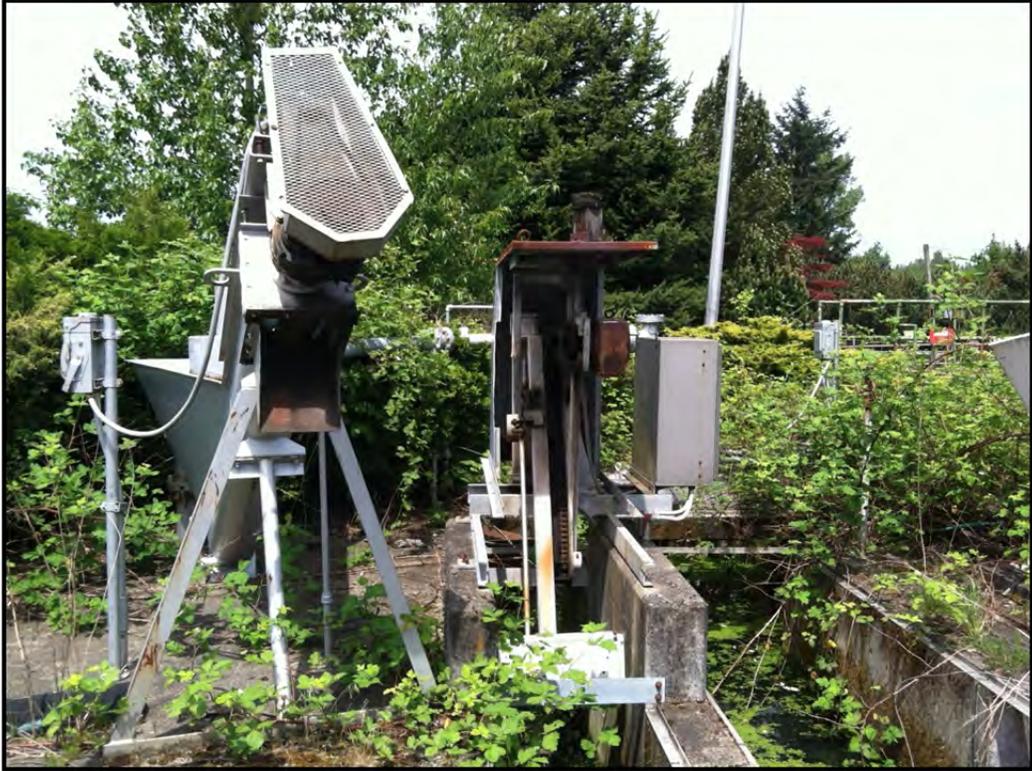
PHOTO #3: EXISTING HEADWORKS FACILITY

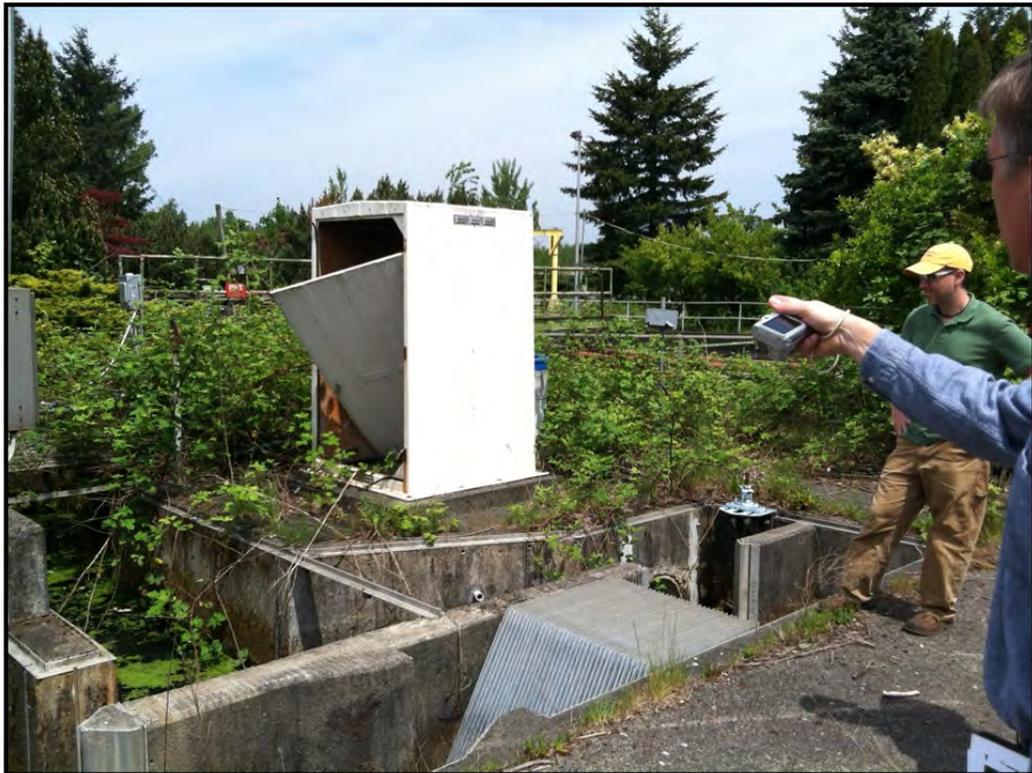
PHOTO #4: EXISTING HEADWORKS FACILITY

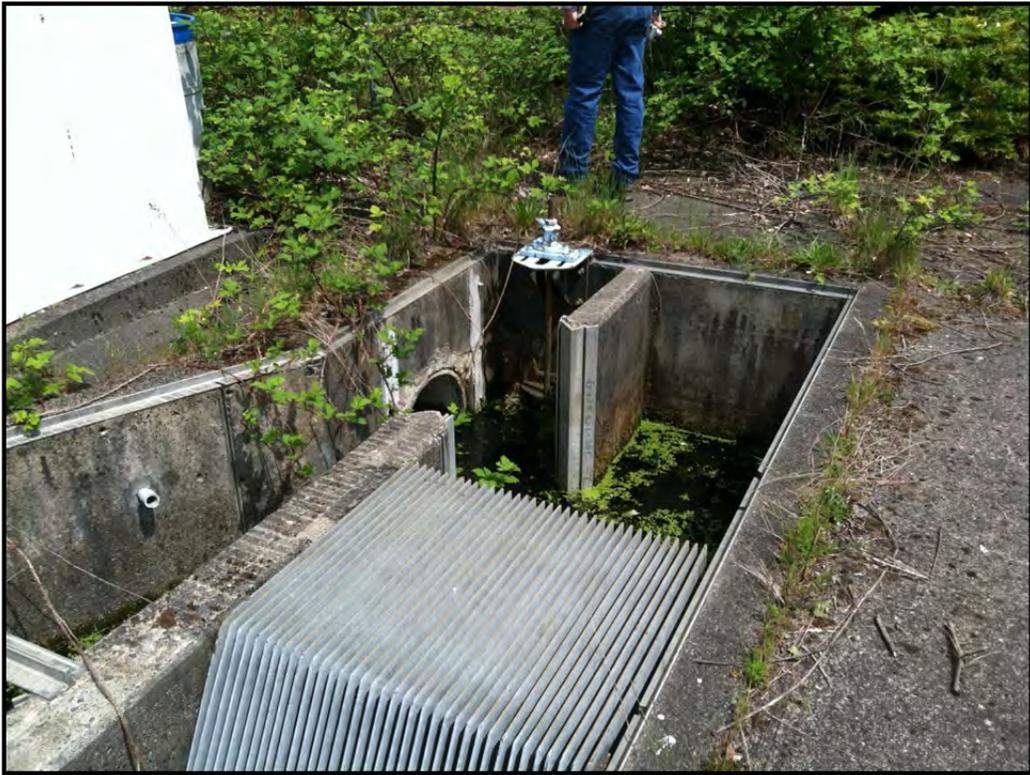
PHOTO #5: HEADWORKS FACILITY

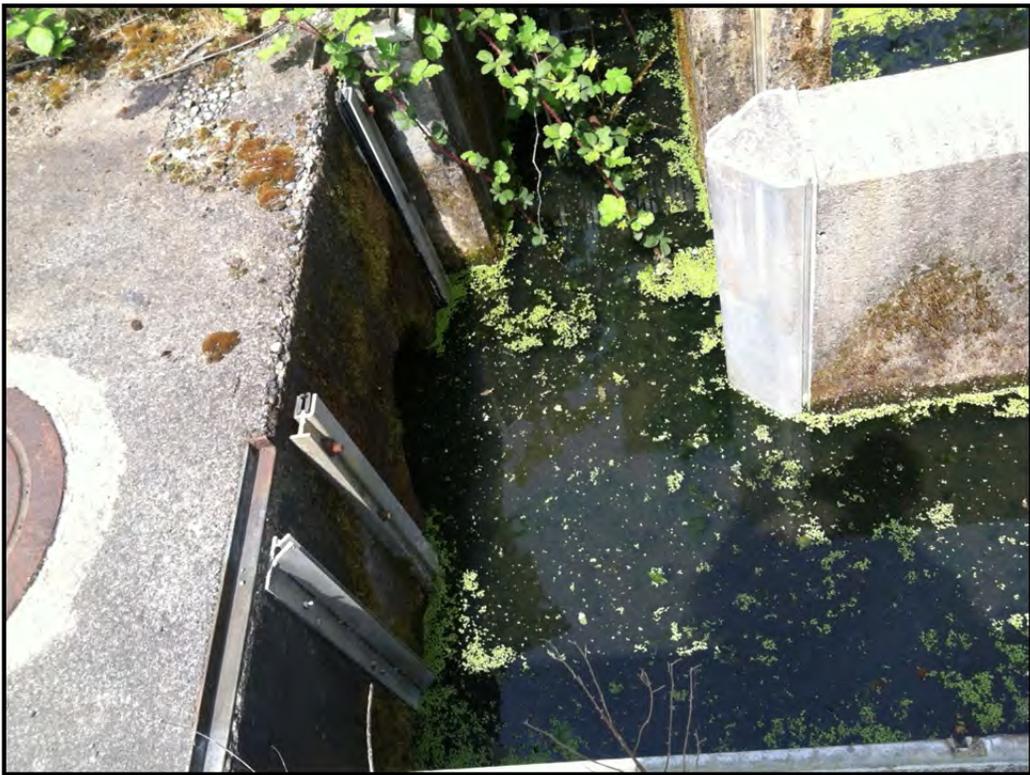
PHOTO #6: HEADWORKS FACILITY

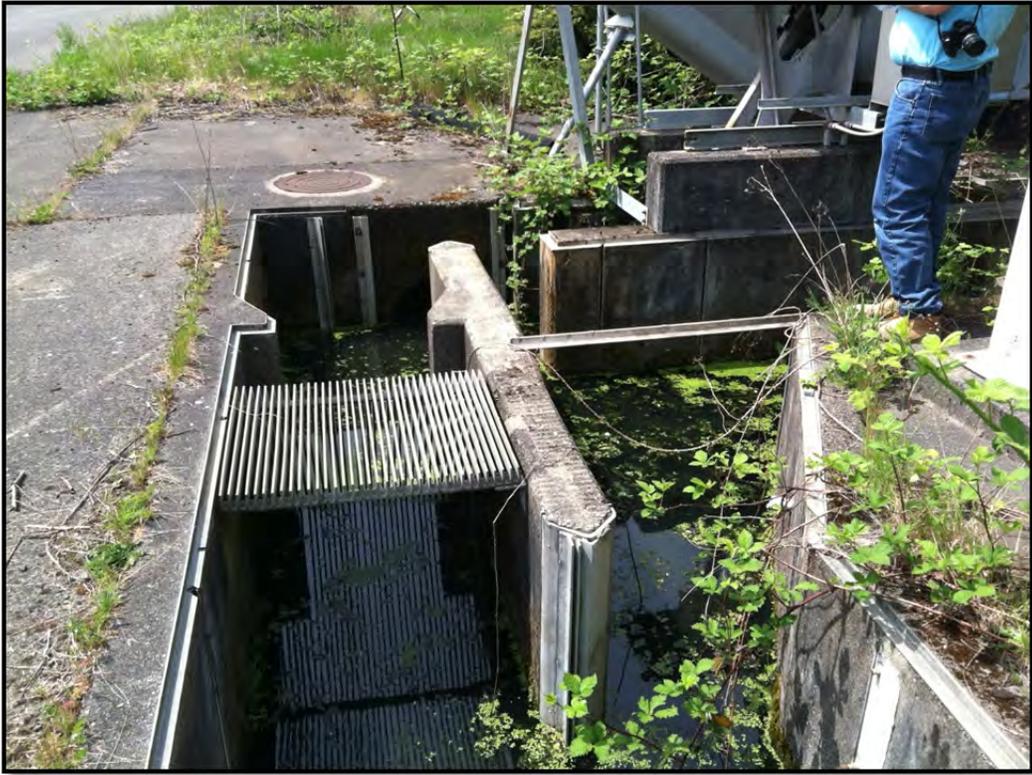
PHOTO #7: HEADWORKS FACILITY

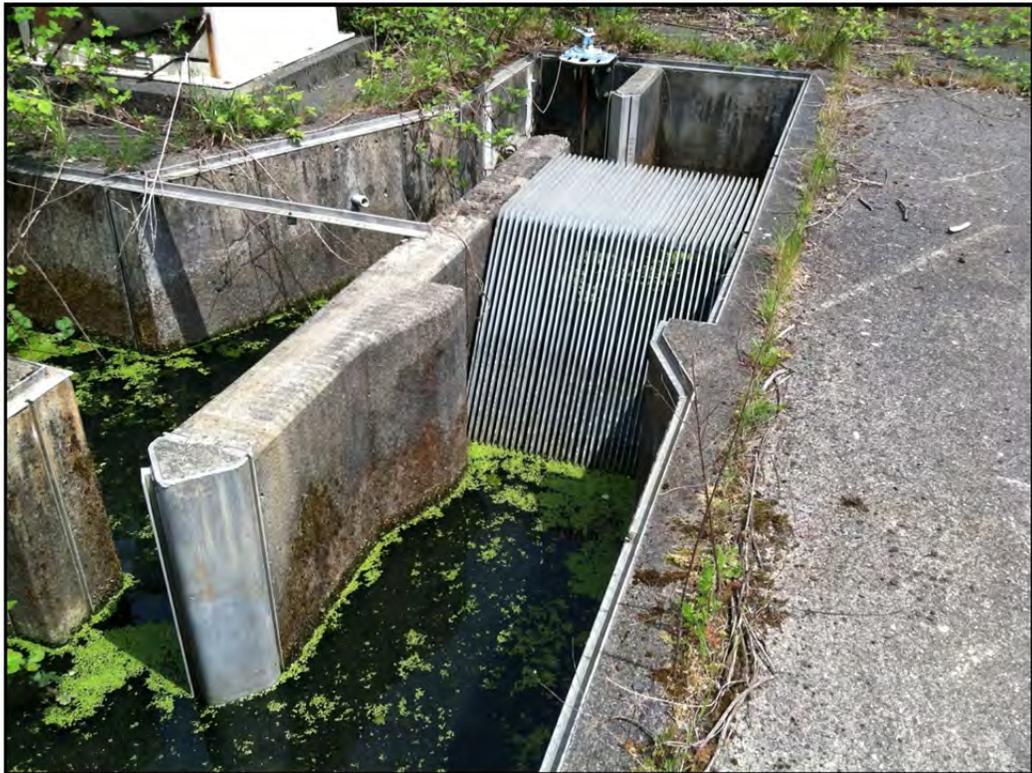
PHOTO #8: HEADWORKS FACILITY

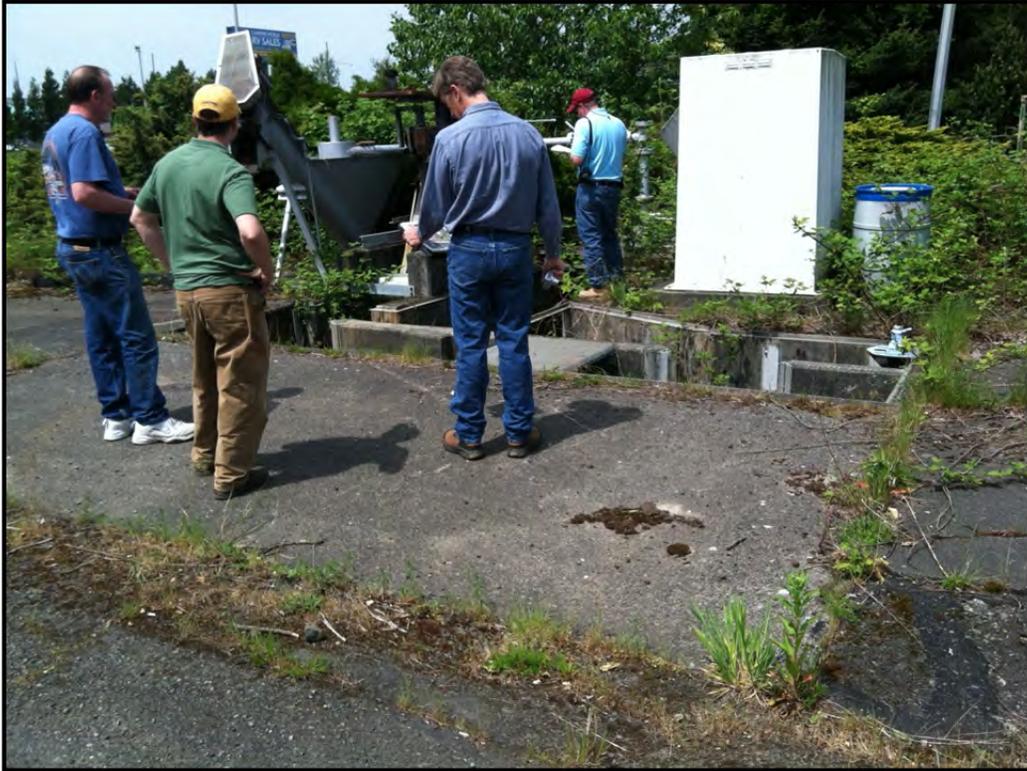
PHOTO #9: HEADWORKS FACILITY

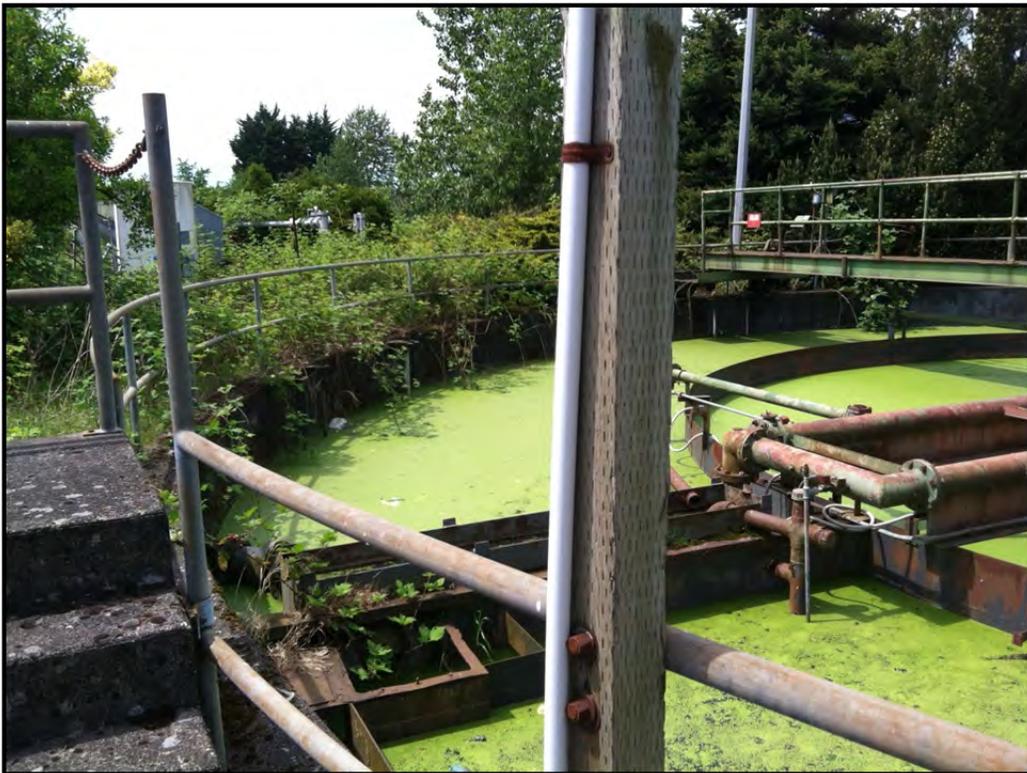
PHOTO #10: PRIMARY CLARIFIER

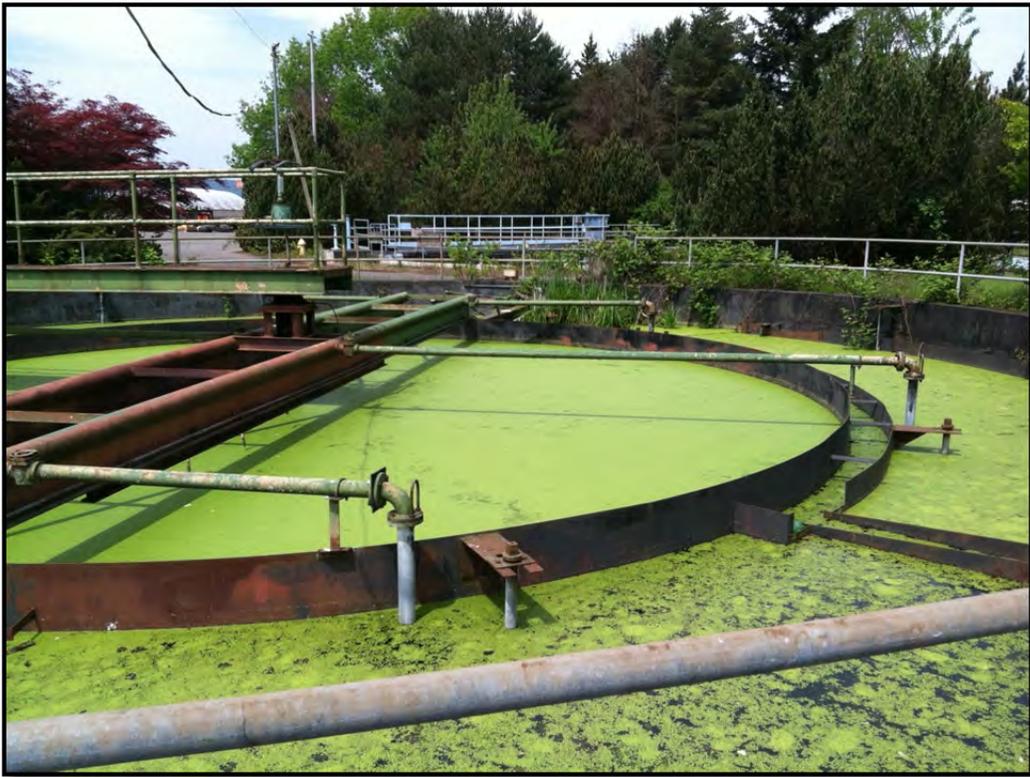
PHOTO #11: PRIMARY CLARIFIER

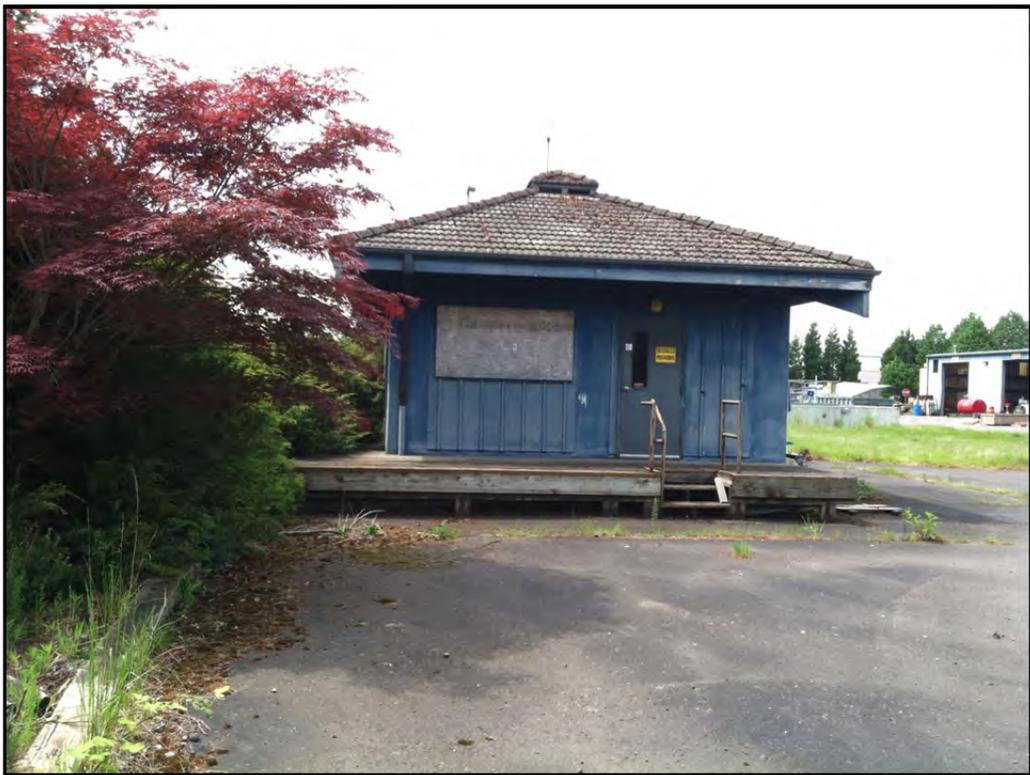
PHOTO #12: ENTRANCE TO CONTROL BUILDING FACING WEST

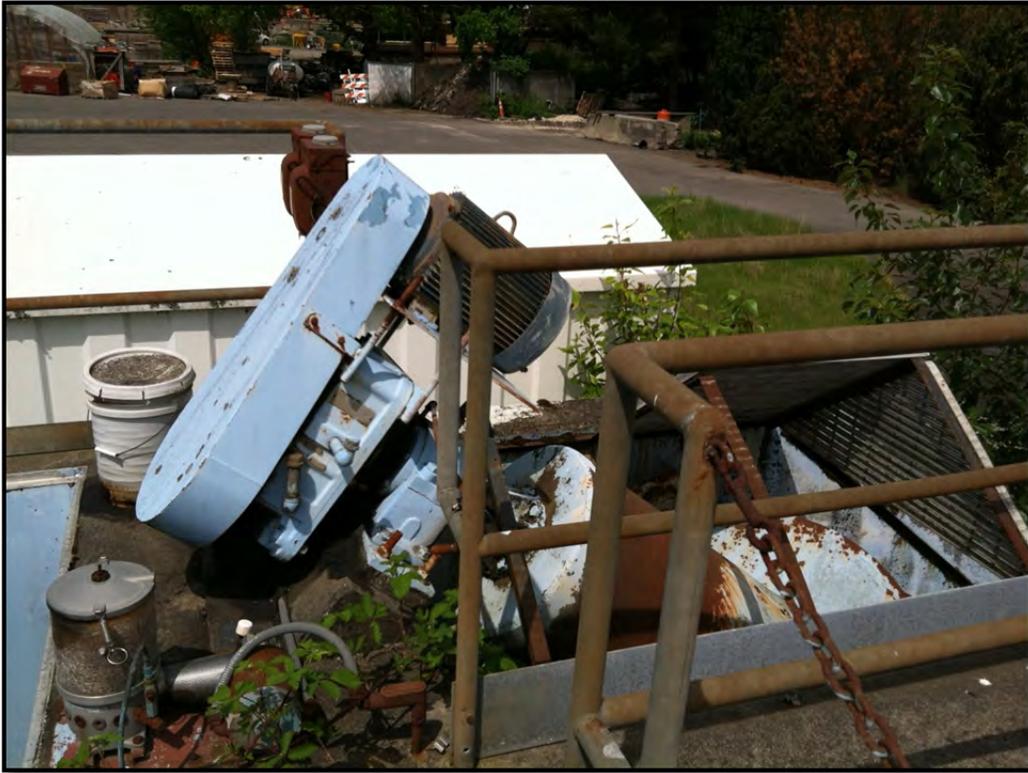
PHOTO #13: SCREW PUMPS

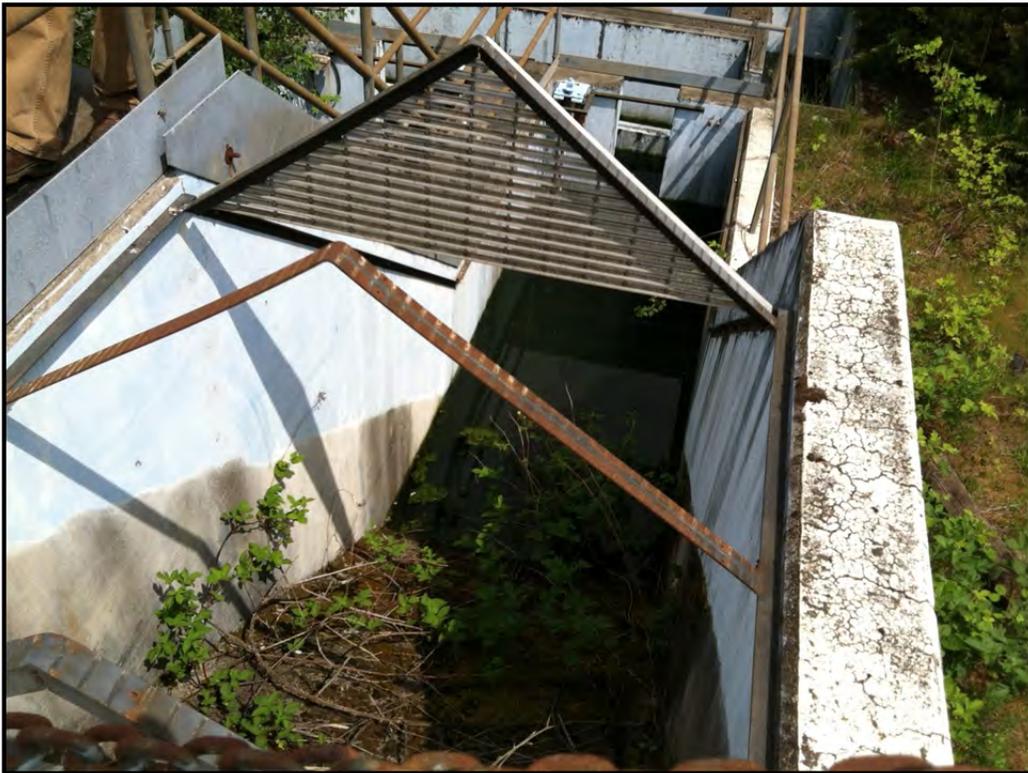
PHOTO #14: SCREW PUMPS

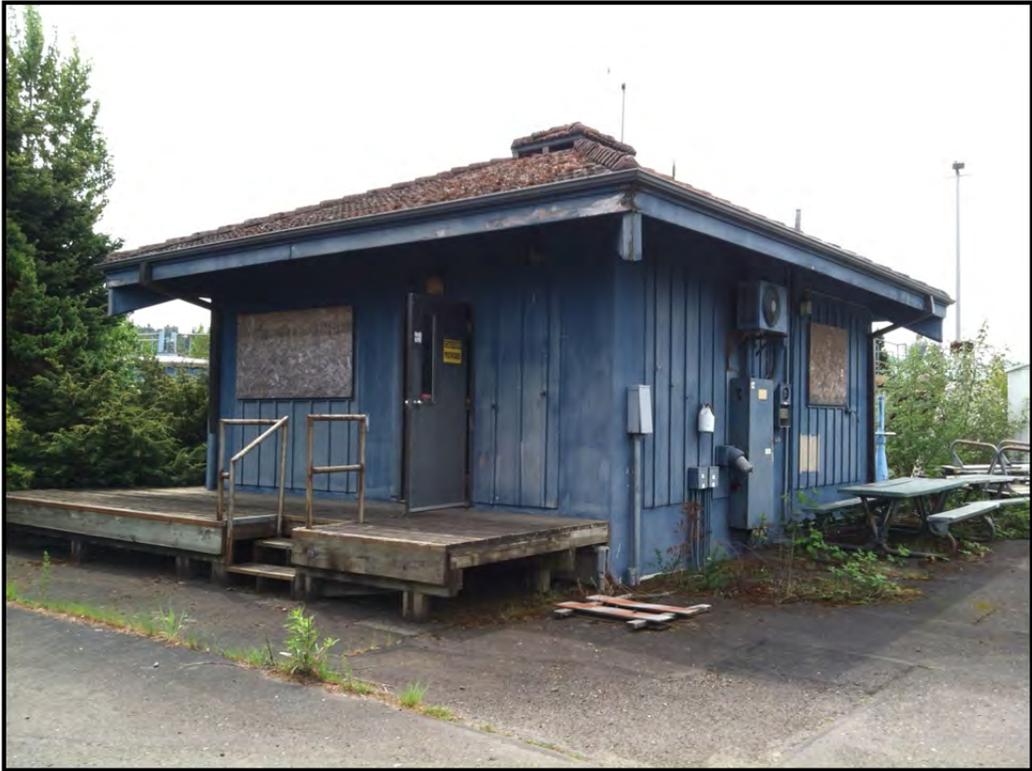
PHOTO #15: CONTROL BUILDING FACING SOUTHWEST

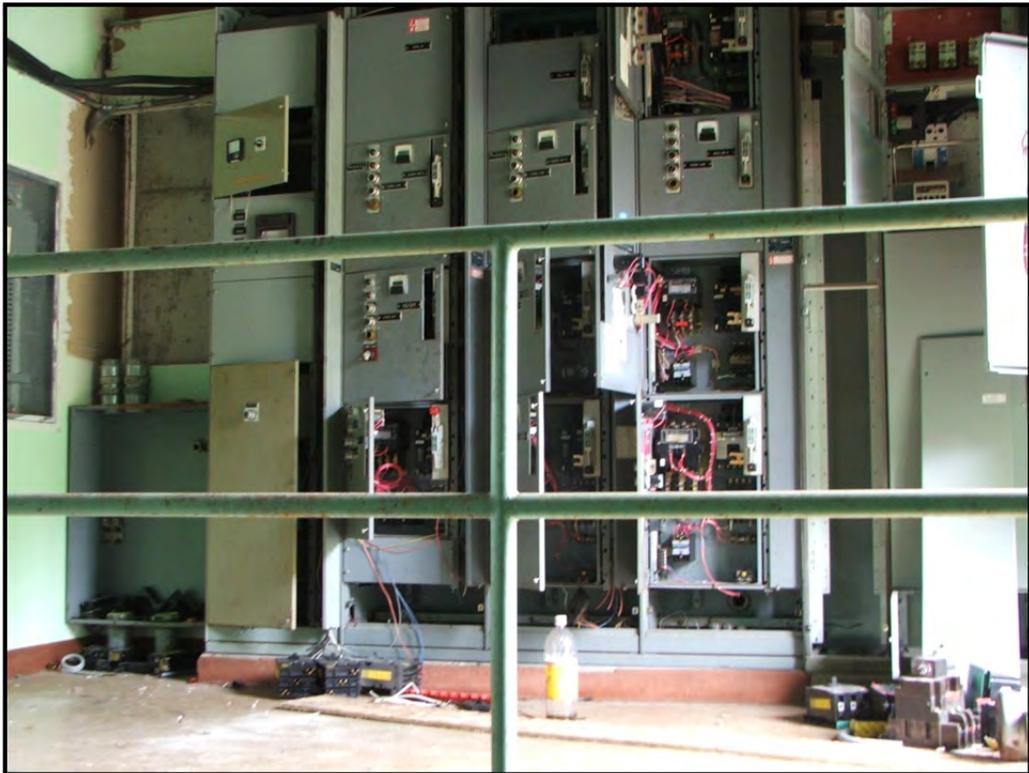
PHOTO #16: MCC CABINETS WITH REMAINING WIRING AND CONTROL EQUIPMENT

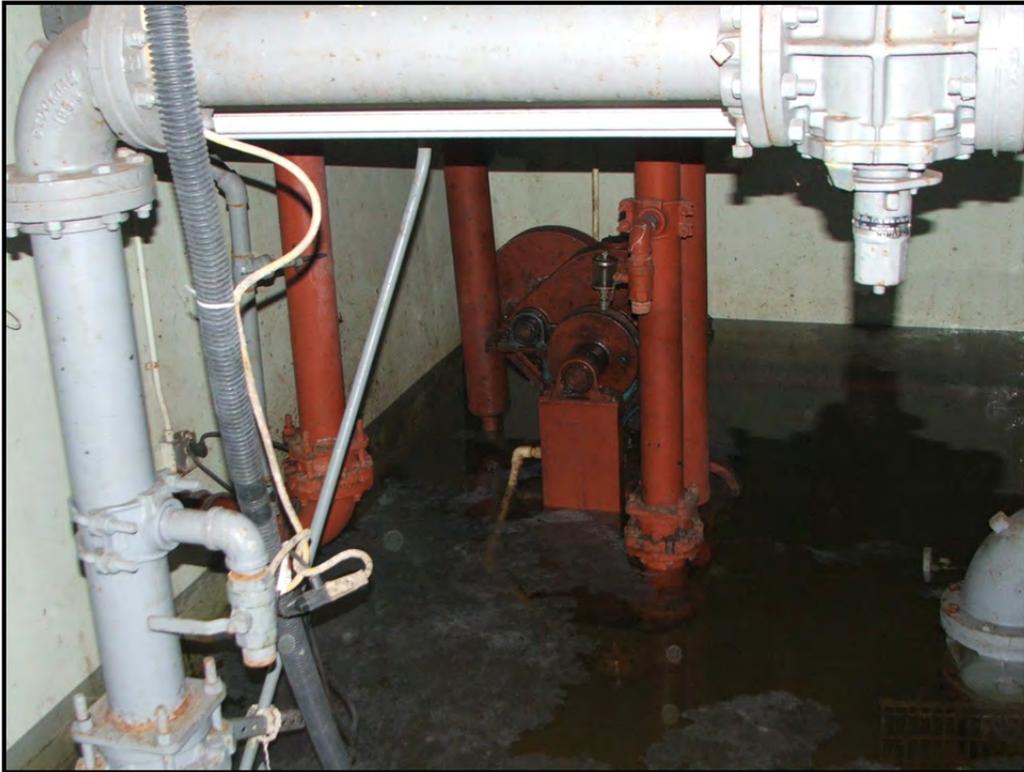
PHOTO #17: CONDITION OF PUMP ROOM

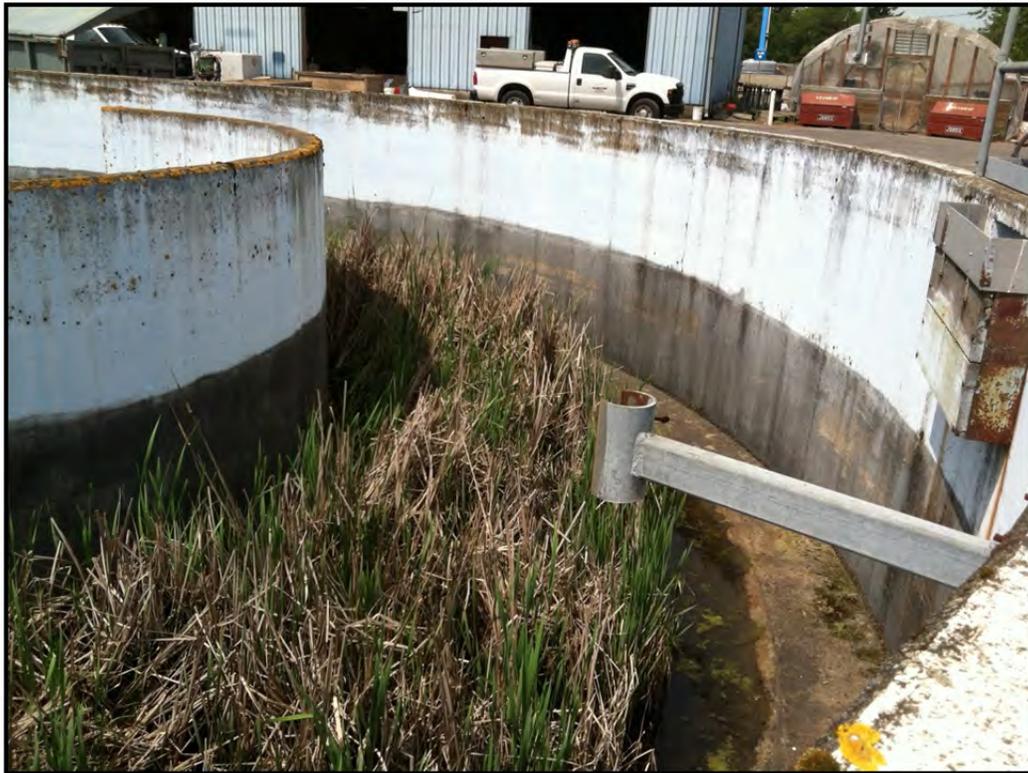
PHOTO #18: AERATION BASIN AND INFLUENT DIFFUSER

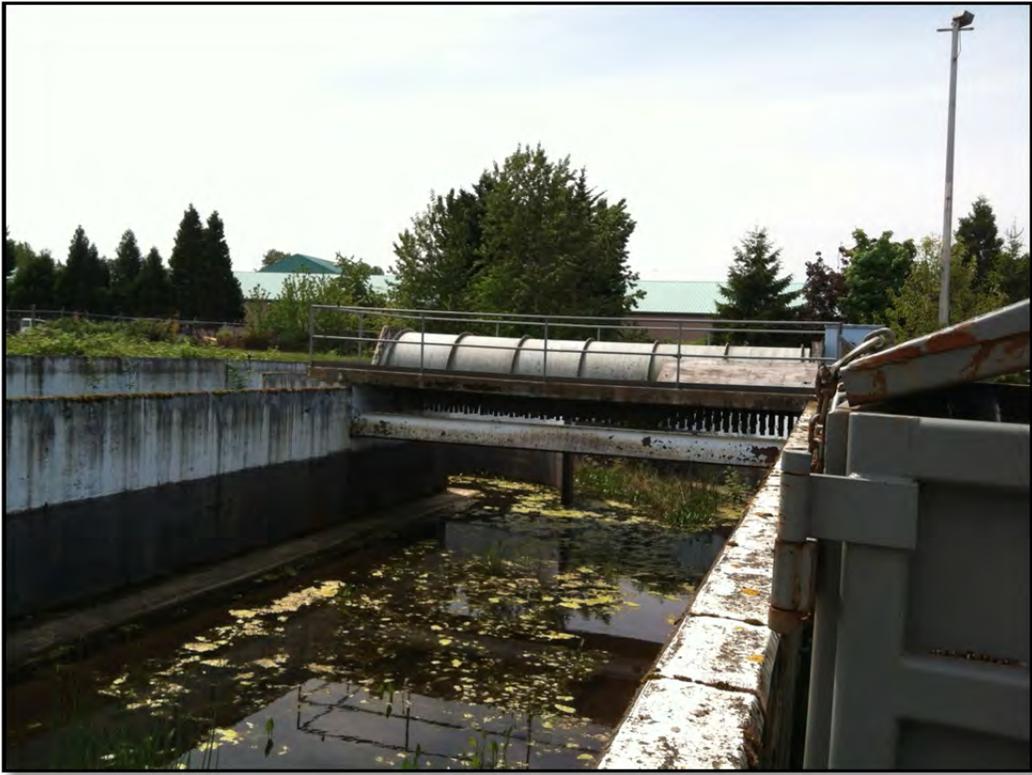
PHOTO #19: MECHANICAL AERATORS

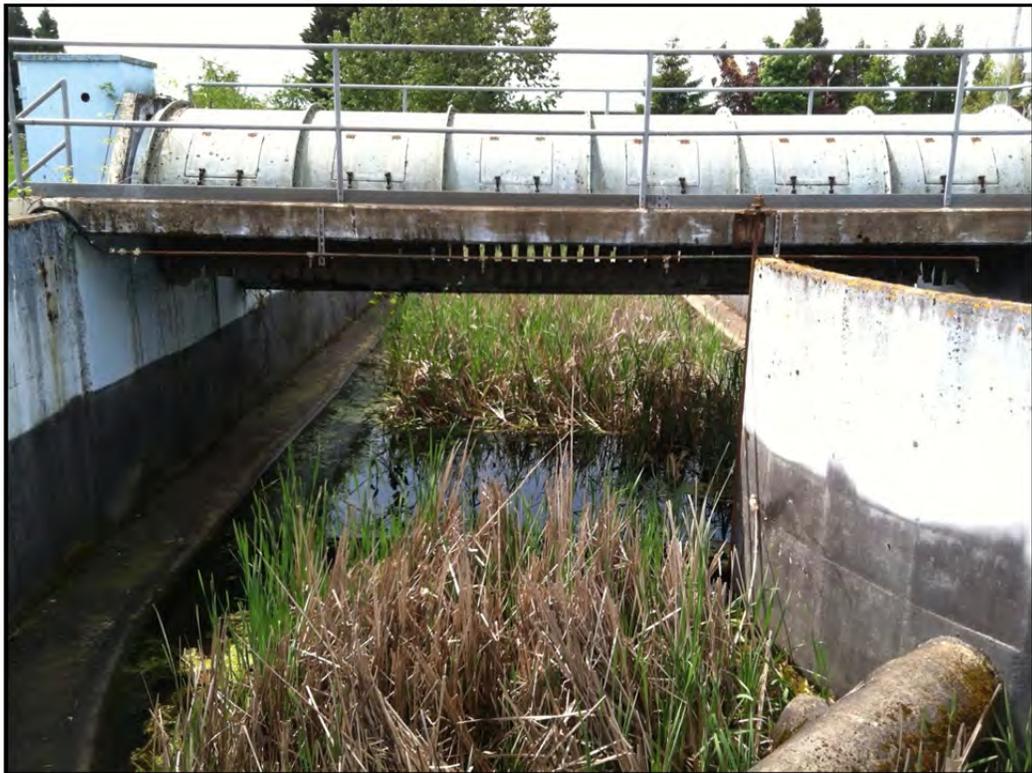
PHOTO #20: MECHANICAL AERATORS

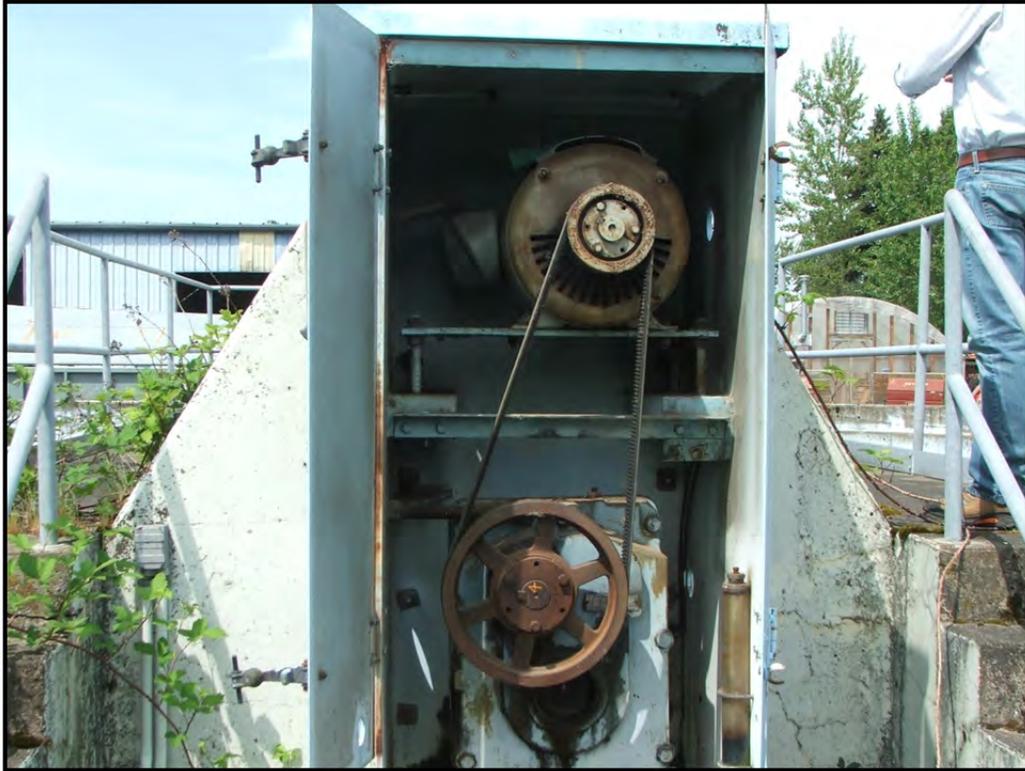
PHOTO #21: DRIVE MOTORS

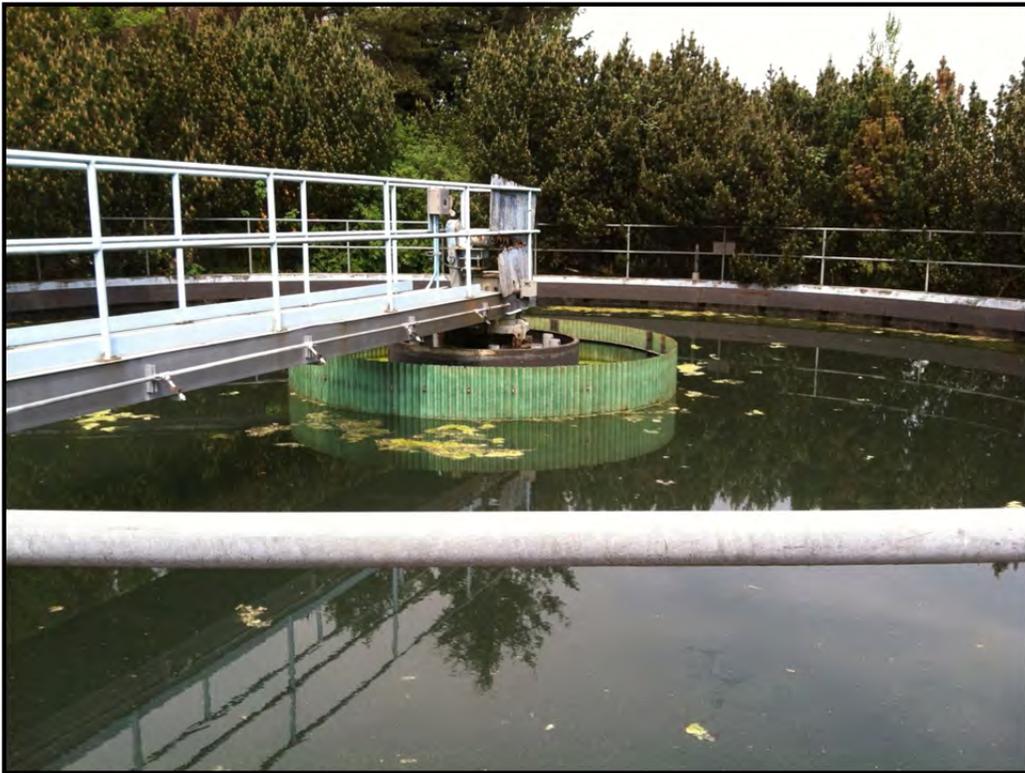
PHOTO #22: CONDITION OF SECONDARY CLARIFIER

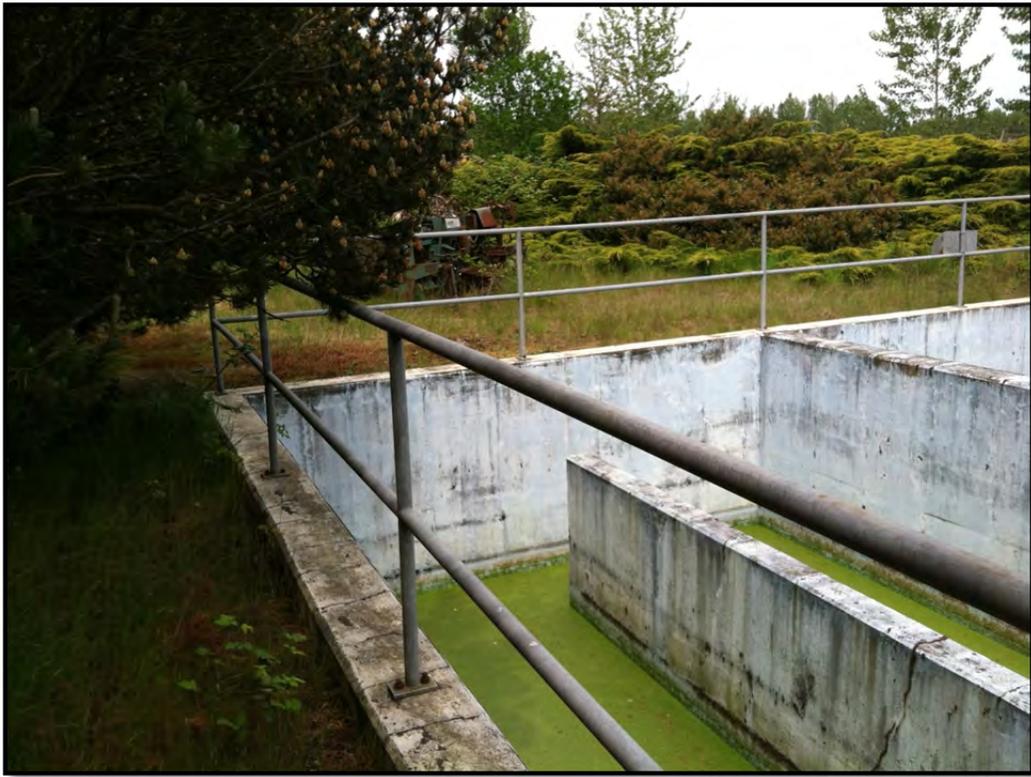
PHOTO #23: CHLORINE CONTACT TANK CONDITION

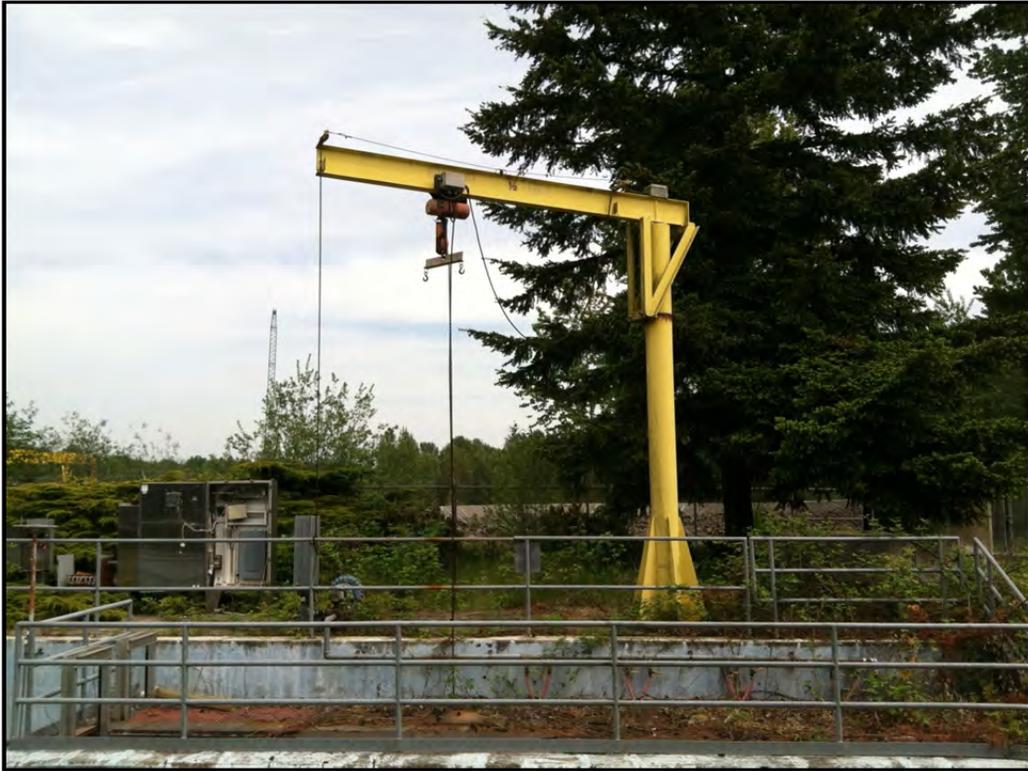
PHOTO #25: JIB CRANE

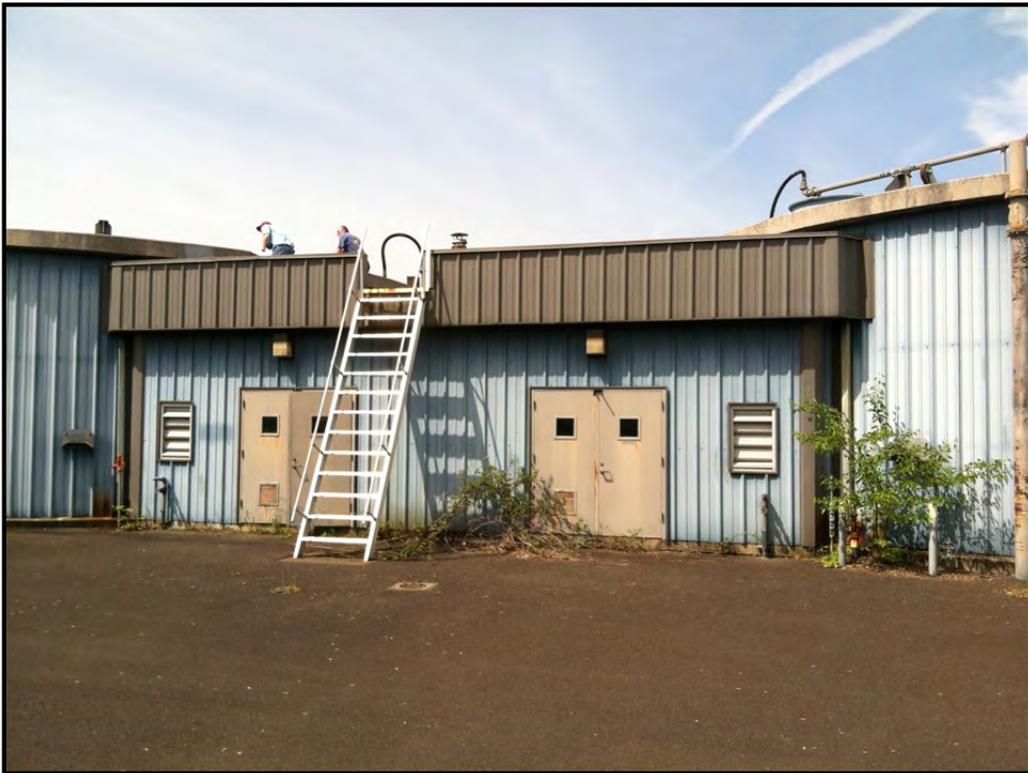
PHOTO #26: REAR ENTRANCE TO THE SLUDGE DIGESTOR FACILITY

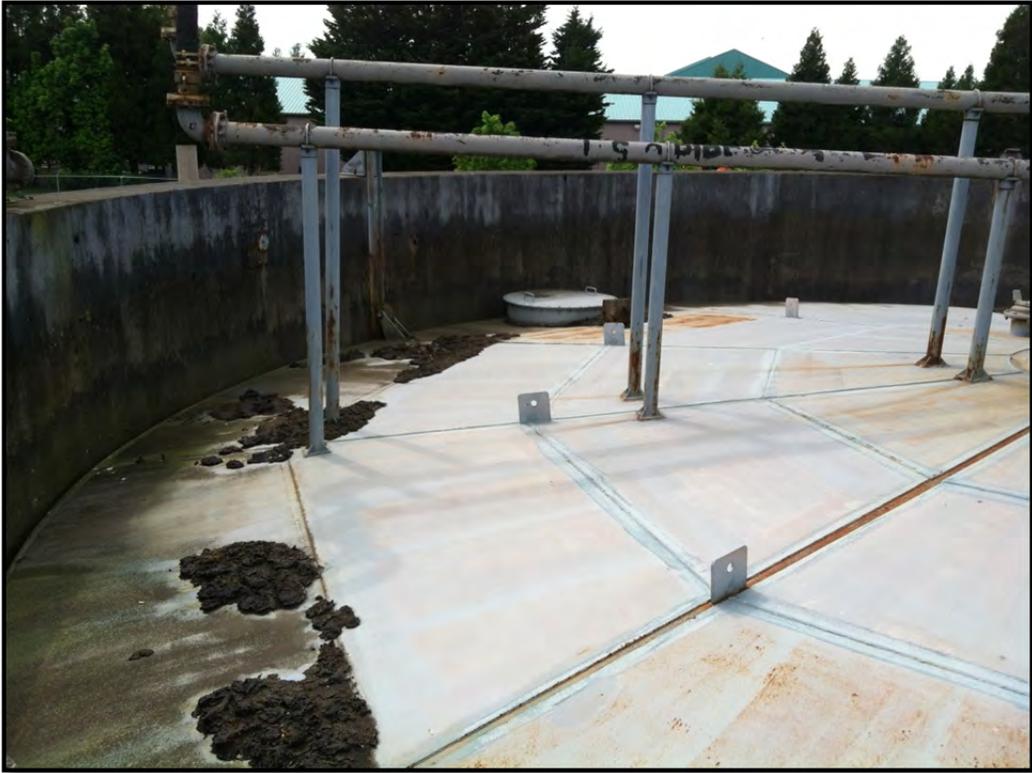
PHOTO #27: CONDITION OF COVER OVER PRIMARY DIGESTOR

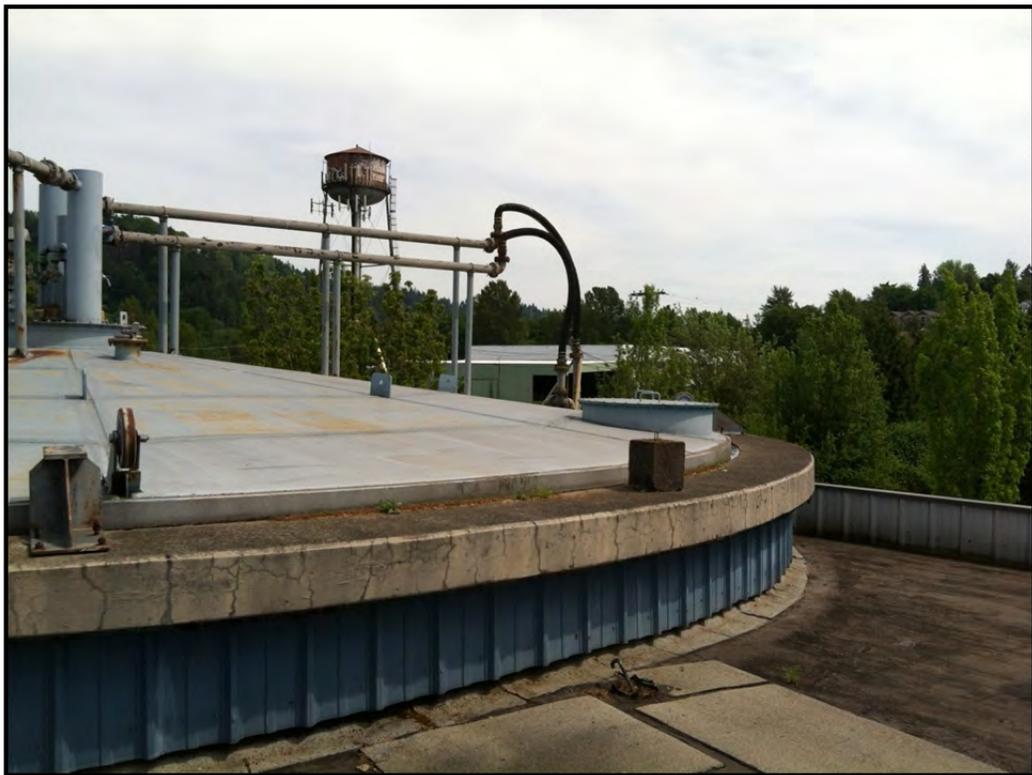
PHOTO #28: COVER OF SECONDARY DIGESTOR

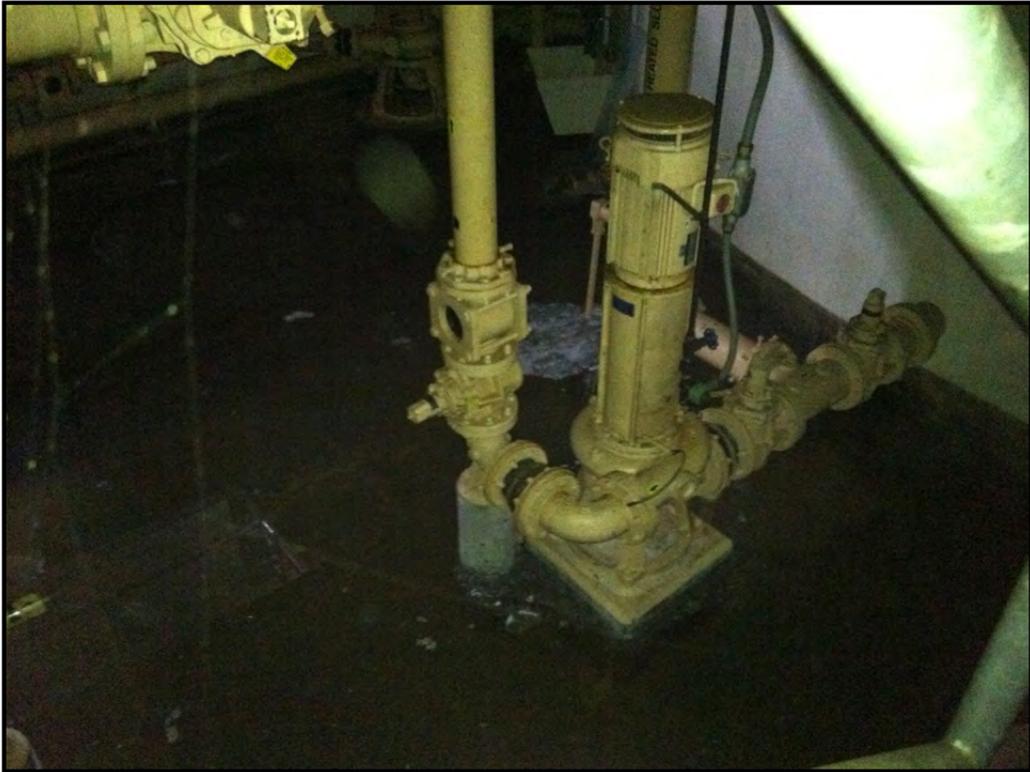
PHOTO #29: PUMP ROOM

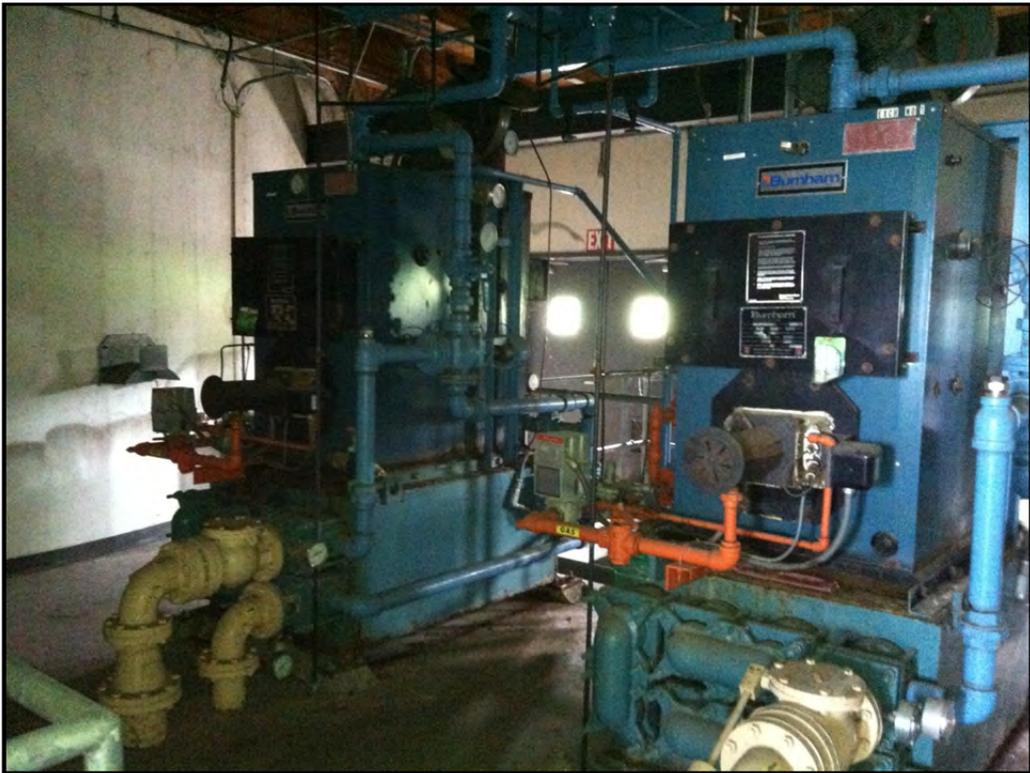
PHOTO #30: TWO BOILERS
