KLEINFELDER

APPENDIX B – PHOTOGRAPHS

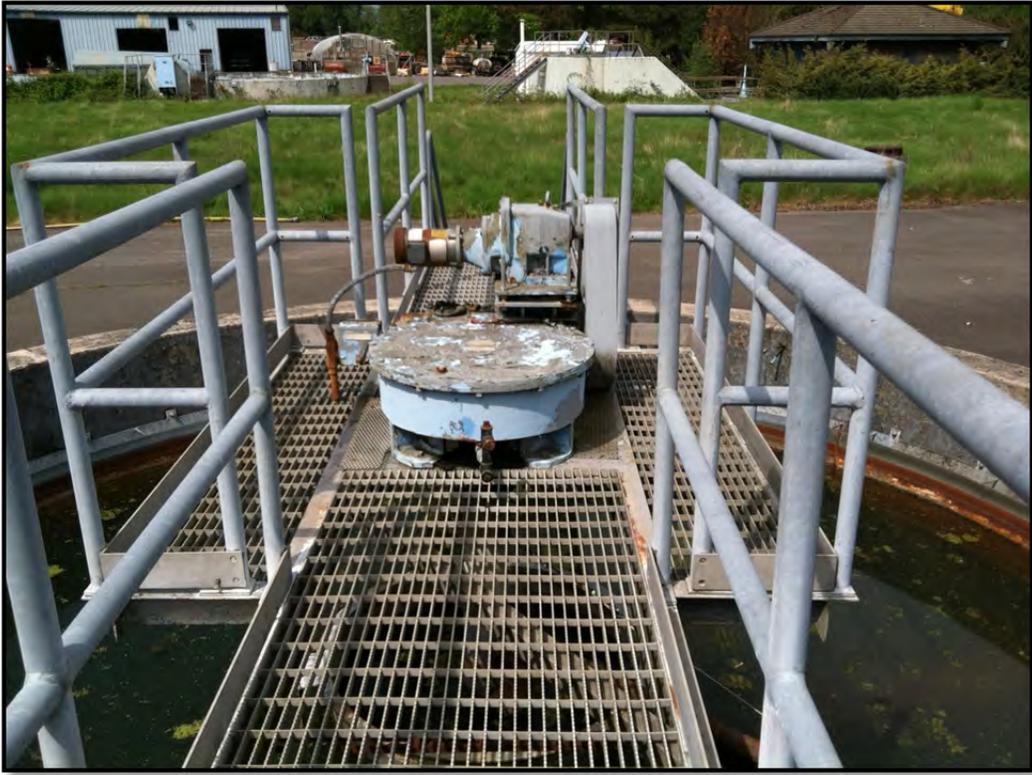
PHOTO #31: CONDITION OF THICKENER

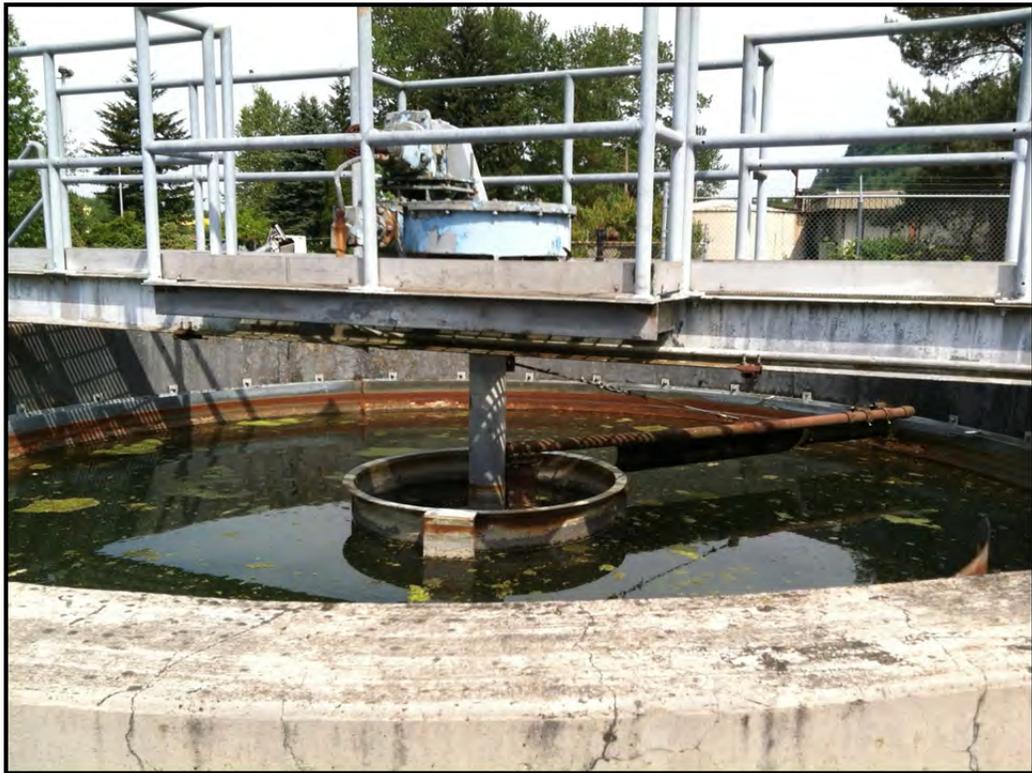
PHOTO #32: CONDITION OF THICKENER

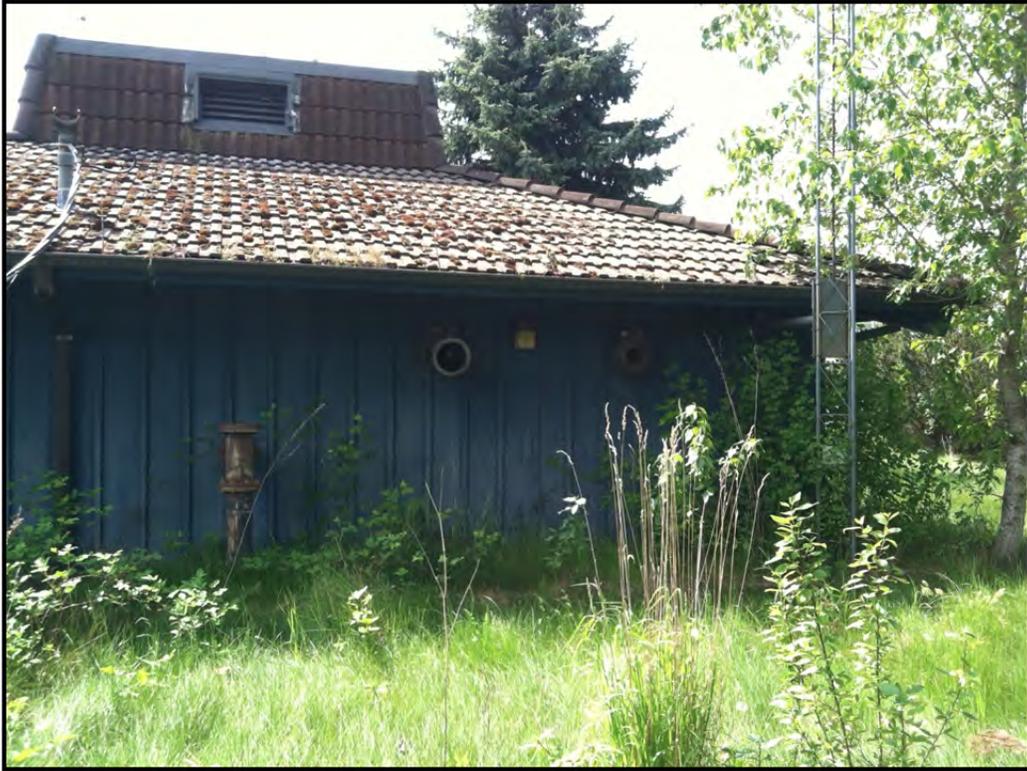
PHOTO #33: EXTERIOR OF BUILDING

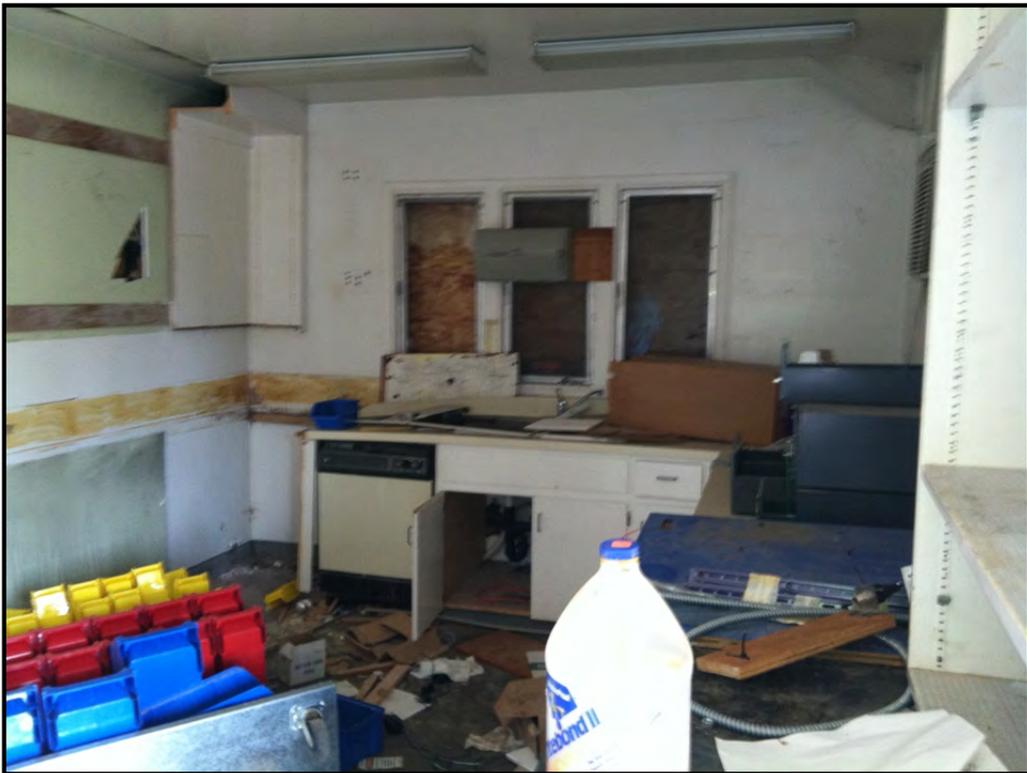
PHOTO #34: CONDITION OF BUILDING

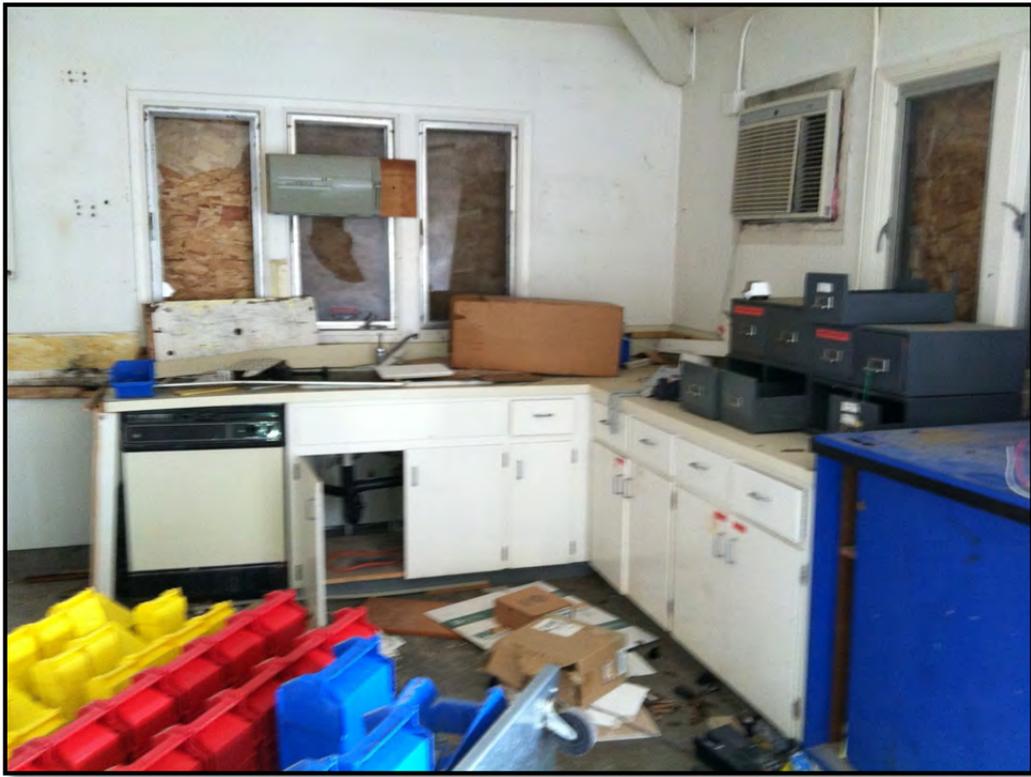
PHOTO #35: CONDITION OF BUILDING

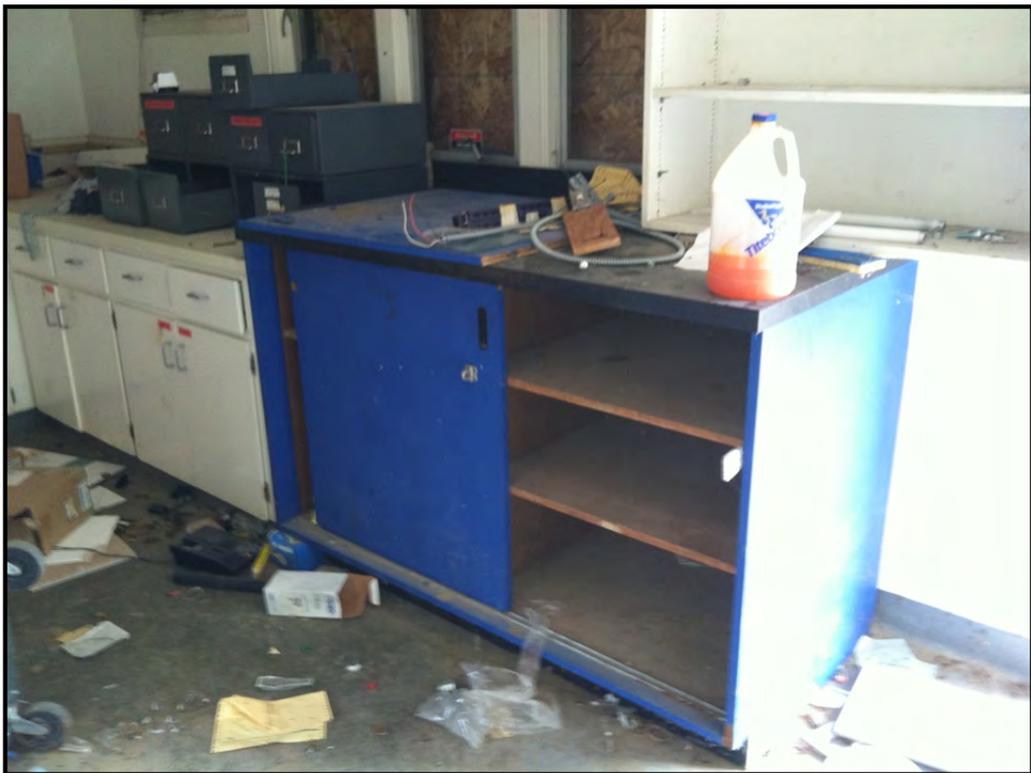
PHOTO #36: CONDITION OF BUILDING

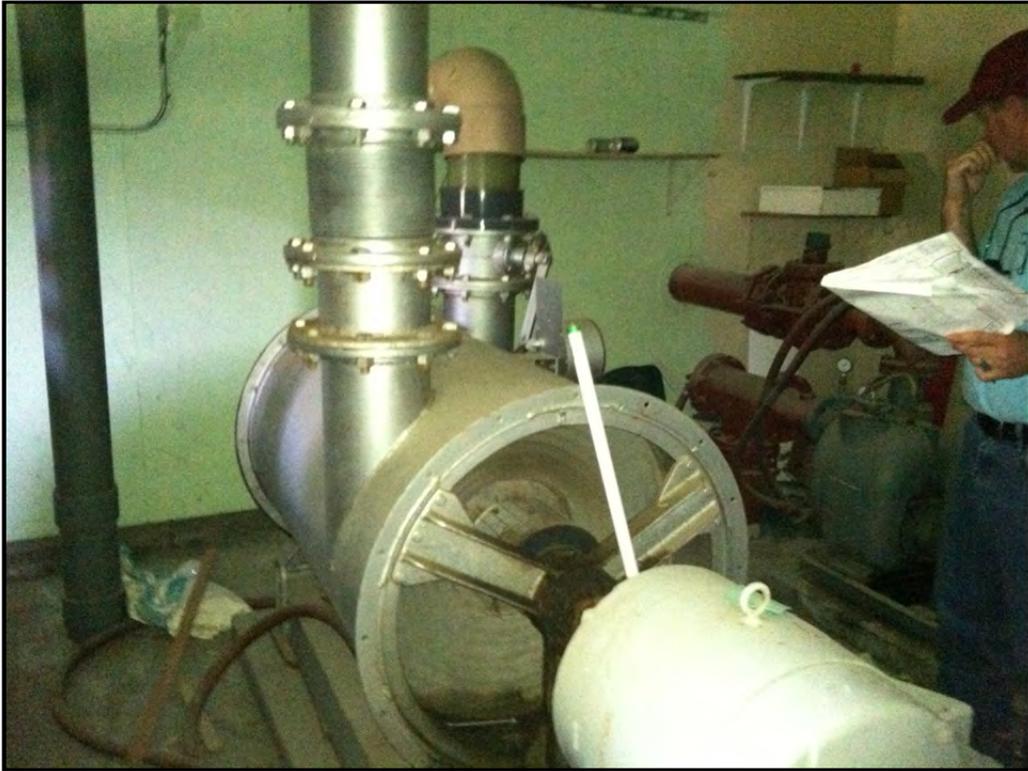
PHOTO #37: ONE OF THE BLOWERS AND SLUDGE PUMP

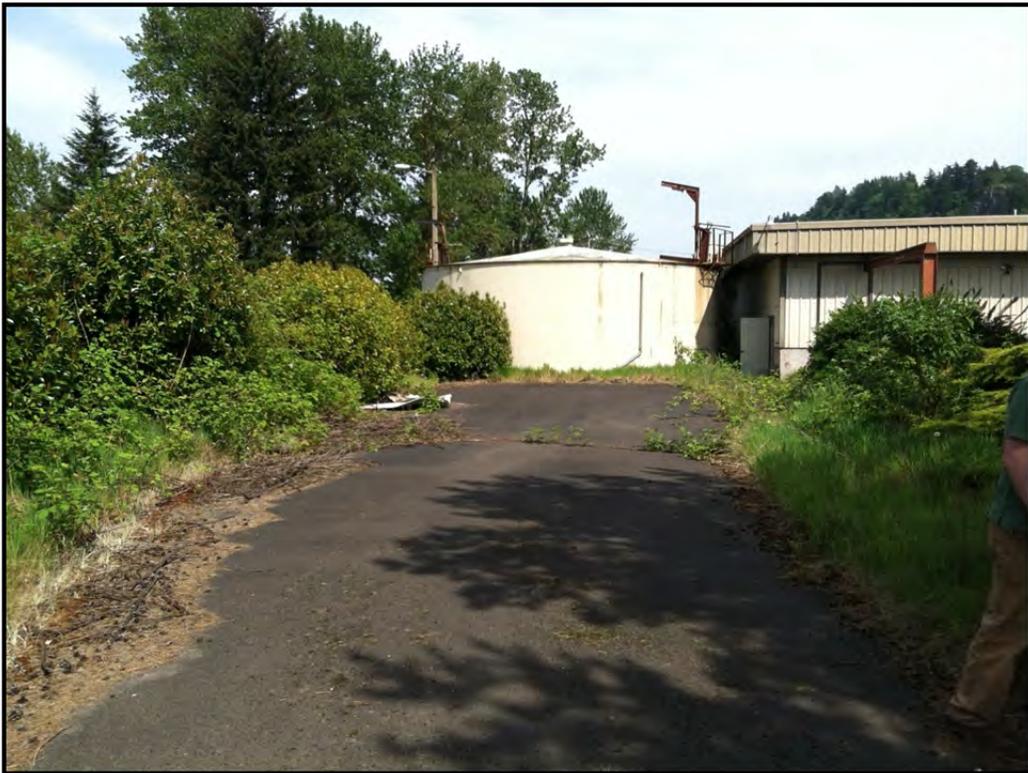
PHOTO #38: SLUDGE STORAGE TANK ADJACENT TO REAR OF OPERATIONS BUILDING

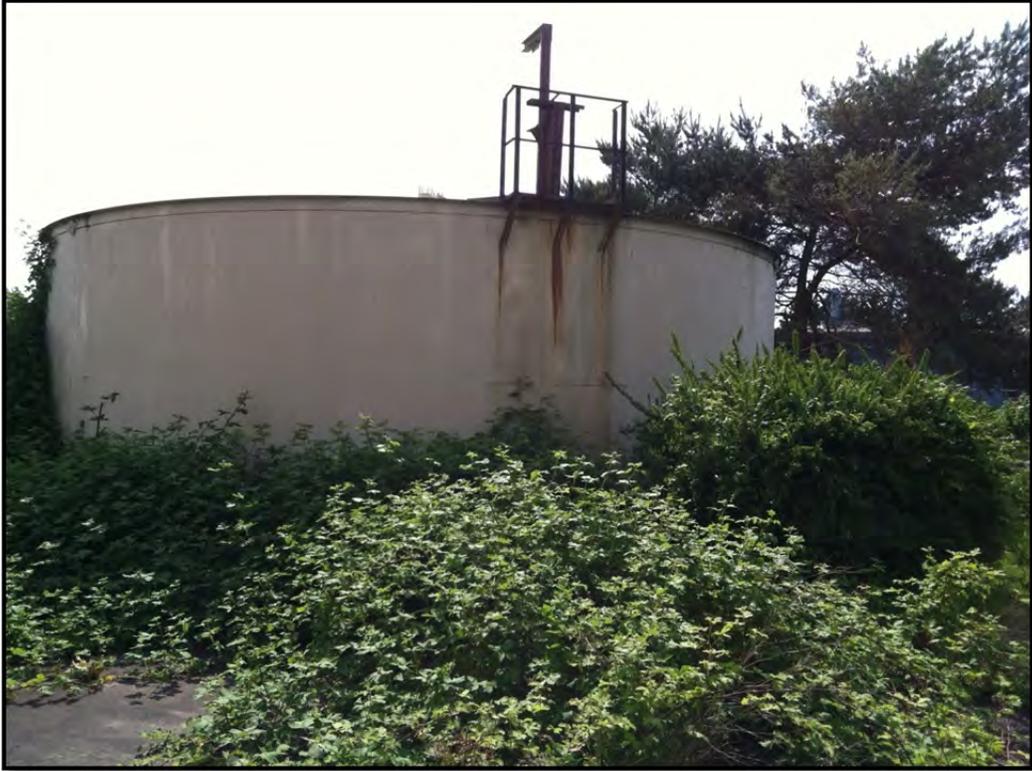
PHOTO #39: WATER STORAGE TANK

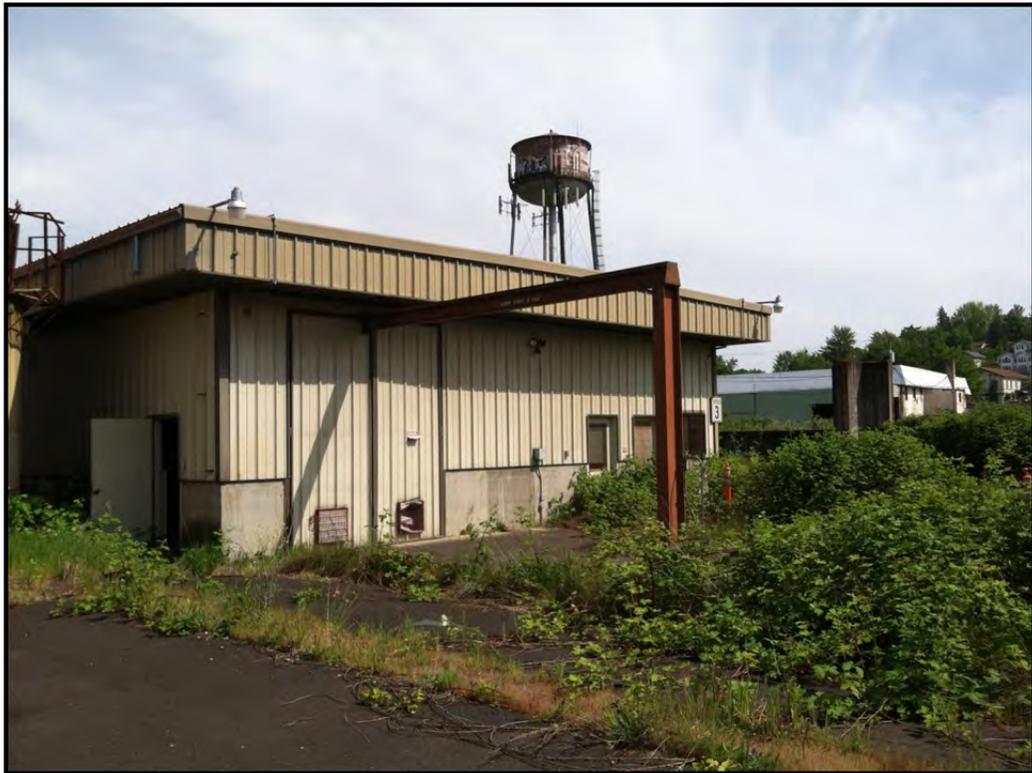
PHOTO #40: SOUTHEASTERLY DIRECTION OF BUILDING

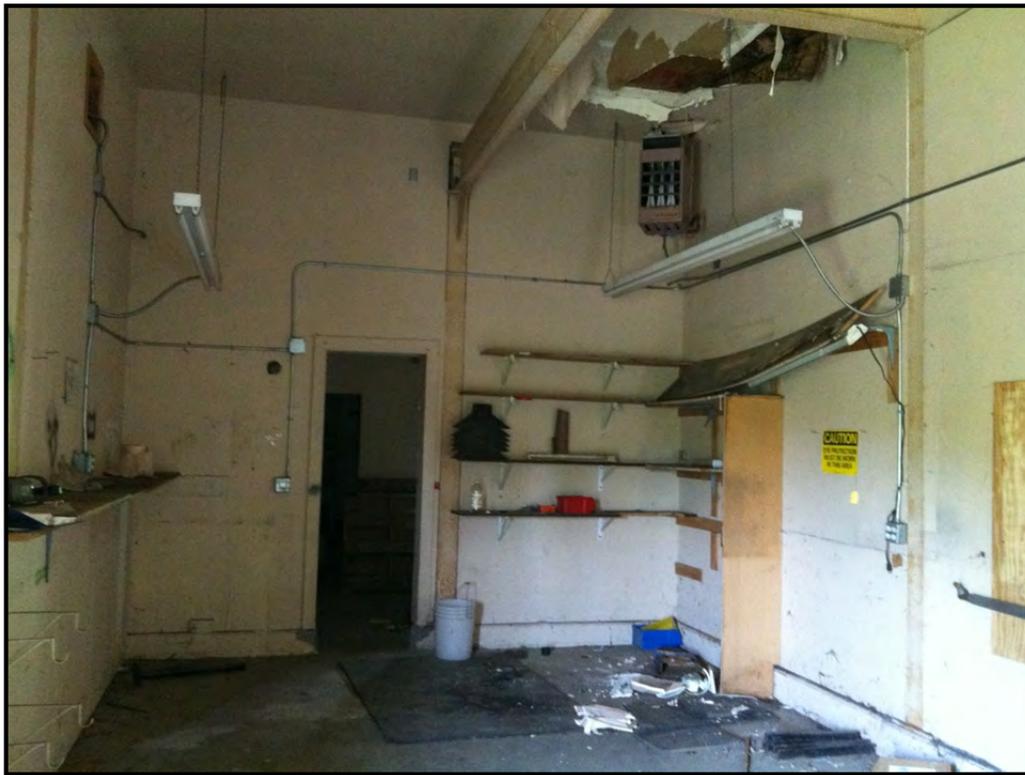
PHOTO #41: INTERIOR OF BUILDING

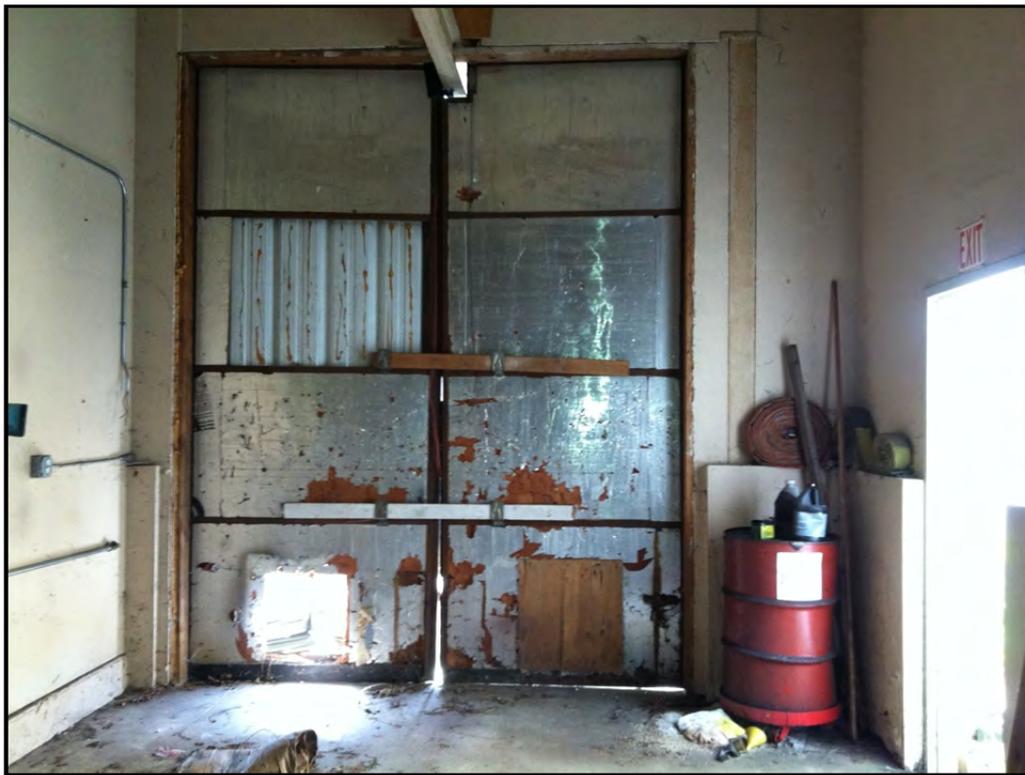
PHOTO #42: INTERIOR OF BUILDING

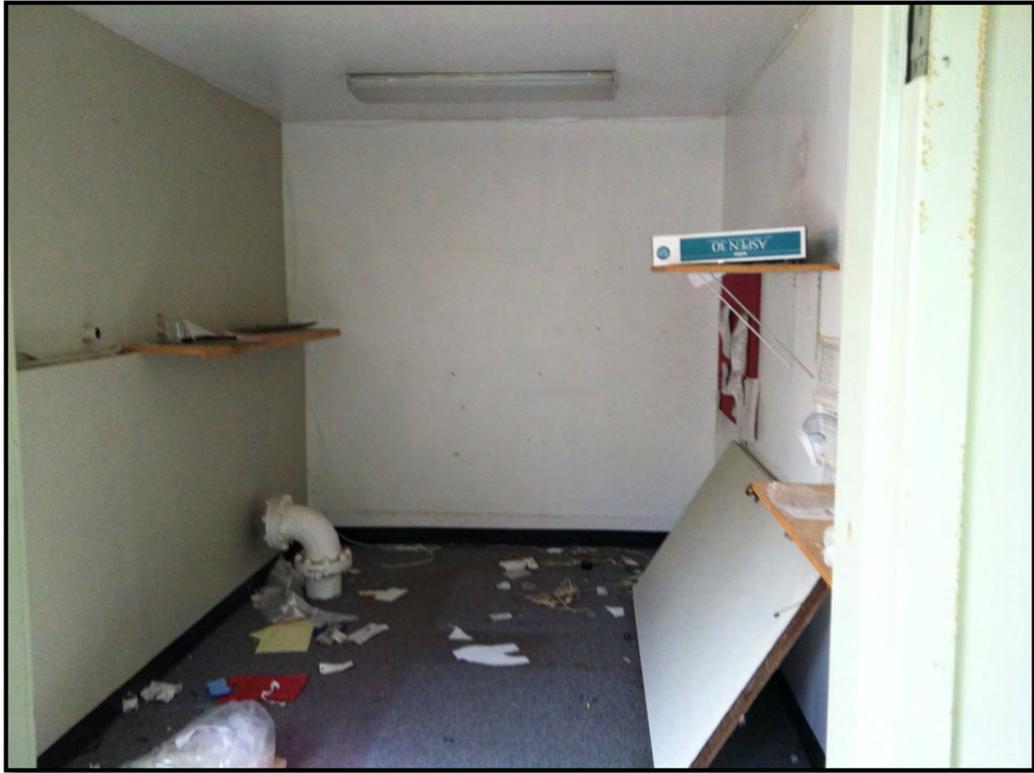
PHOTO #43: INTERIOR OF BUILDING

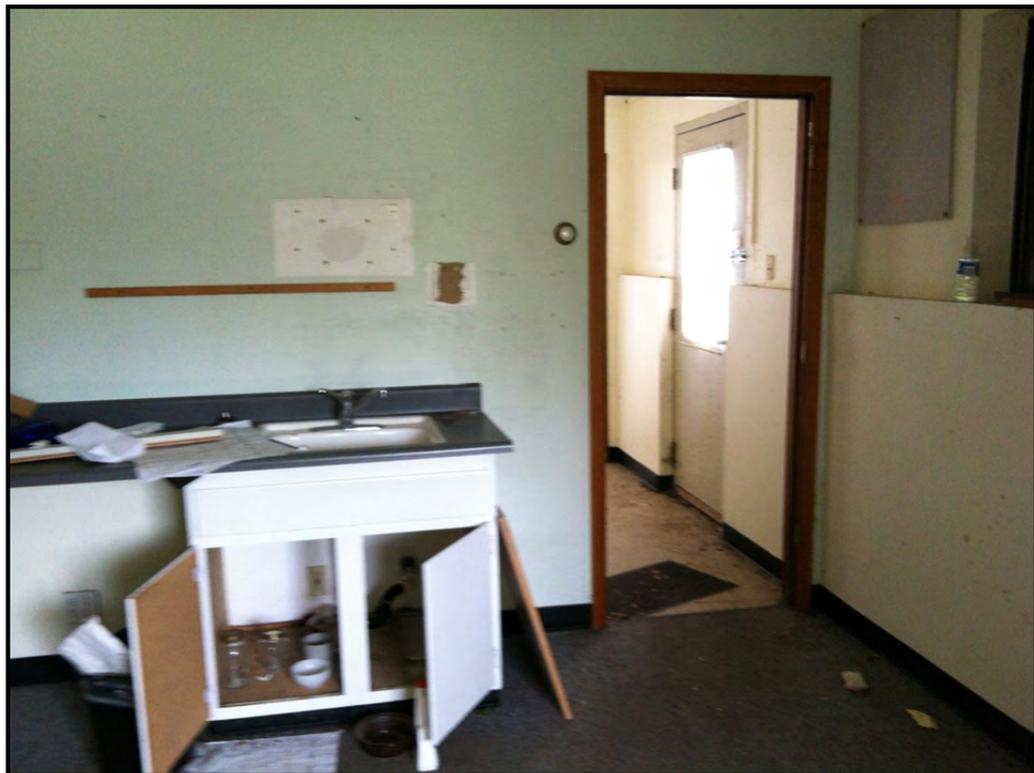
PHOTO #44: INTERIOR OF BUILDING

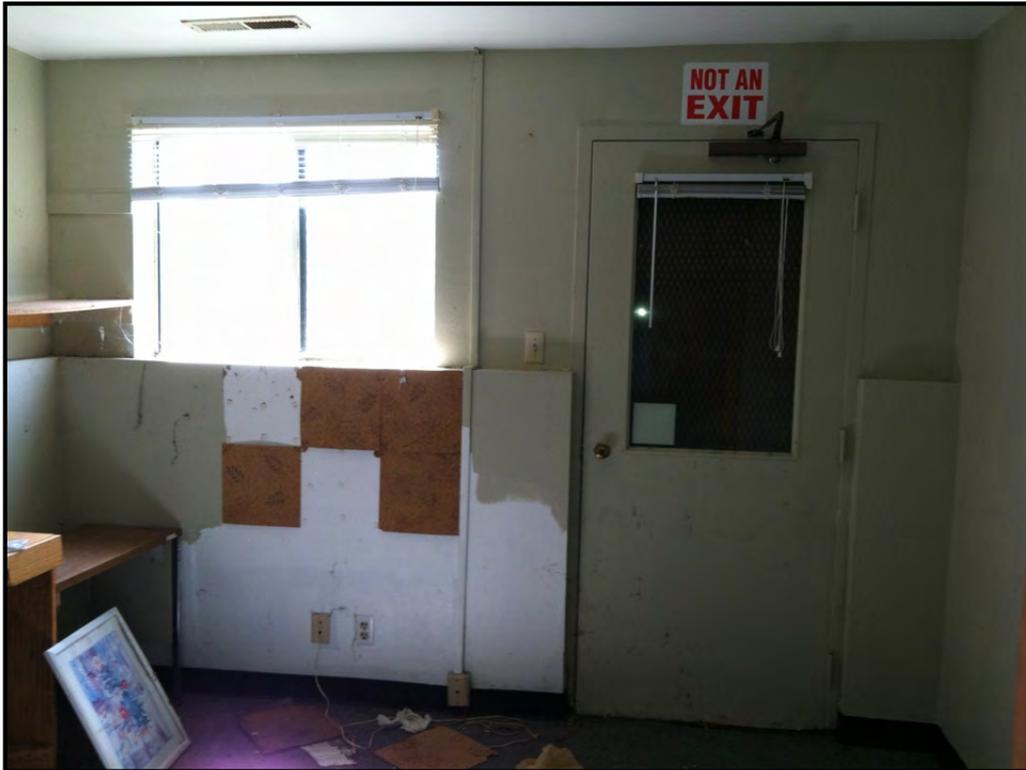
PHOTO #45: INTERIOR OF BUILDING

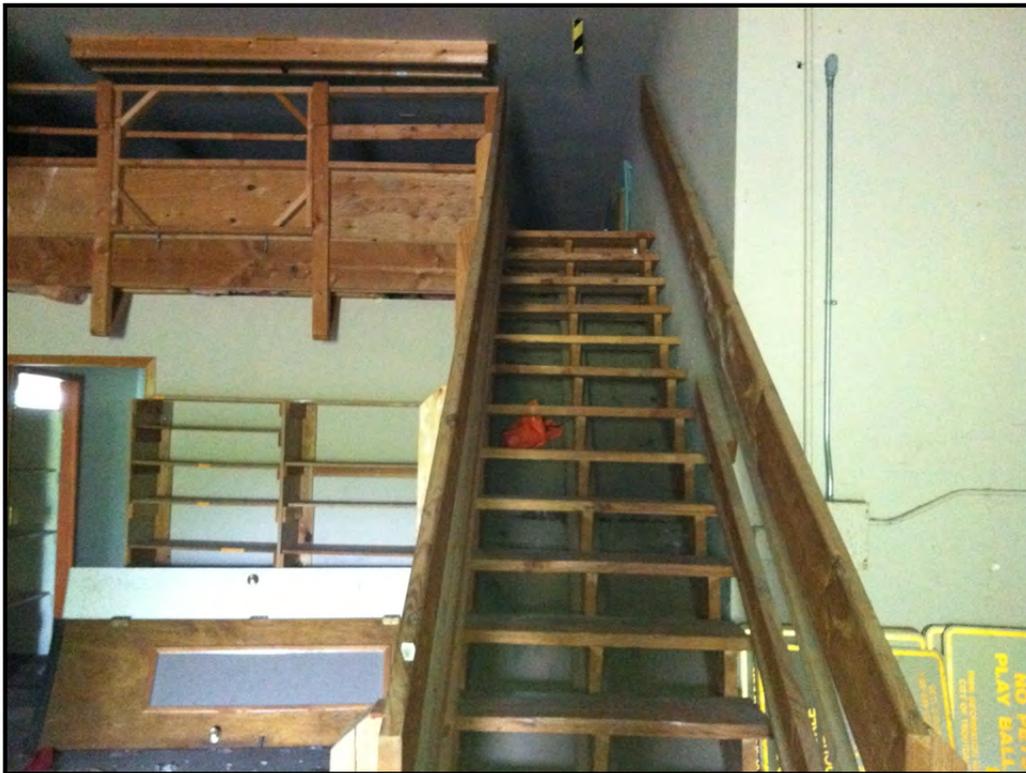
PHOTO #46: INTERIOR OF BUILDING

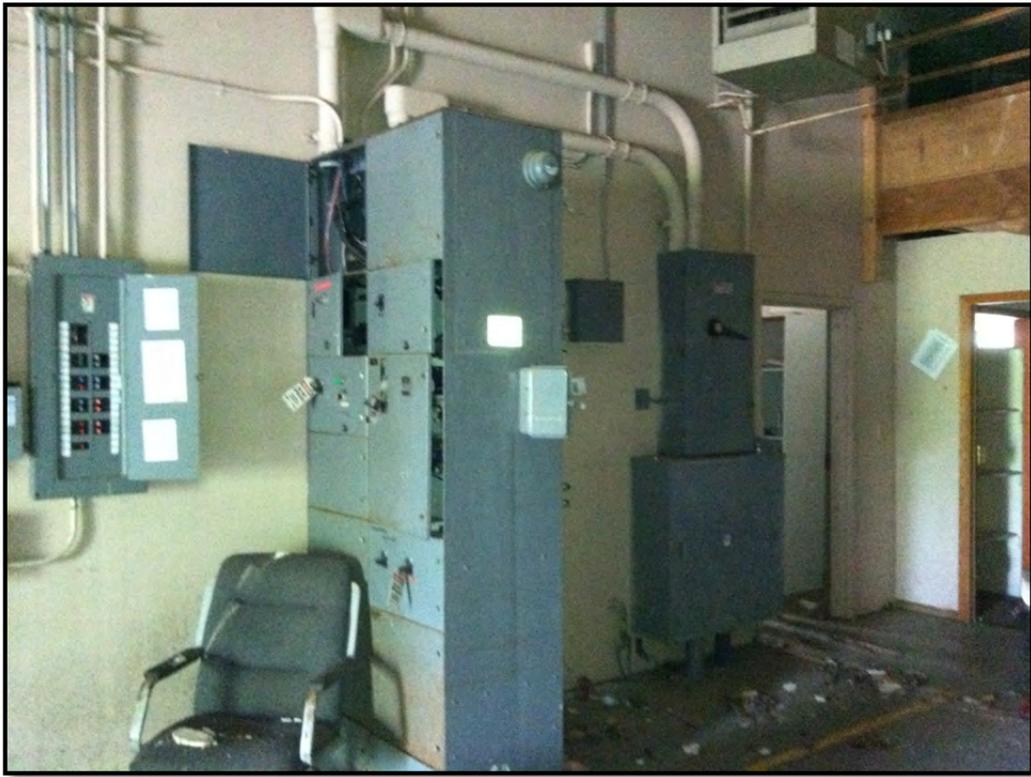
PHOTO #47: INTERIOR OF BUILDING

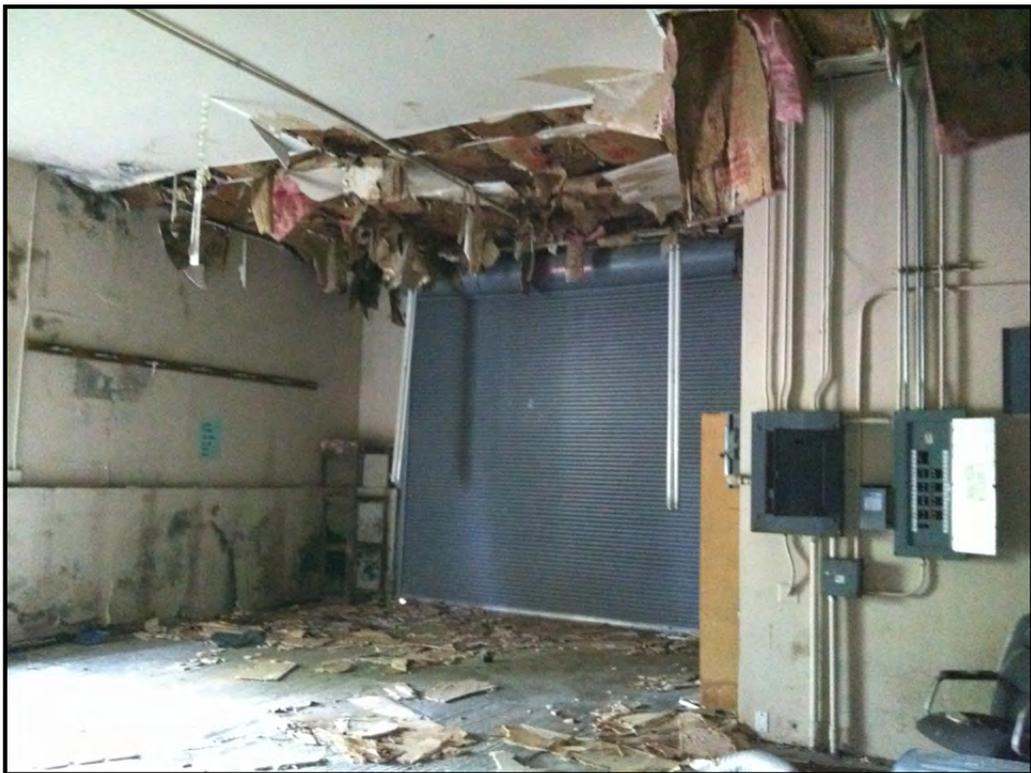
PHOTO #48: INTERIOR OF BUILDING

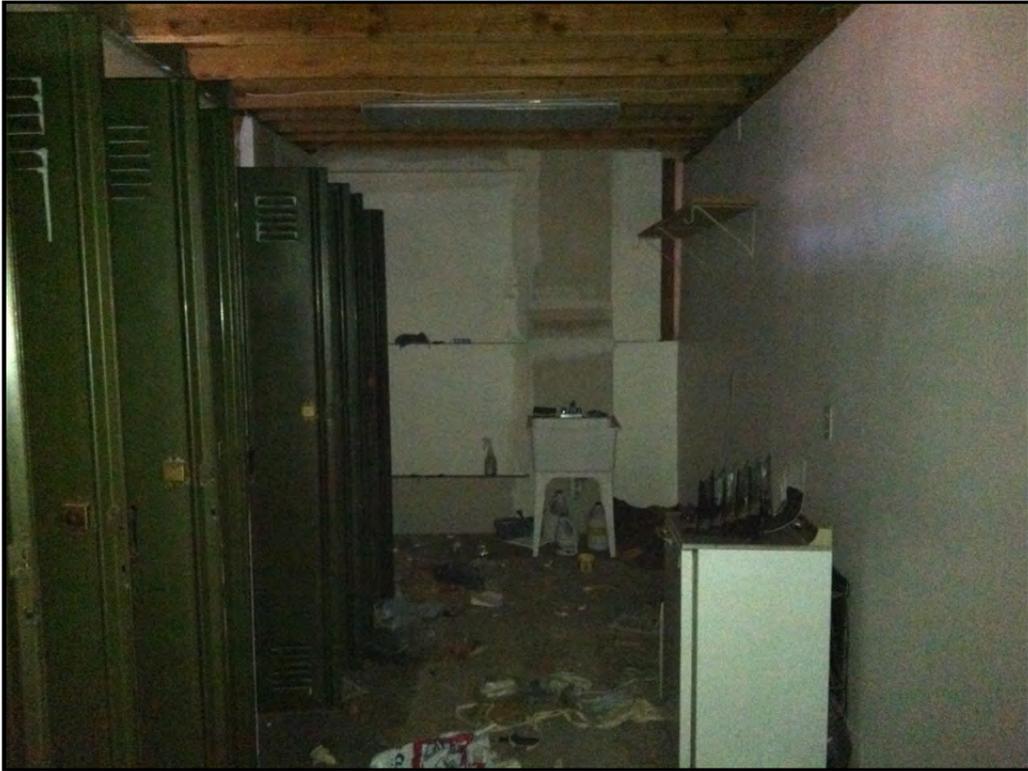
PHOTO #49: INTERIOR OF BUILDING

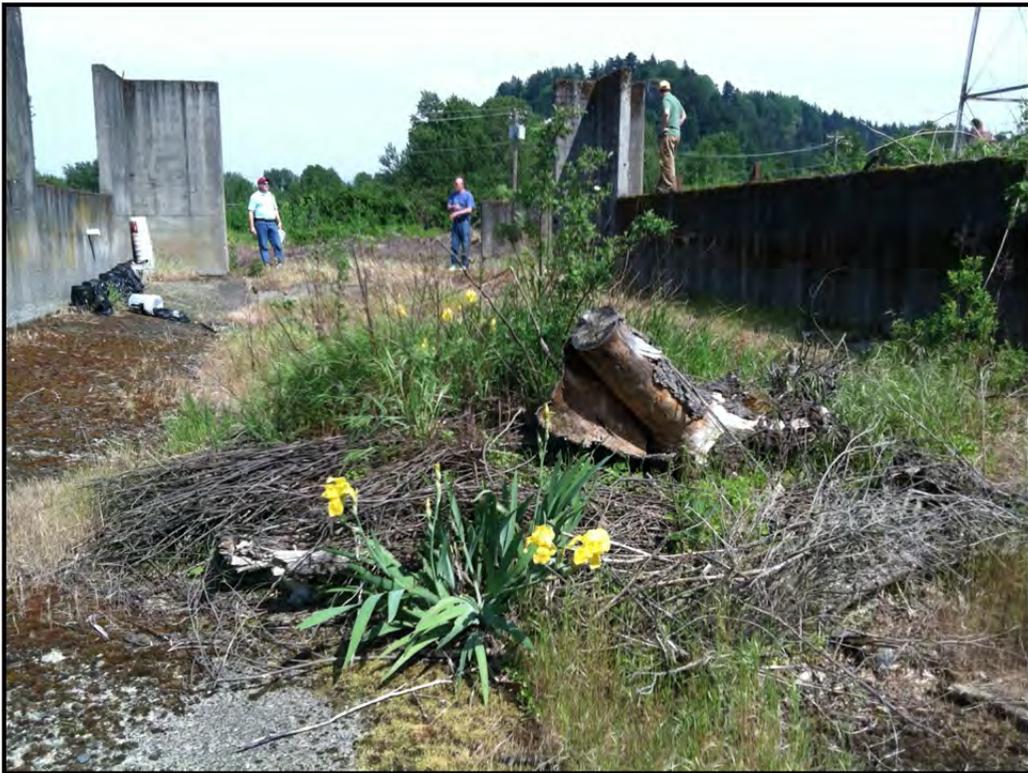
PHOTO #50: DRYING BEDS

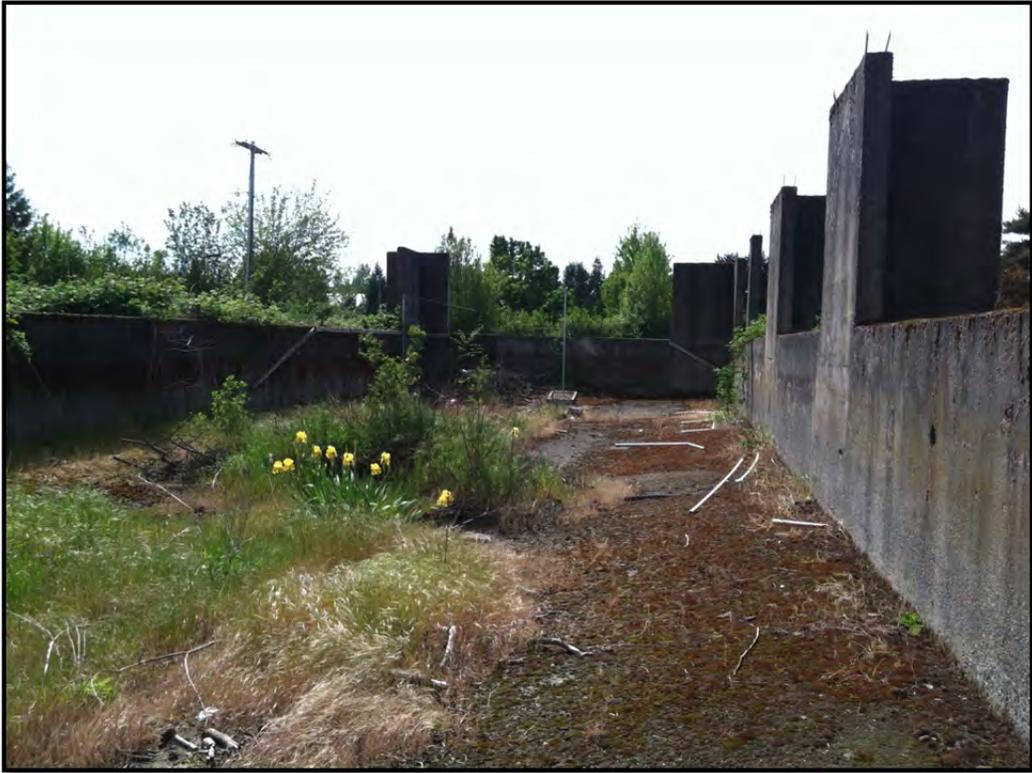
PHOTO #51: DRYING BEDS

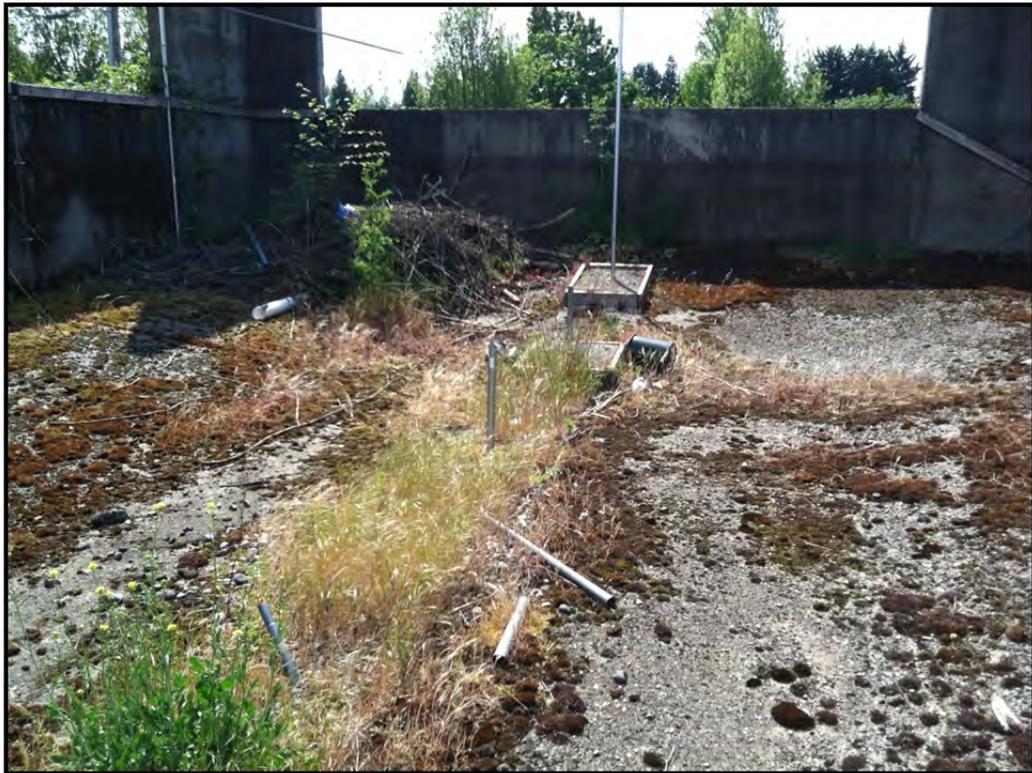
PHOTO #52: DRYING BEDS

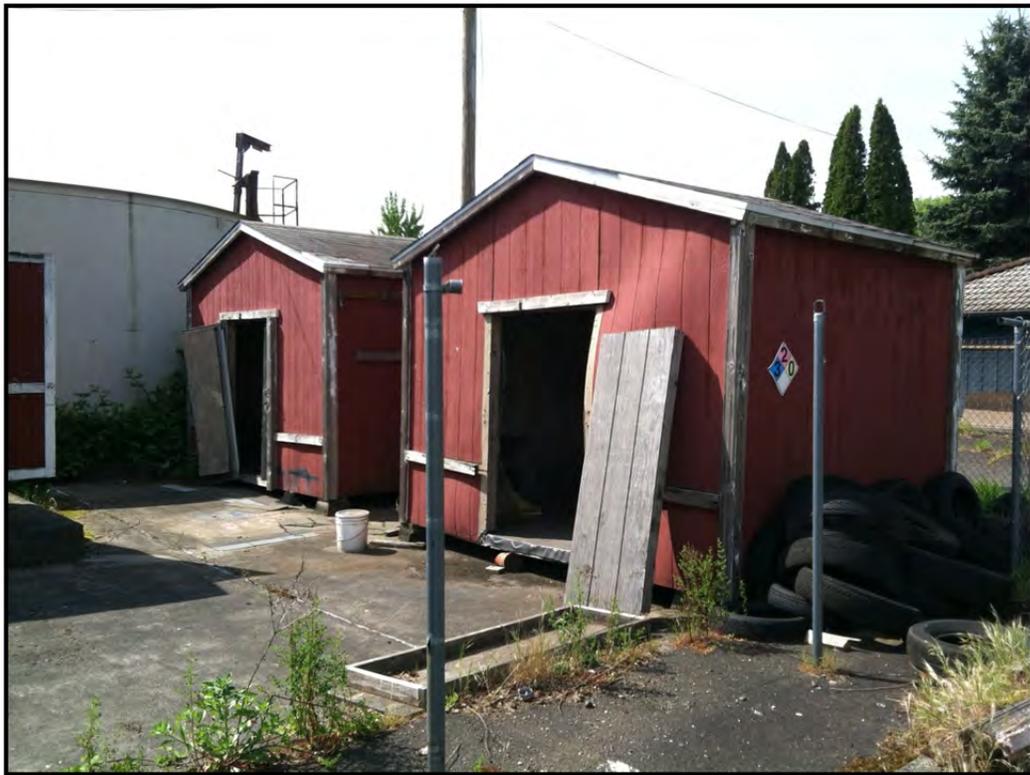
PHOTO #53: EXTERIOR OF SHED

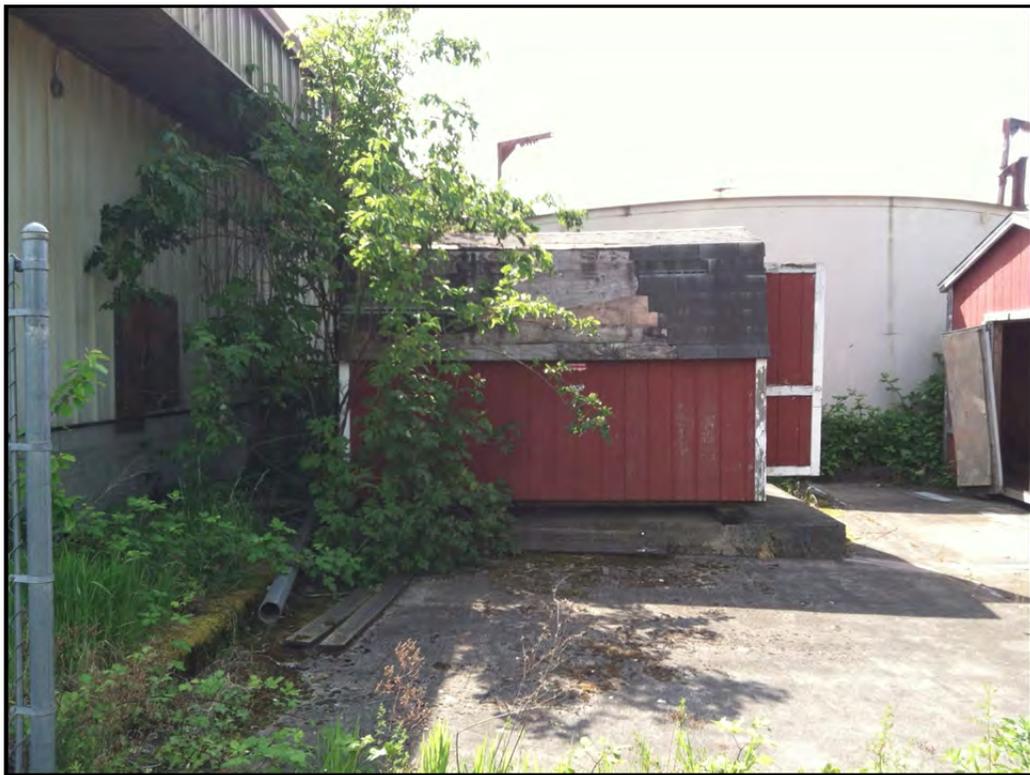
PHOTO #54: EXTERIOR OF SHED

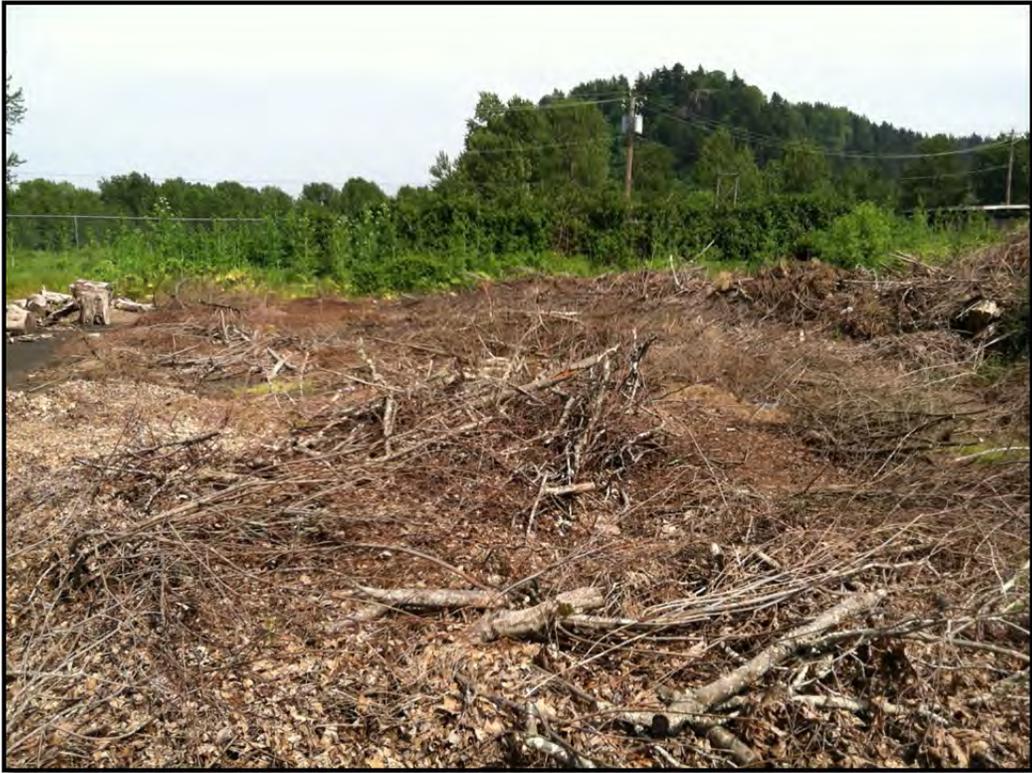
PHOTO #55: BLENDING AREA USED FOR YARD AND STREET DEBRIS

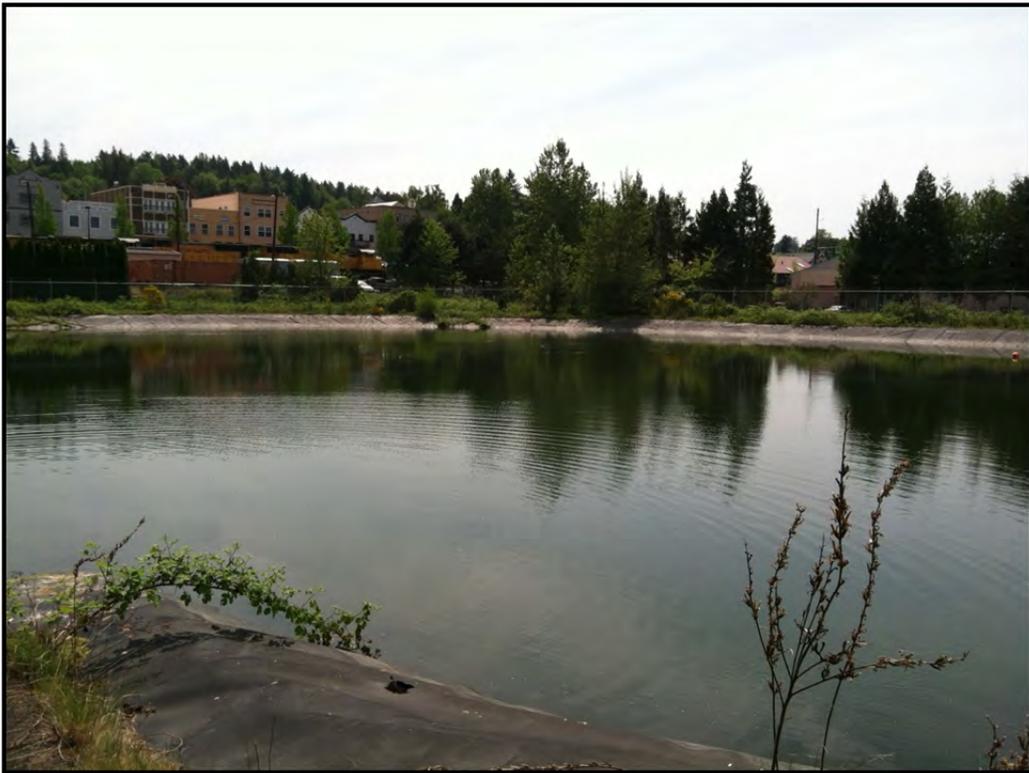
PHOTO #56: CONDITIONS OF LAGOON FACING SOUTH

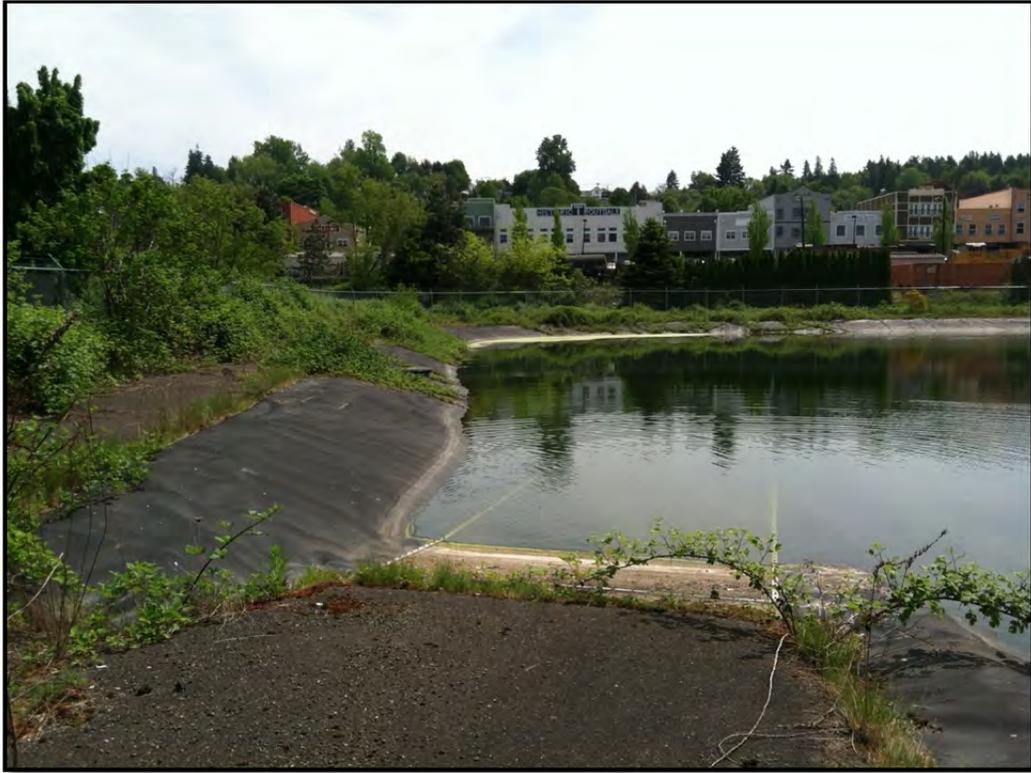
PHOTO #57: CONDITIONS OF LAGOON FACING SOUTH

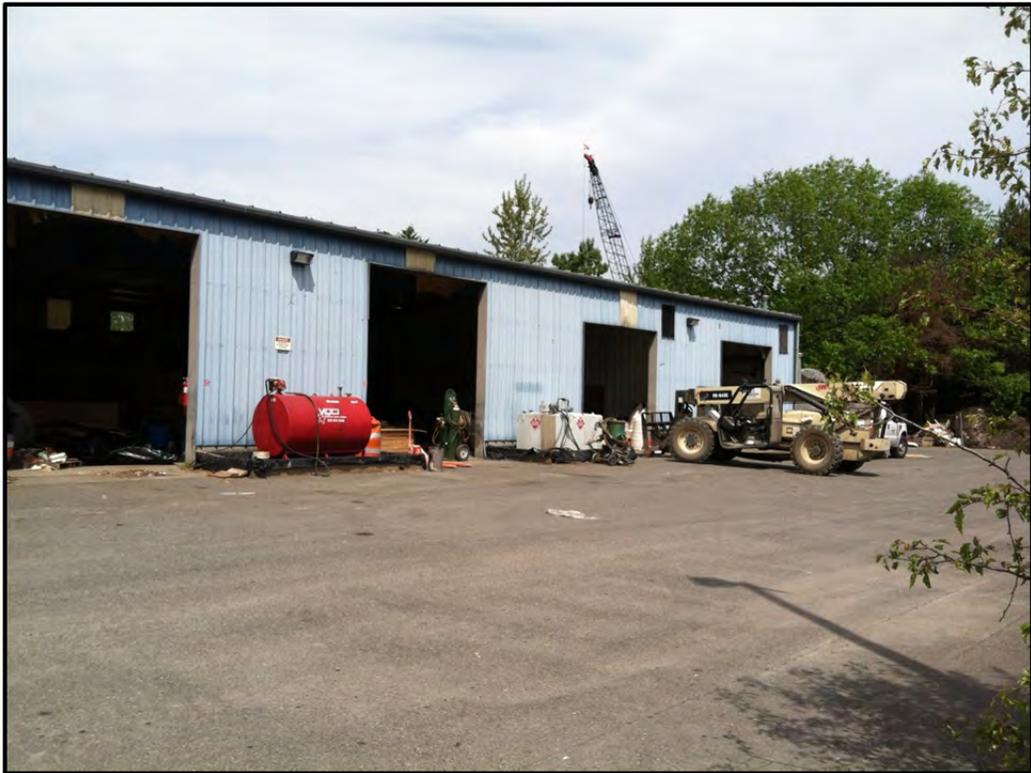
PHOTO #58: MAINTENANCE BUILDING VIEWED FROM SOUTH
