Drainage Master Plan

North Troutdale and Sandy Drainage Improvement Company Drainage Master Plan

Prepared for
Sandy Drainage Improvement Company and City of Troutdale
November 2020
Updated January 2021

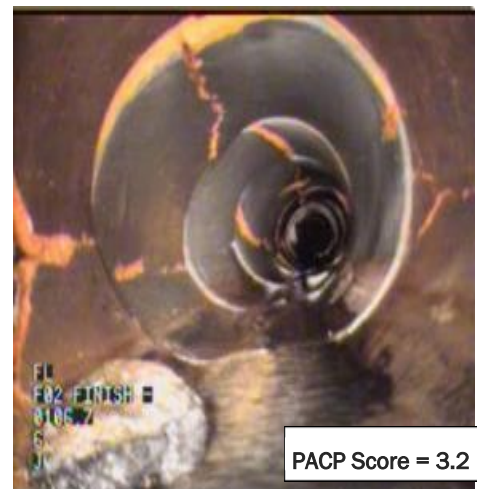
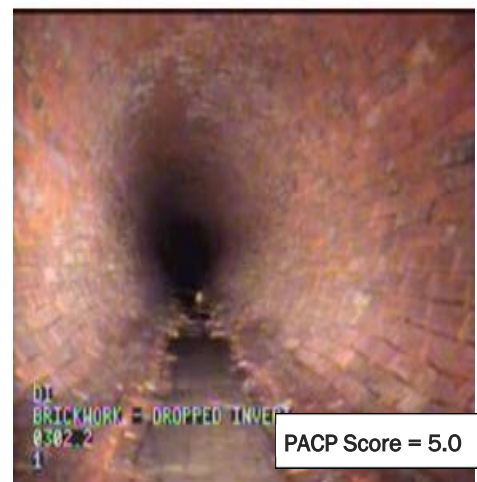
Figure 3-1. The PACP score does not tell the whole story. Engineering investigation is needed to determine rehabilitation needs.

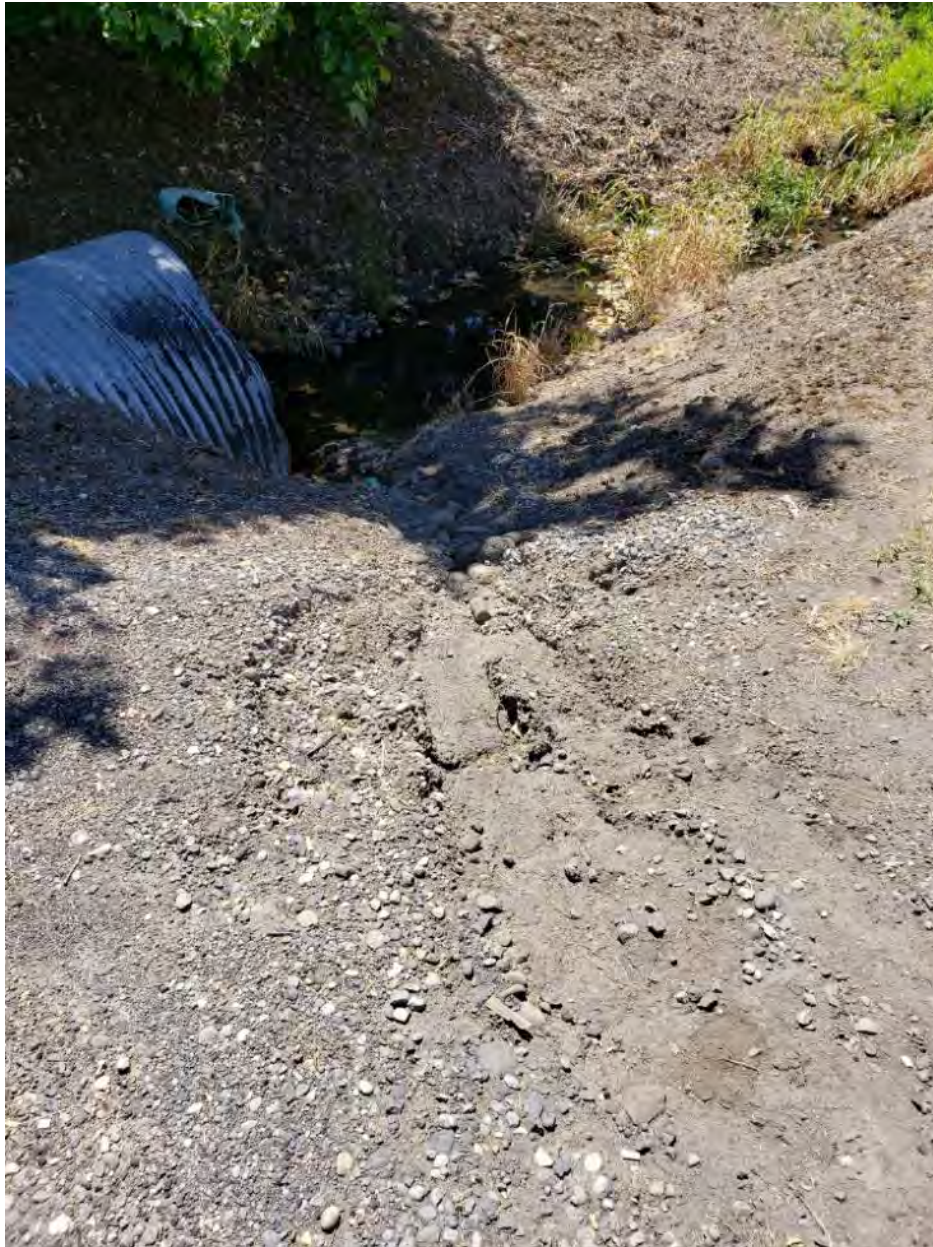
Figure 2. Filename: ArcGISApp_1560891829862.jpg - Erosion at driveway to Twelve Mile Disposal Services (2430 NW marine Dr.)

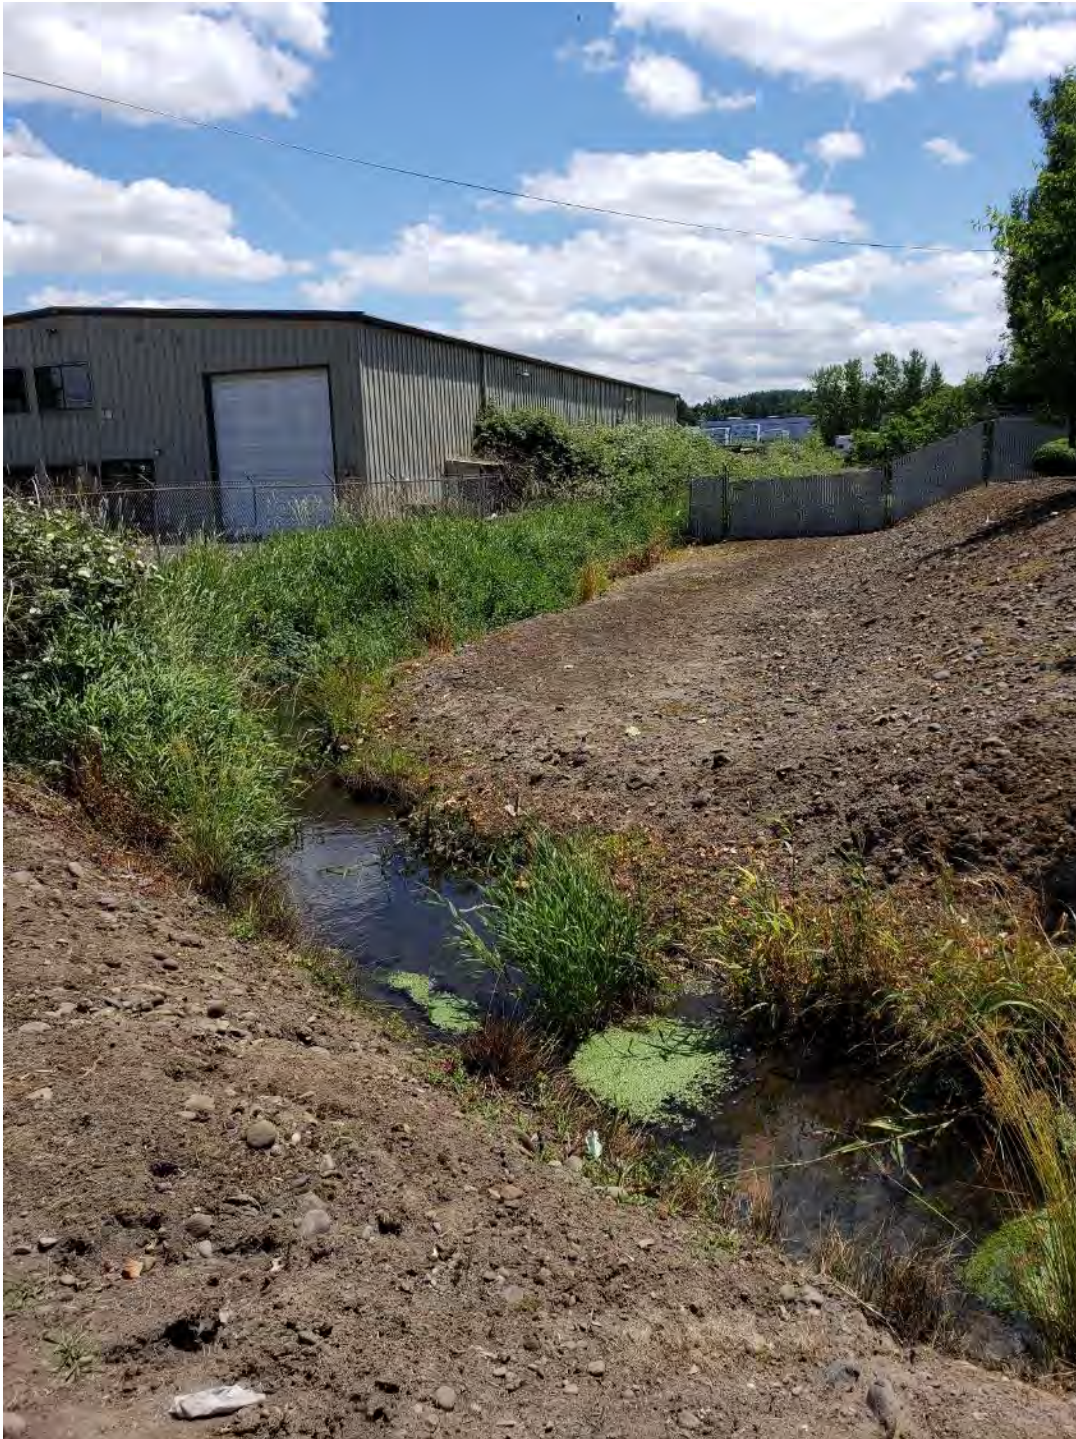
Figure 3. Filename: ArcGISApp_1560891601488.jpg - Arata Creek, North-to-West bend at Marine Dr – bank erosion.

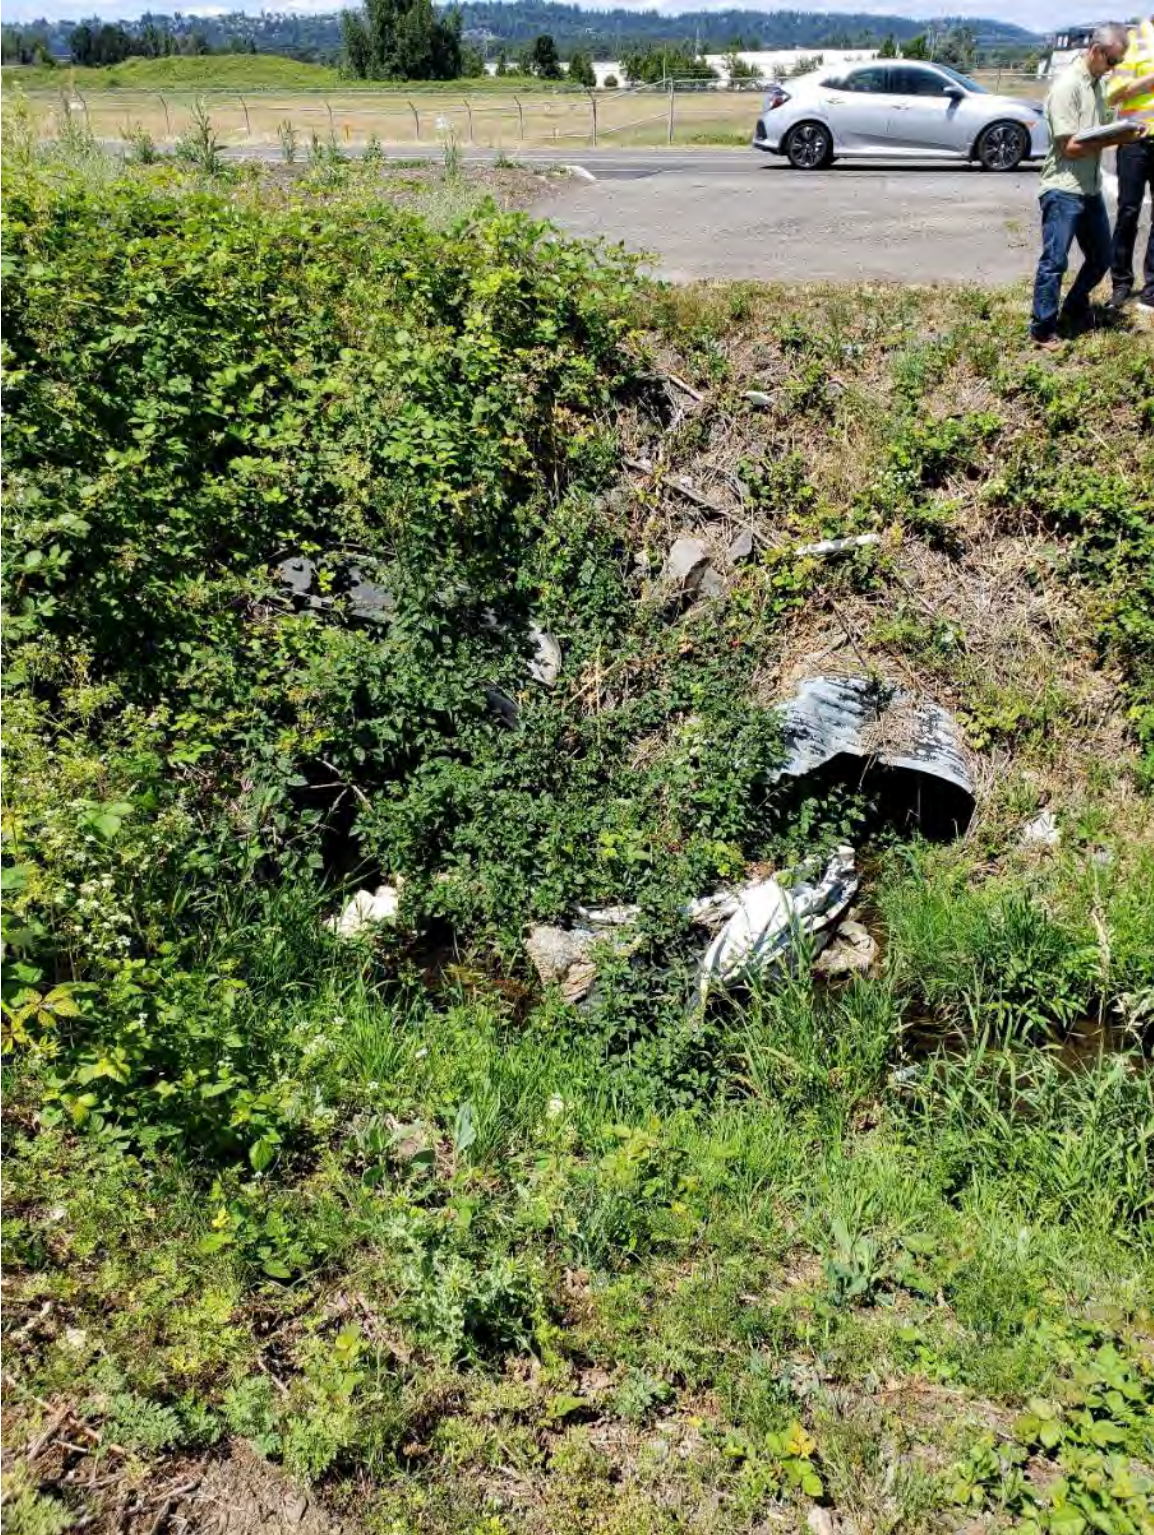
Figure 4. Filename: ArcGISApp_1560892038682.jpg - Arata creek culvert entrance, south side of Marine Drive. Debris and partially crushed CMP.

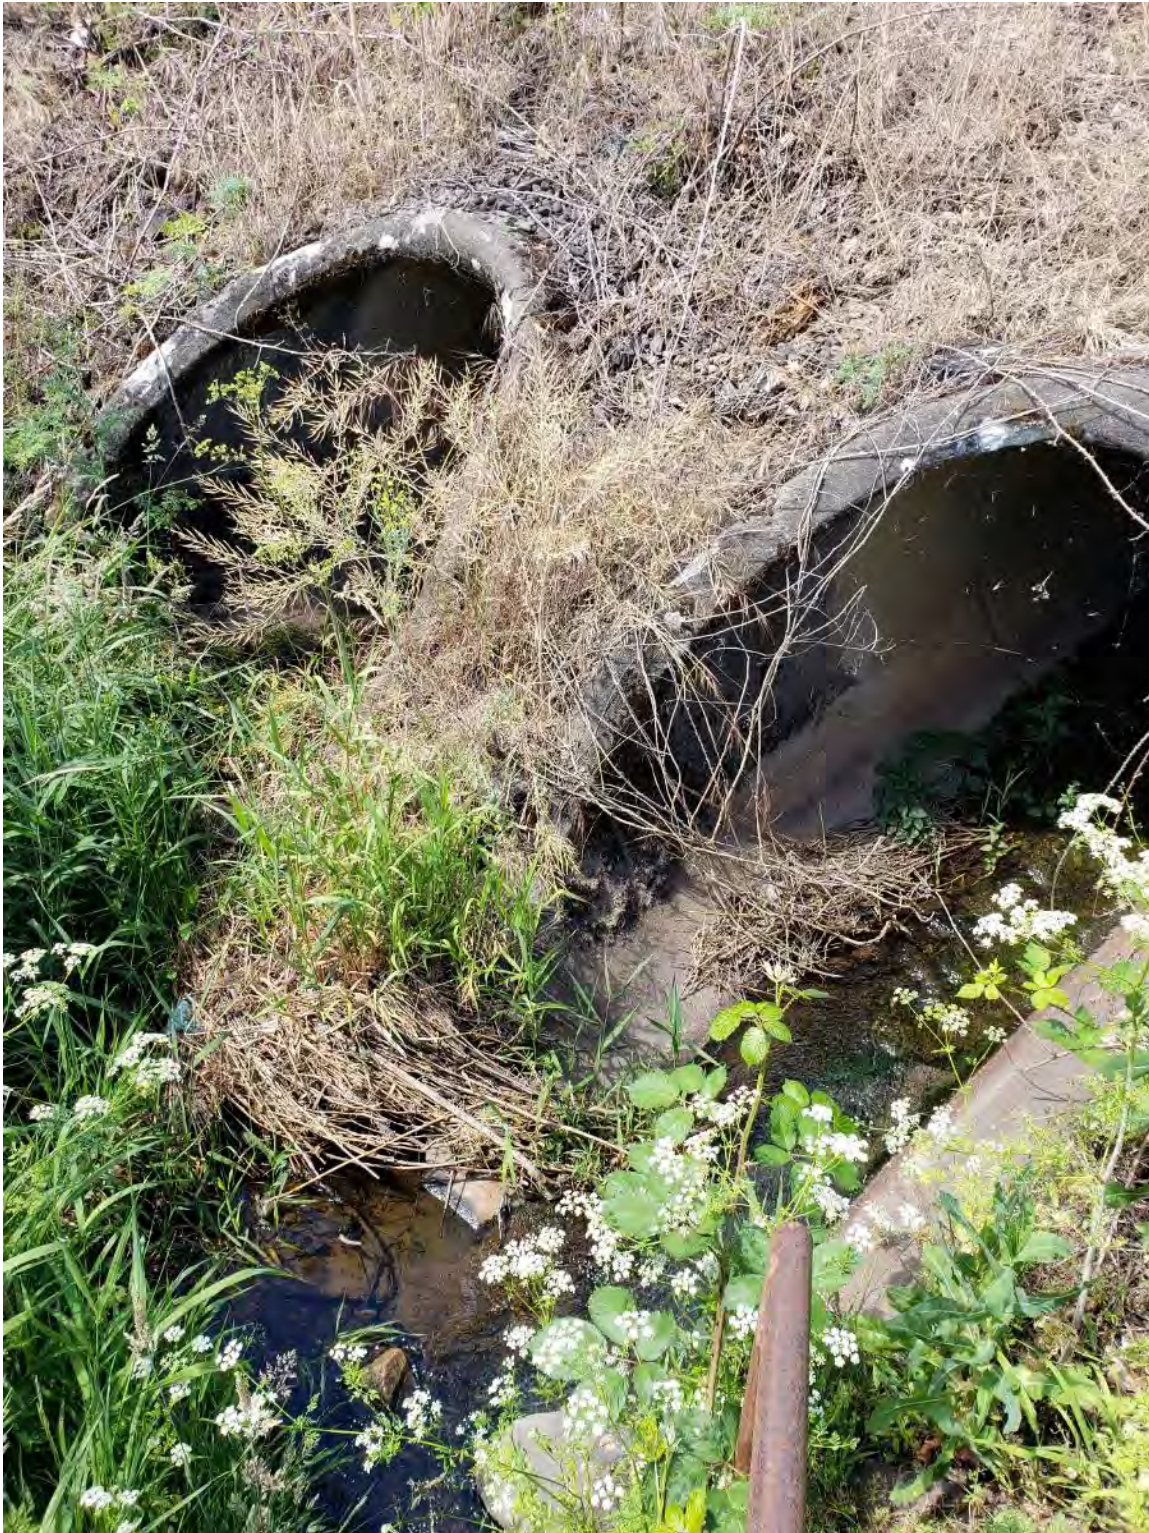
Figure 8. Filename: ArcGISApp_1560892745887.jpg - close up of Arata Creek culvert at Roger's Circle entrance (south side) – some vegetation, looked to be in good shape.

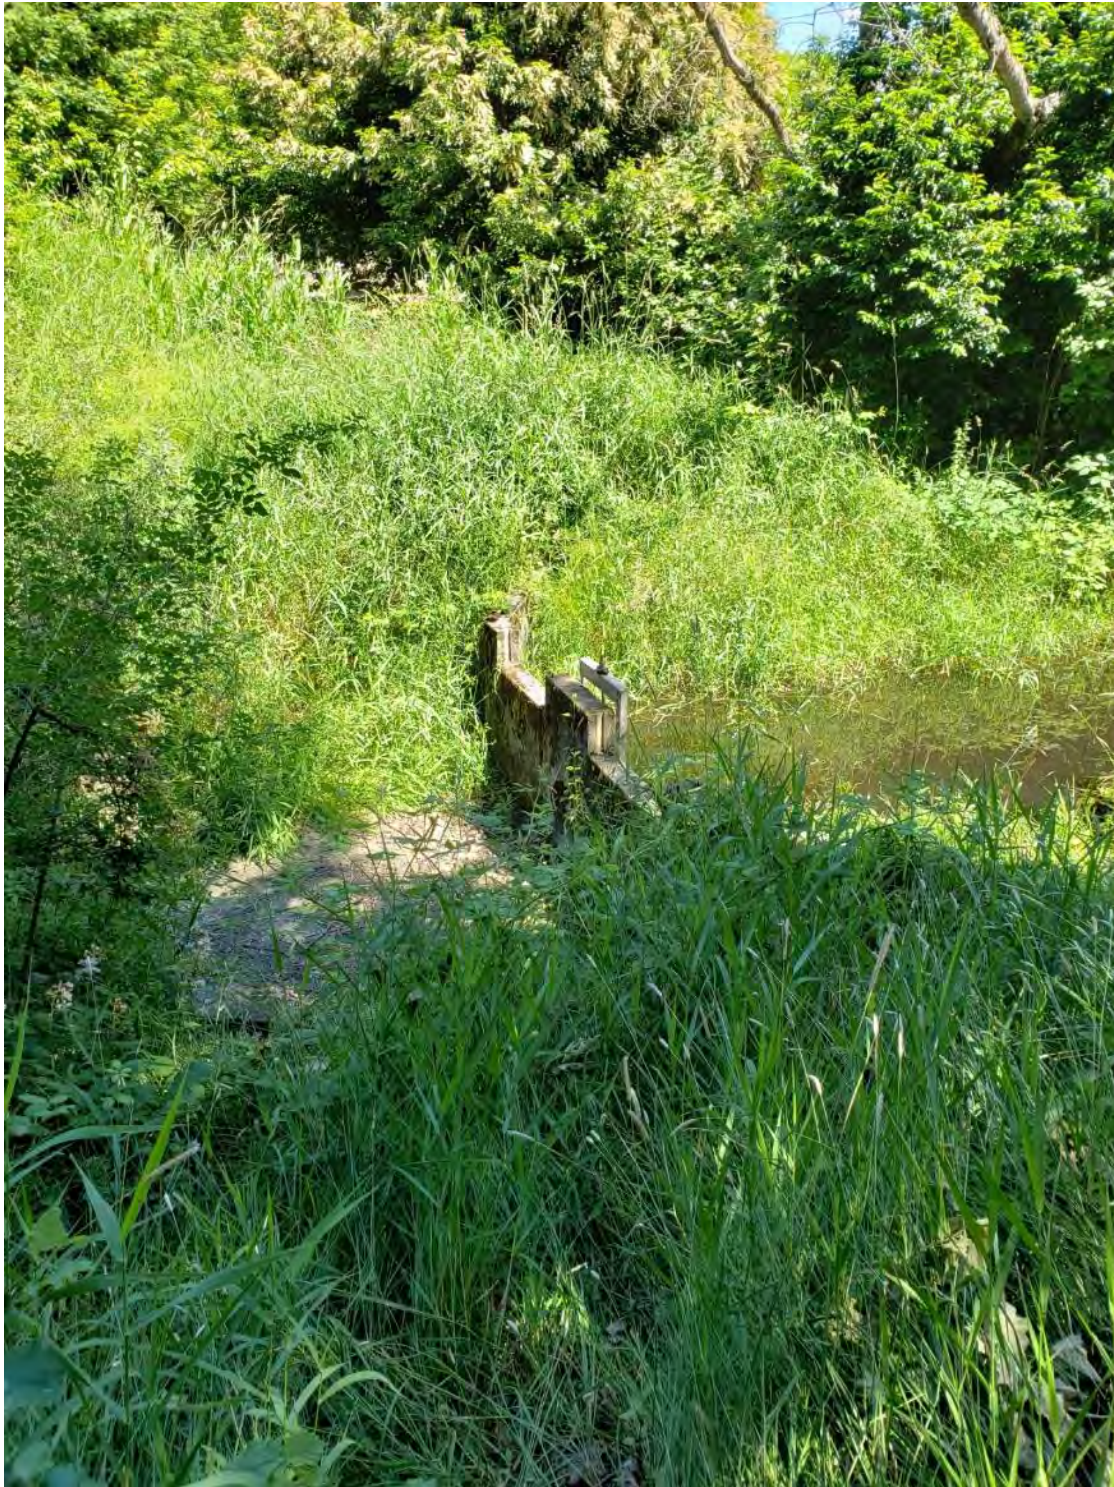
Figure 16. Filename: ArcGISApp_1560895410744.jpg - shot from behind sluice gate /overflow weir. Gate currently closed.

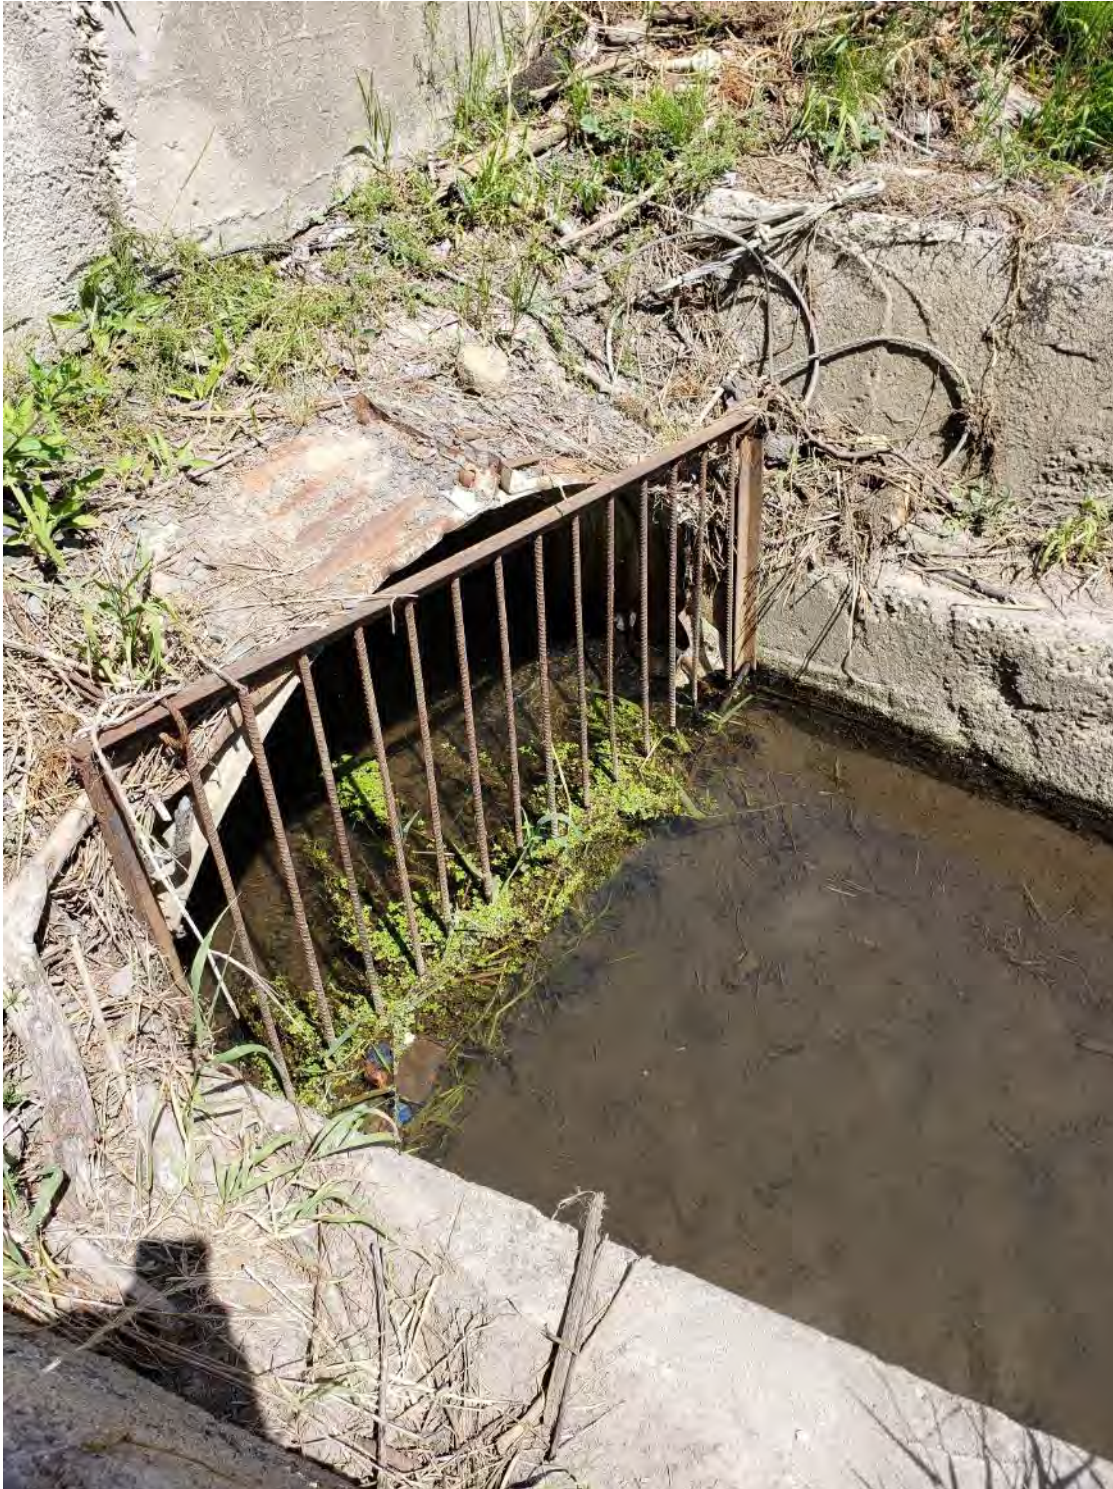
Figure 19. Filename: ArcGISApp_1560891093552.jpg - Zoom-in on culver entrance. CPP slightly crushed or elliptical shape. Some sediment build-up and vegetation growth.

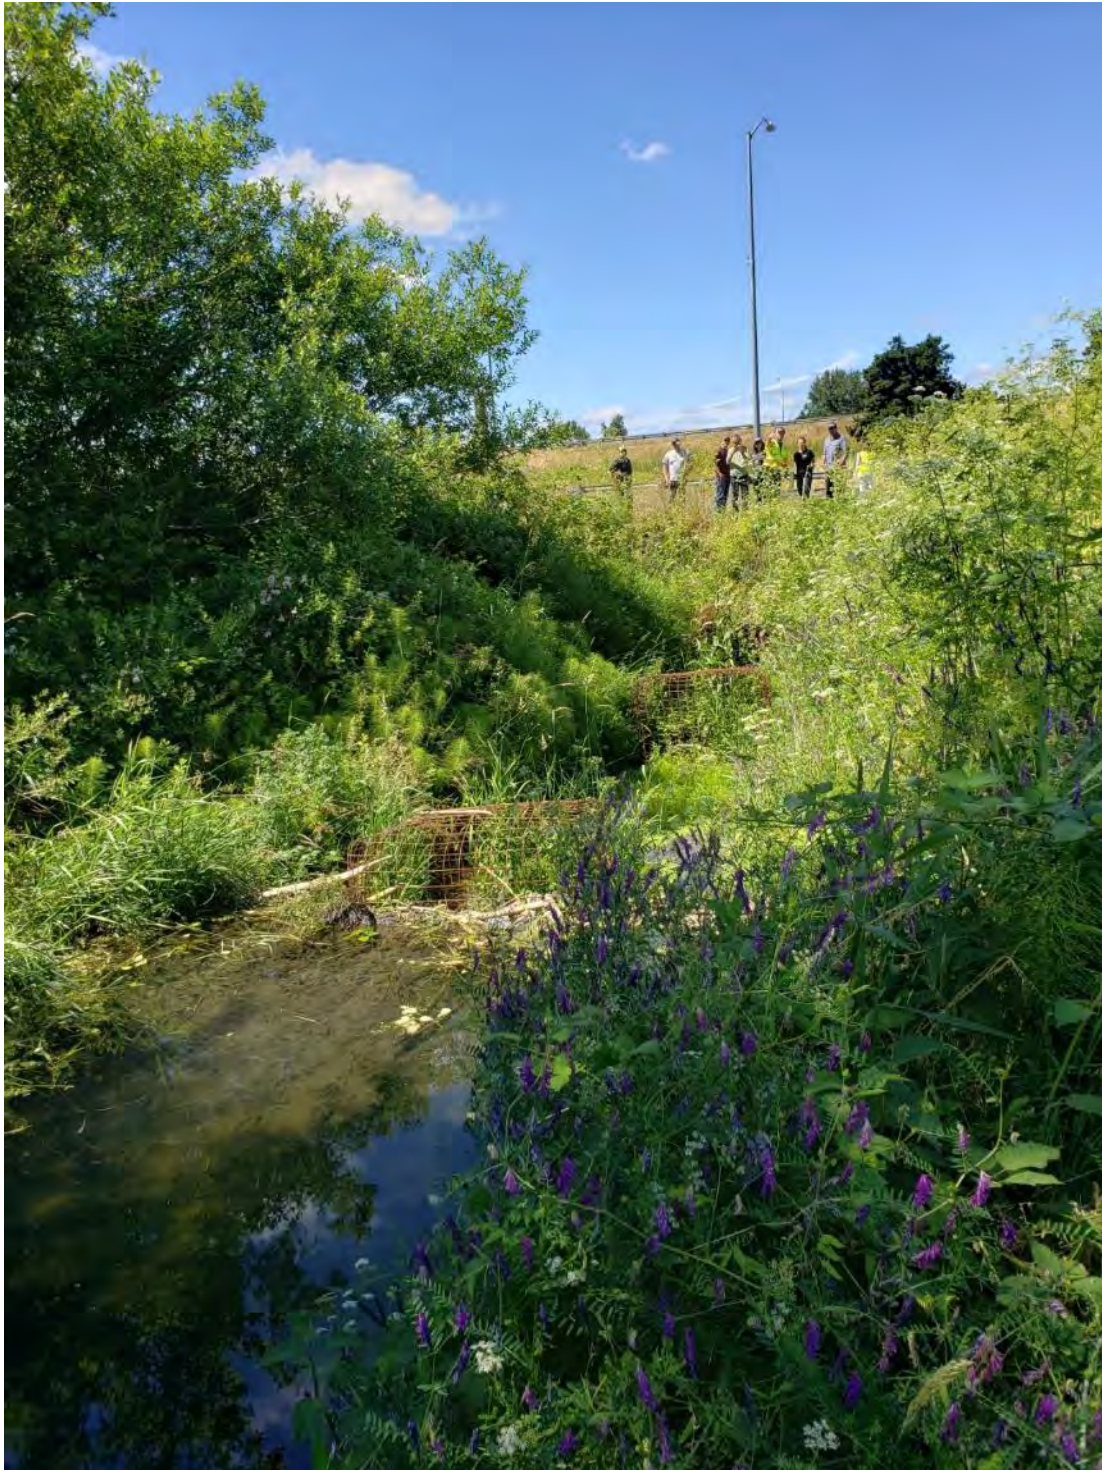
Figure 20. Filename: ArcGISApp_1560896281402.jpg - Drainage ditch south of Frontage Rd. Three beaver deceivers installed, heavy vegetation. View facing North.
