South Beaver Creek Natural Area

Restoration Project Narrative

Submitted by METRO

January 17, 2024

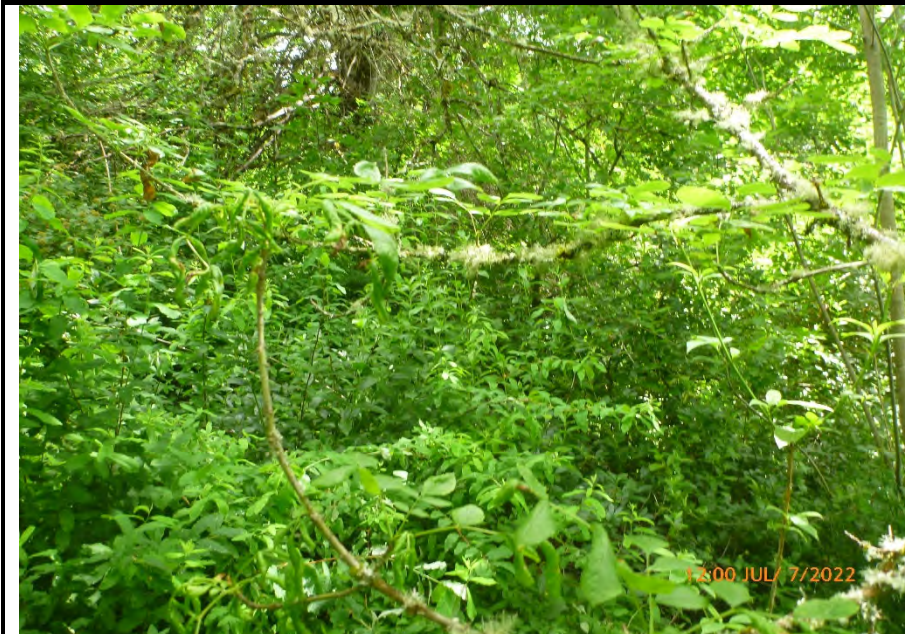
Photo point 3. Photo 1. Wetland A, in access route, looking north.

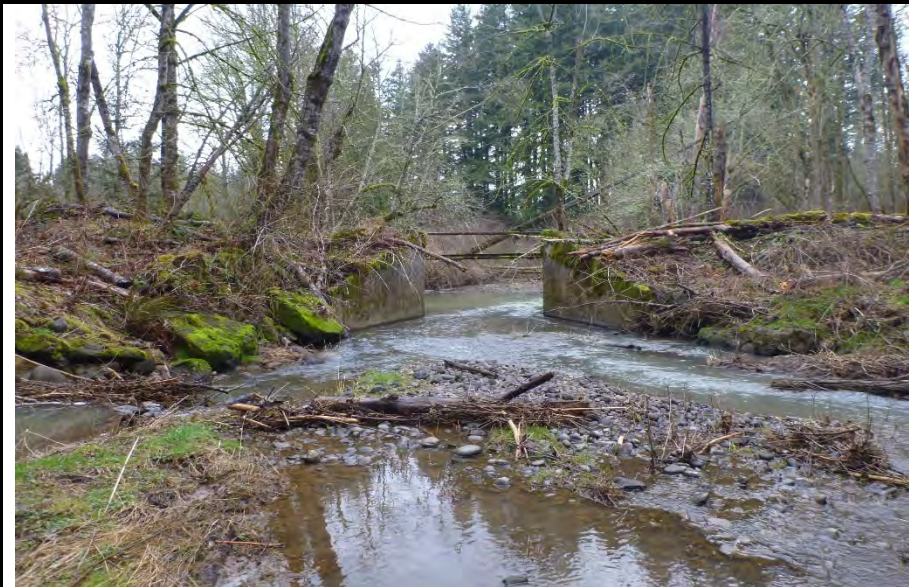
Photo point 7. Photo 1. Looking north, 320°, downstream at weir and earthen berm.

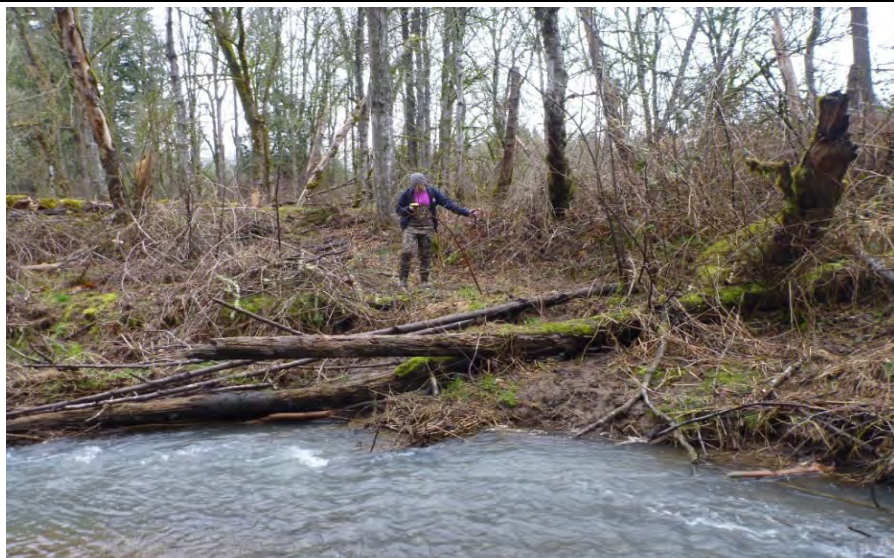
Photo point 8. Photo 1. Biologist standing on modeled OHWM at the Reach 1 and 2 boundary, above evidence of wracking, bed and bank, and natural line impressed on the bank indicators.

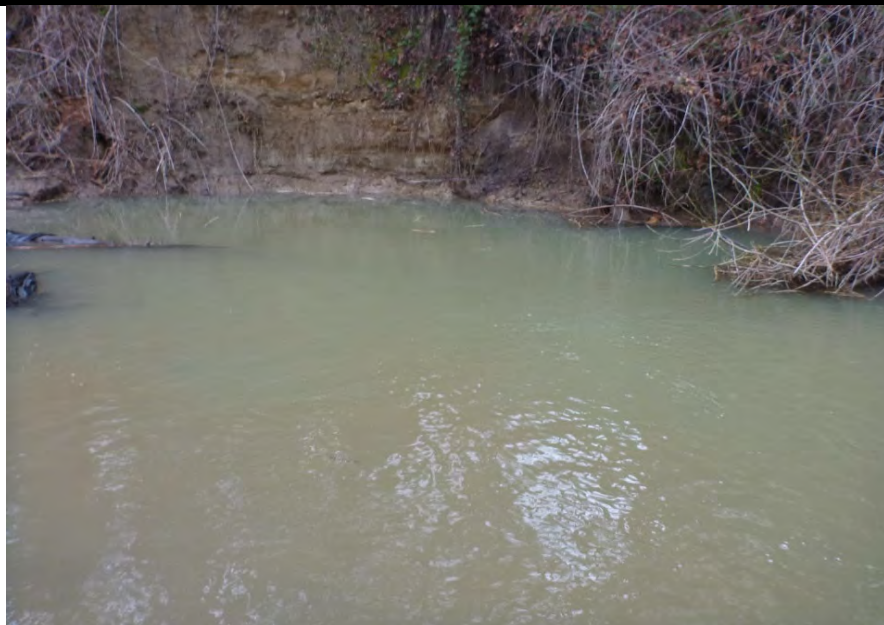
Photo point 9. Photo 2. Looking north, 15°, in beaver pond.

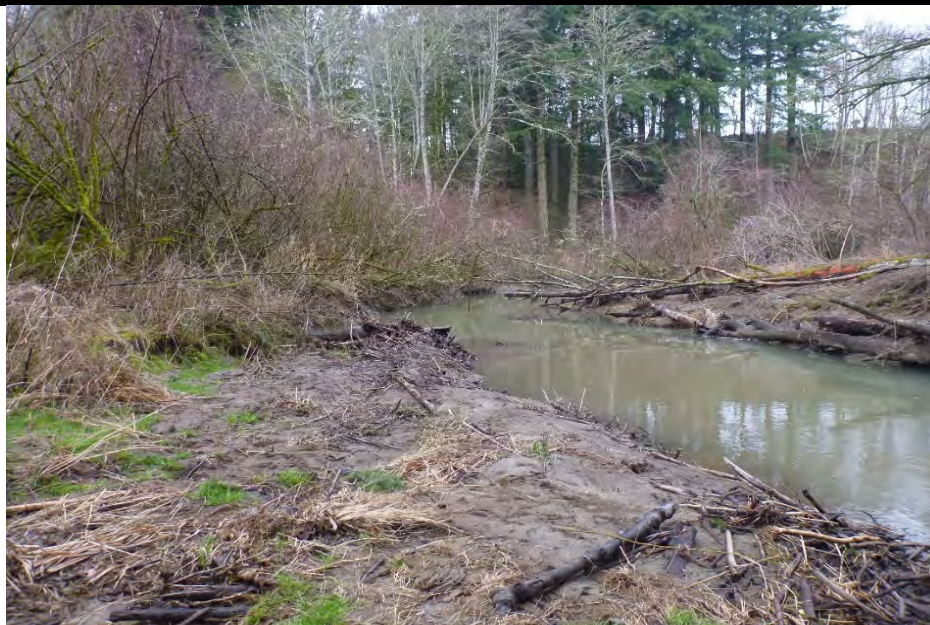
Photo point 9. Photo 3. Looking southeast, 240°, backwatered from beaver dam.

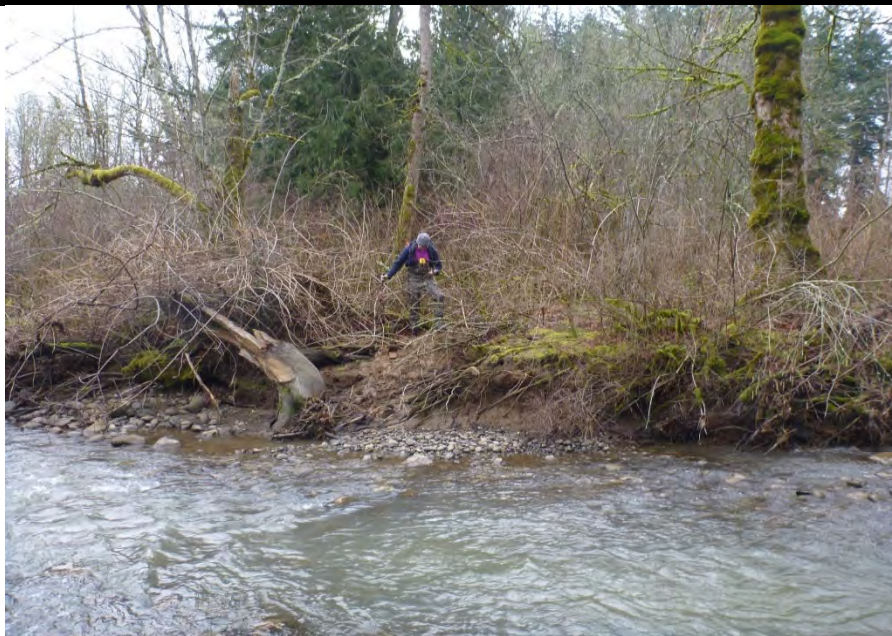
Photo point 10. Photo 1. Biologist standing at modeled OHW at the Reach 2 and 3 boundary, above areas of scour, bed and bank, and shelving indicators.

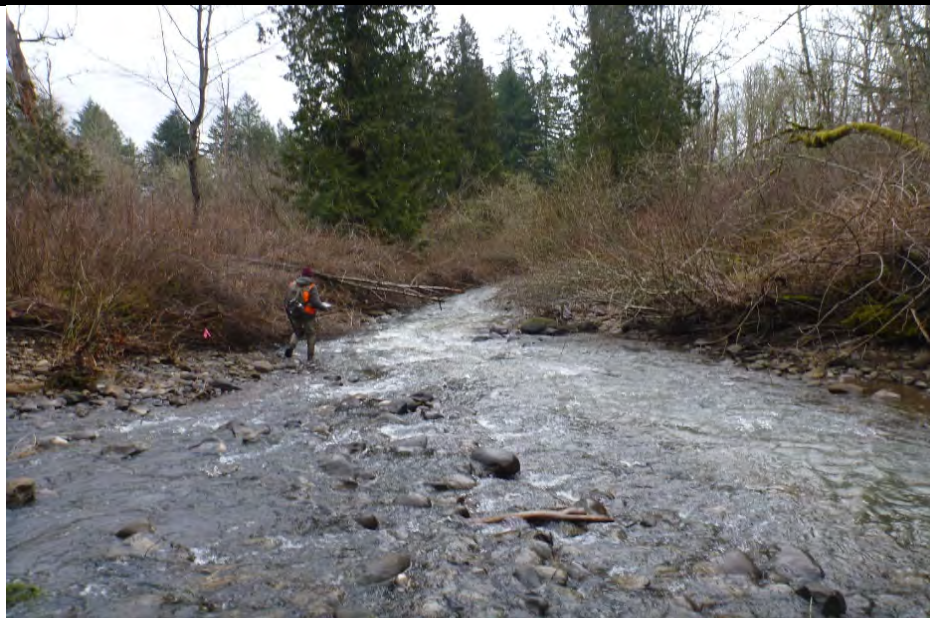
Photo point 11. Photo 3. Looking east, 80°, downstream at Kelly Cr. confluence.

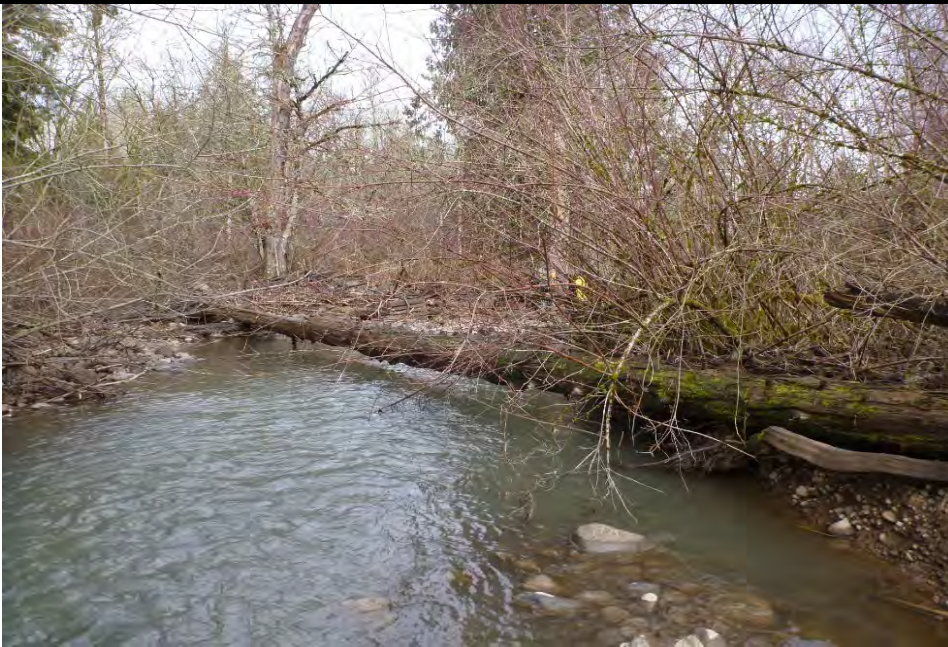
Photo point 12. Photo 2. Looking north, 10°, downstream.

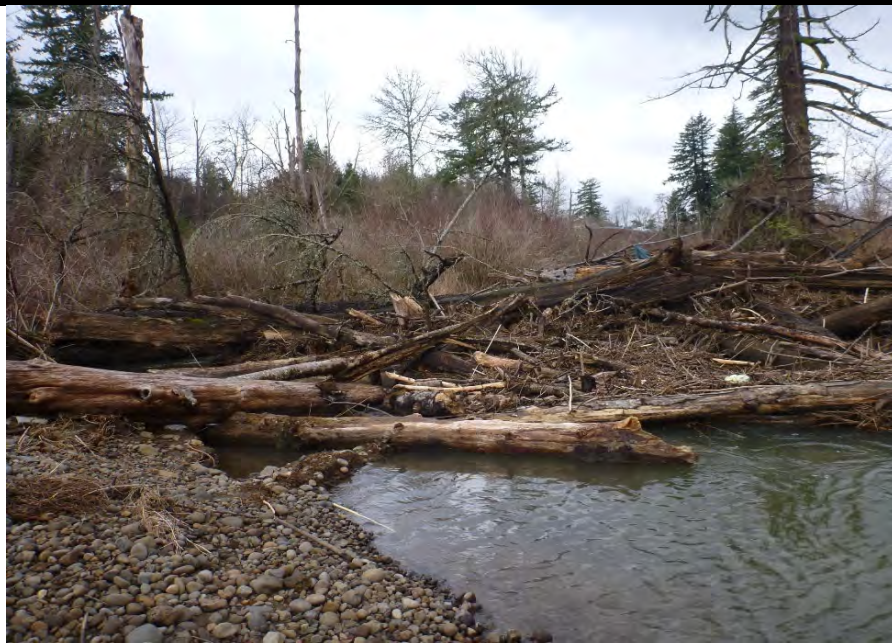
Photo point 13. Photo 1. Looking north, 350°, at debris jam.

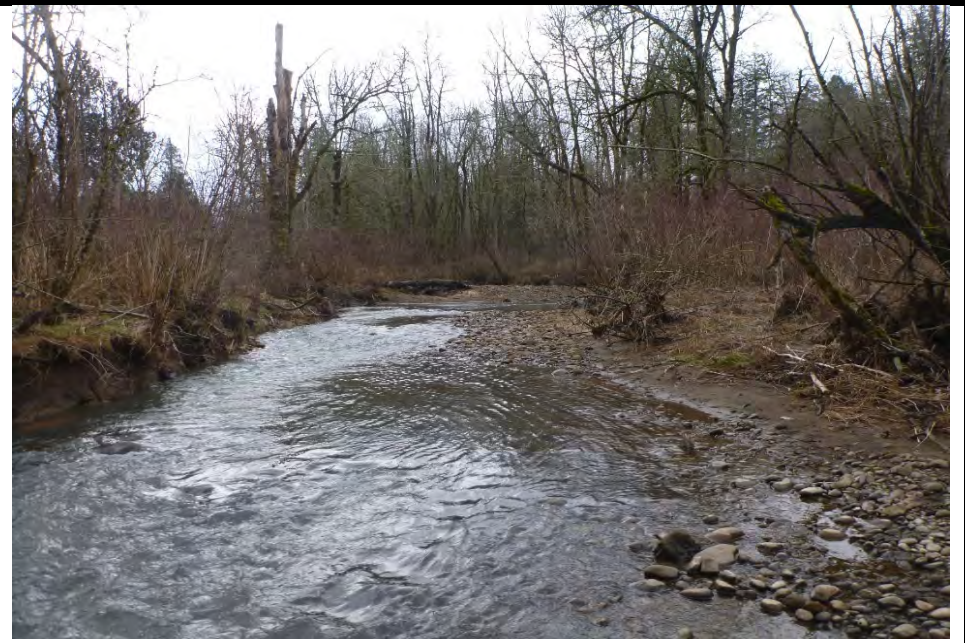
Photo point 13. Photo 2. Looking southeast, 220° upstream.

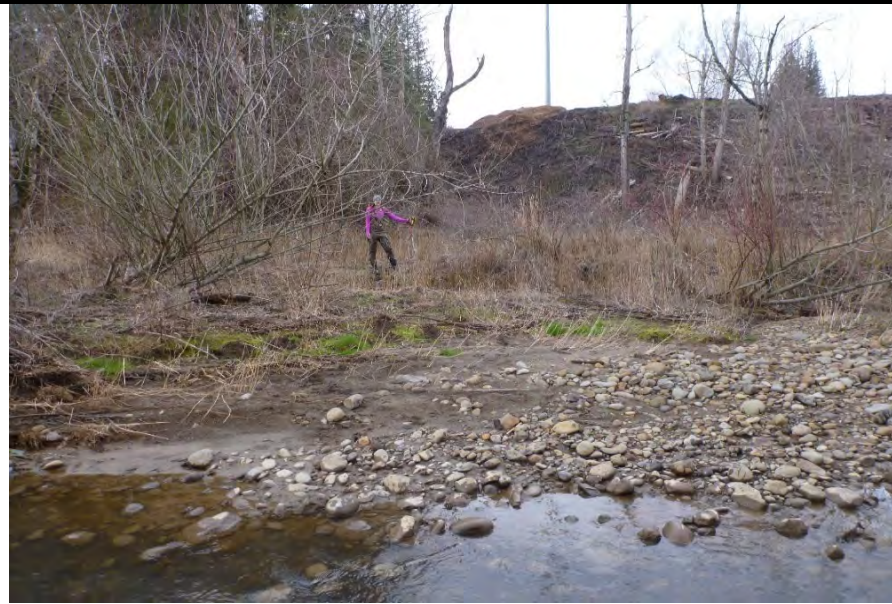
Photo point 14. Photo 1. Biologist standing at modeled OHW line at the Reach 3 and 4 boundary above destruction of terrestrial plant community, sediment sorting and deposition indicators.

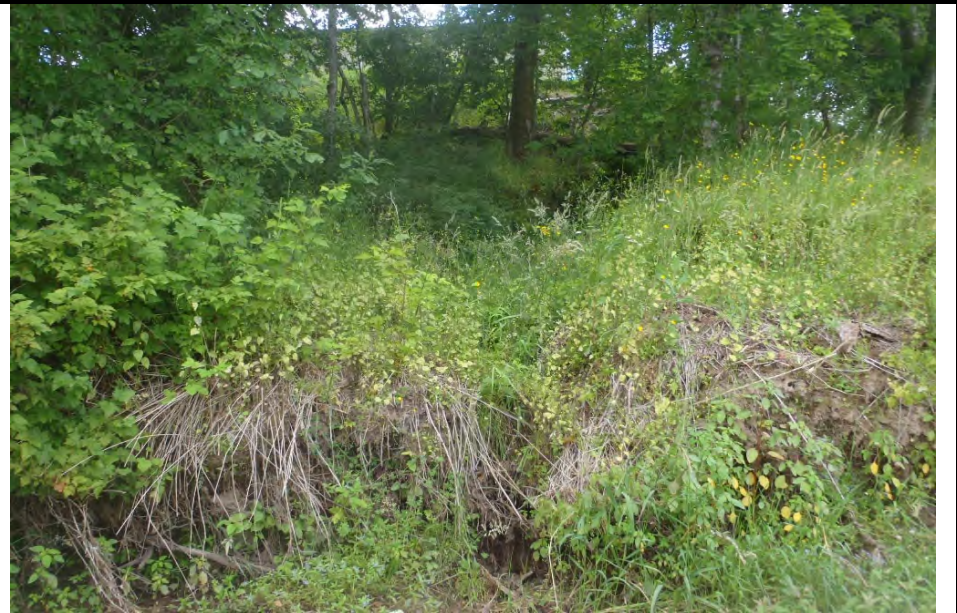
Photo point 15. Photo 1. Base of outfall gully. Outfall lacks bed and bank or other field indicators of OHWM.

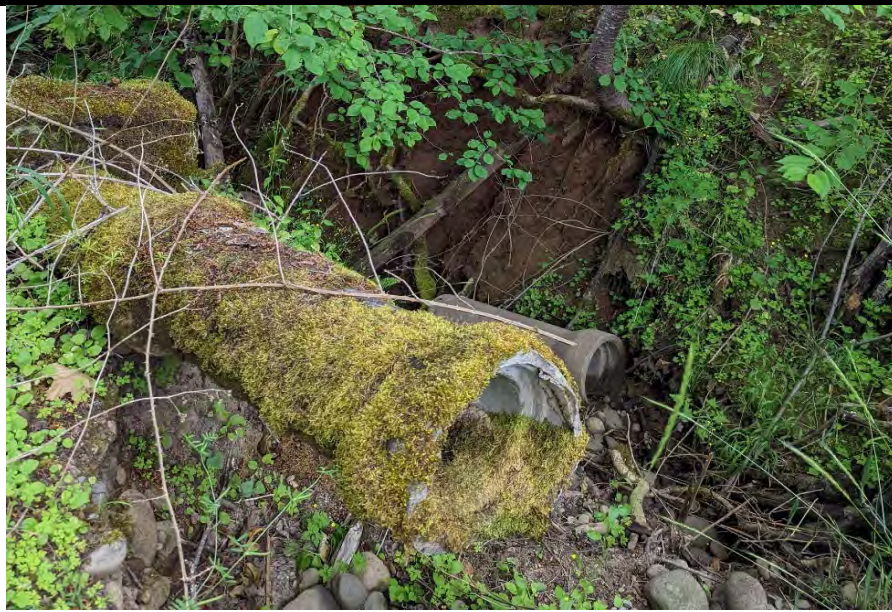
Photo point 16. Photo 1. Top of stormwater outfall gully, facing downslope at old culvert segments that have become disconnected due to undercutting of soil

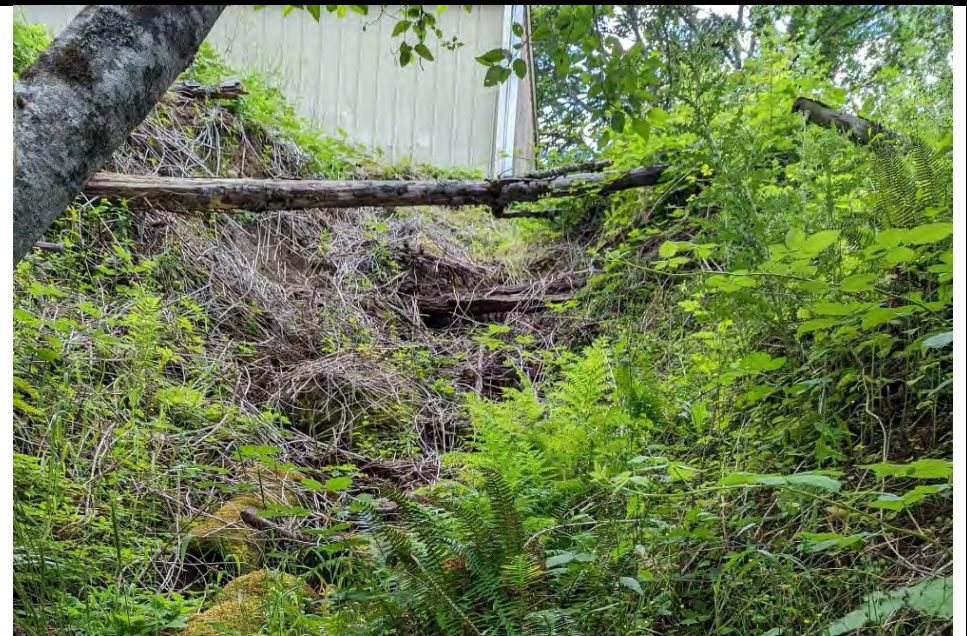
Photo point 16. Photo 2. Top of stormwater outfall gully, facing west and upslope.

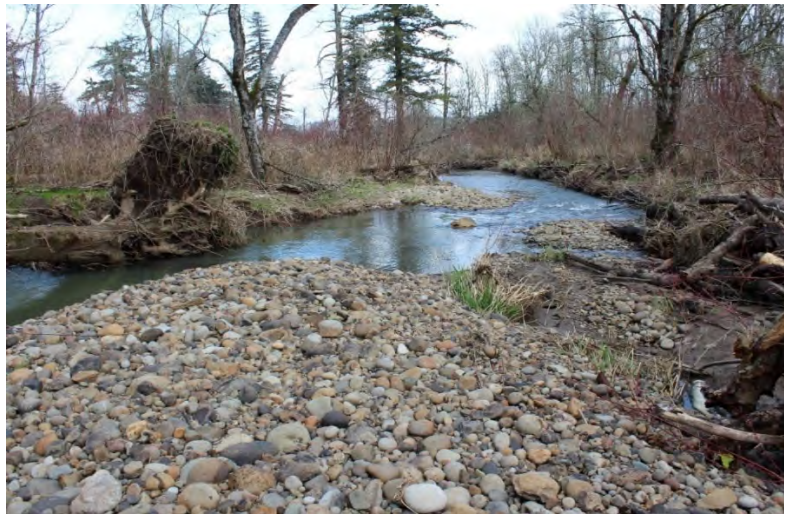
Figure 2 illustrates how localized hydraulic characteristics result in sediment transport (erosion and deposition). In the photo, large material (approximately 6-inch-diameter cobble) was deposited during the recent high-flow events. The woody material shown on the right edge of the photo protected the right bank of the channel from the high-flow energy so no large bed material was transported to this area, allowing smaller sand material to deposit in the less turbulent area.

Figure 2. Sediment deposition in Beaver Creek, upstream of the Stark Street Culvert

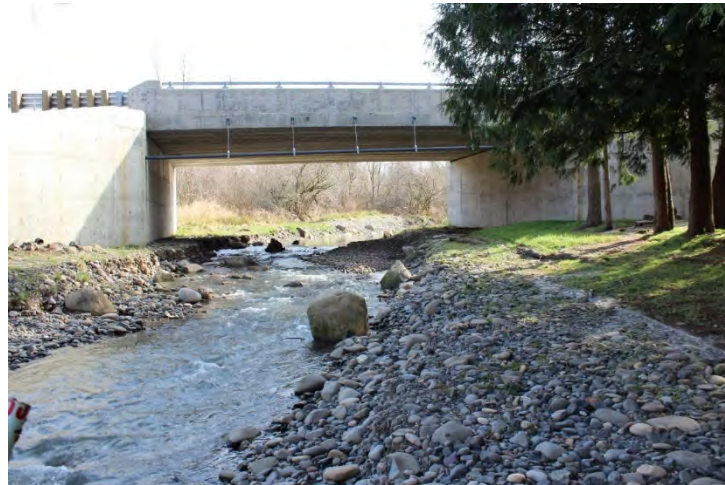
Reach 1 stretches approximately 650 feet from the bridge at SE Cochran Road downstream to a concrete weir. The Cochran Road culvert was recently replaced with a bridge (Figure 5). Historically, the culvert acted as a flow control during high-flow events, attenuating flows entering this reach. According to the Beaver Creek Flood Insurance Study (FEMA 2019), the attenuation from the historical culvert flow restriction of the 10-year high-flow event reduced estimated flows from 992 cfs to 329 cfs. The flow attenuation of the culvert during lower flows is not documented, but flow attenuation during more recurring high-flows event was likely impacted.

Figure 5. SE Cochran Road Bridge (looking upstream)

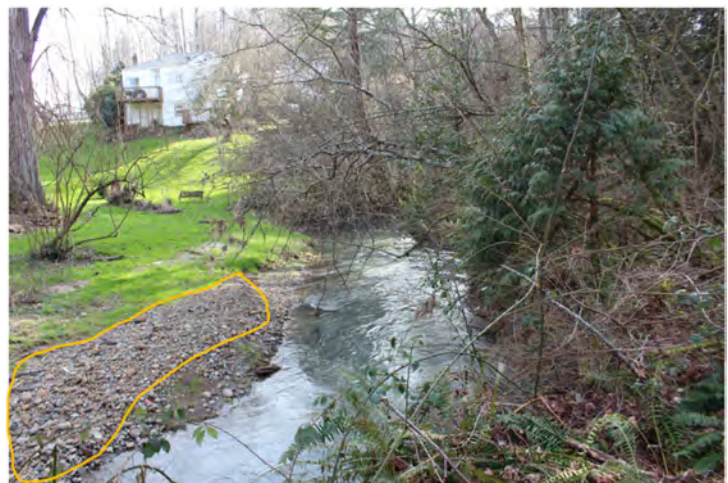
With the new bridge structure, Beaver Creek now experiences a new flow regime throughout Reaches 1-4, with the greatest impacts likely in Reaches 1 and 2. Flow impacts from the bridge structure are less significant downstream of the Kelly Creek confluence, because Kelly Creek contributes a relatively large percentage of the total flow to Beaver Creek. The impacts of the culvert replacement are evident at and downstream of the new bridge structure. As shown in Figure 5, streambed material was placed at the project site when the Cochran Road Bridge was constructed, and some bank erosion has occurred. It is assumed that the placed boulders were sized to represent the D100 sediment size for Beaver Creek. It is not known if the visible erosion has been on-going or was the result of the recent high-flow event. In either scenario, the eroded material has contributed to gravel and cobble bars downstream of the site (Figure 6).

Figure 6. Recently deposited cobbles and gravels

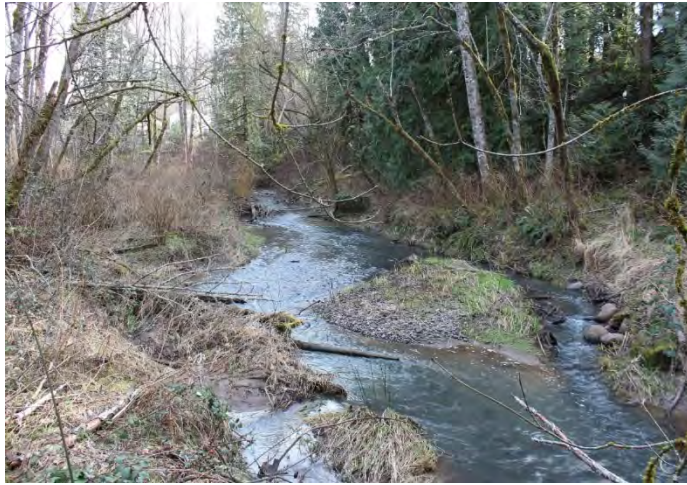
Downstream of the SE Cochran Road bridge, the creek meanders along private property (Figure 7). It appears the recent high flows have deposited cobbles at the inside of the meander, and bank erosion on the outside of the bend is continuing. The tree shown in the center of the photo with the leaning trunk and vertical upper section suggests the streambank at that location has been stable for a few years. Continued bank erosion along the right bank of the creek will

Figure 7. Recently deposited cobbles and gravels upstream of weir

The backwater effect of the weir constriction is not known at this time, but the vegetated cobble island shown in Figure 7 suggests the weir provides enough flow capacity to initiate the movement of cobble from upstream, then at some flow rate, ponding

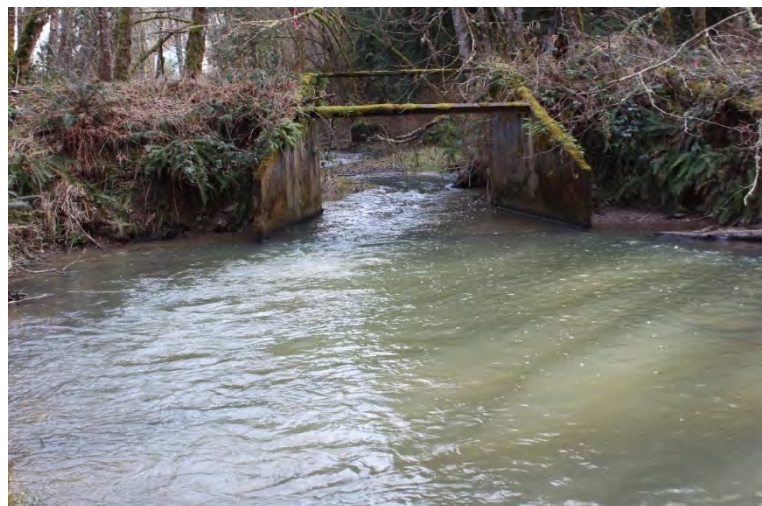
Reach 2 includes the concrete weir structure shown in Figure 8 and extends approximately 1,400 feet to the confluence with Kelly Creek. Beaver Creek in this reach becomes more complex than Reach 1. This section of Beaver Creek has an established floodplain, and there are multiple natural wood debris accumulations within the upper part of the reach.

The concrete weir structure has a concrete apron extending out to the edge of the wingwalls. During low-flow periods, the concrete apron likely creates a fish passage barrier due to low-flow depths. With the current upstream channel flow paths, the stream flow entering the weir is skewed, and flow is directed to the west bank.

Figure 8. Culvert weir (looking upstream)

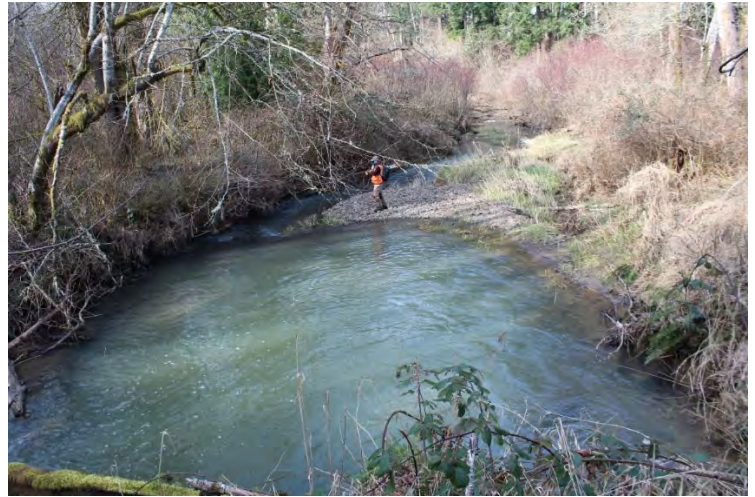
As the flow passes the concrete apron of the weir, the energy is released creating a large scour pool (Figure 9). Due to the current skewed flow path at the weir, cobbles and gravel have deposited during high-flow events and pushed the creek to the west. Vegetation in the cobble area suggests the creek has been in the current alignment at least long enough for grass to become established in the area. Some of the vegetation appears to be recently covered, likely from the recent high-flow event. As the gravel island upstream of the concrete weir changes, the flow direction will change, resulting in changes to the configuration of the scour pool.

Figure 9. Scour pool downstream of the concrete weir

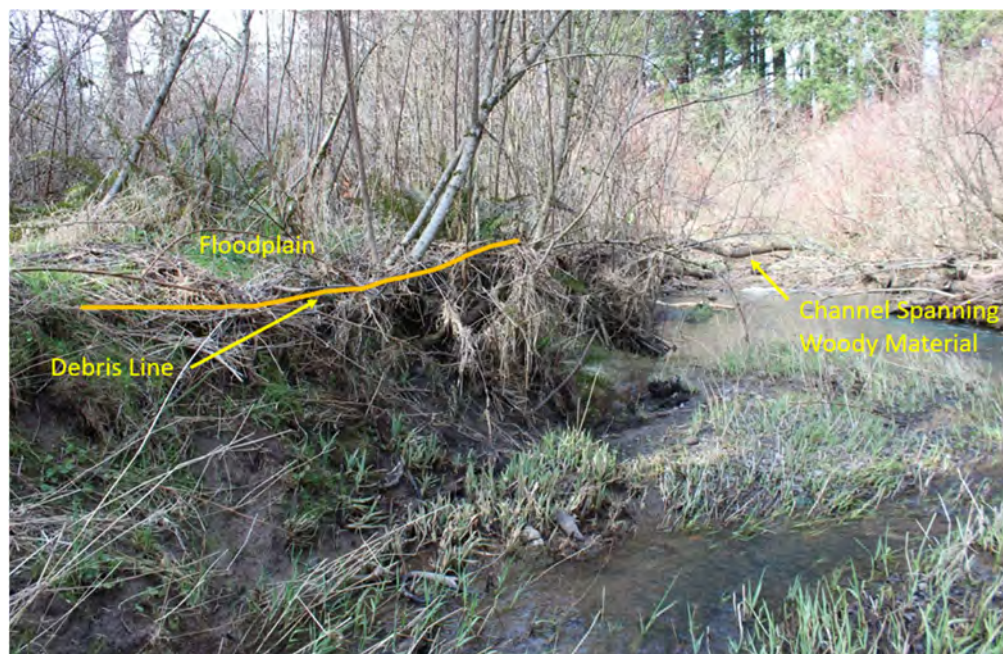
Downstream of the scour pool, the creek enters a reach with accessible floodplains and some woody debris accumulations. Figure 10 shows the debris line from the recent high-flow event at the top of the western bank. Throughout Reach 2, there is evidence of flows across the floodplain, including flattened grass and debris lines. Also shown in the photo is a creek-spanning log jam. However, many of the existing log jams in this reach are only submerged during high flows so do not interact with average or low-flow conditions. The riparian community has some potential for future LWD recruitment, but it is not great in terms of tree size or quantity.

Figure 10. Looking downstream at flood terrace and in-stream wood

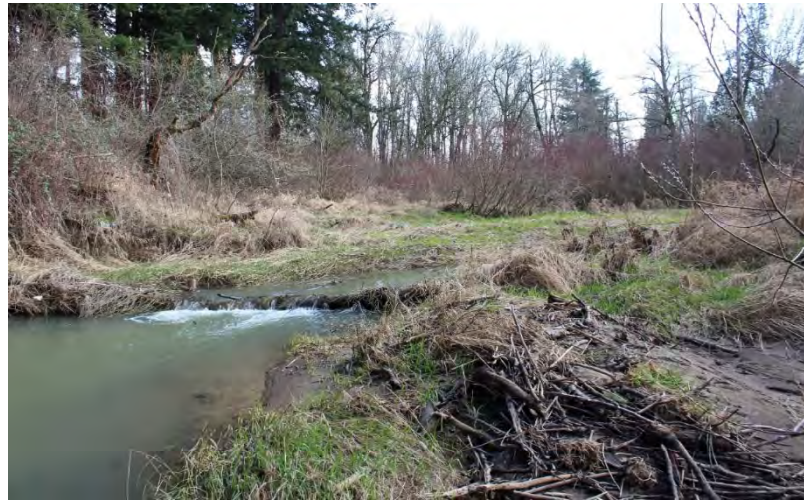
This Beaver Creek reach includes a short series of meanders where the tree canopy opens and the floodplain is dominated by reed canarygrass (*Phalaris arundinaceae*). Figure 11 depicts the floodplain upstream of a channel-spanning log. As shown in the photo, looking upstream, the floodplain is dominated by reed canarygrass.

Figure 11. Active floodplain at channel spanning log

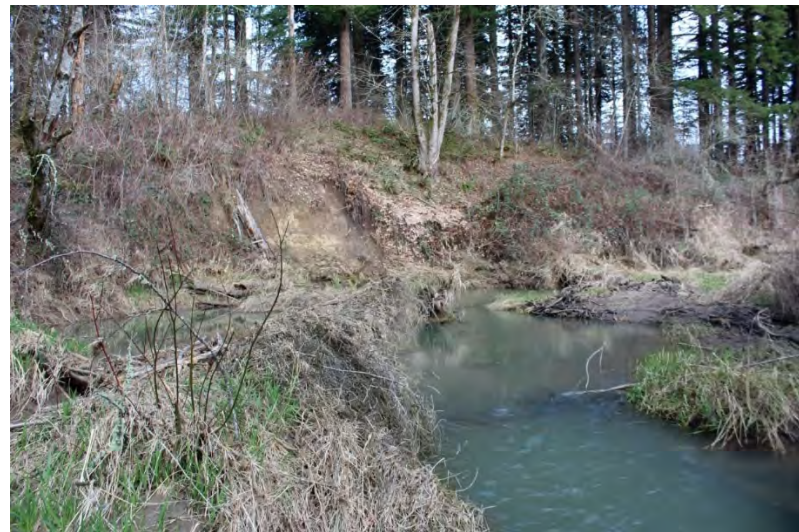
Immediately downstream of the log shown in Figure 12, Beaver Creek is eroding a steep bank. It appears the bank erosion has caused a tree to fall into the creek. Due to the vegetation growing on the tree and accumulated material, the tree has been there for more than this season. The tree appears to be a hard point, maintaining flows in the main channel.

Figure 12. Bank erosion at confined meander (lateral beaver dam shown on left)

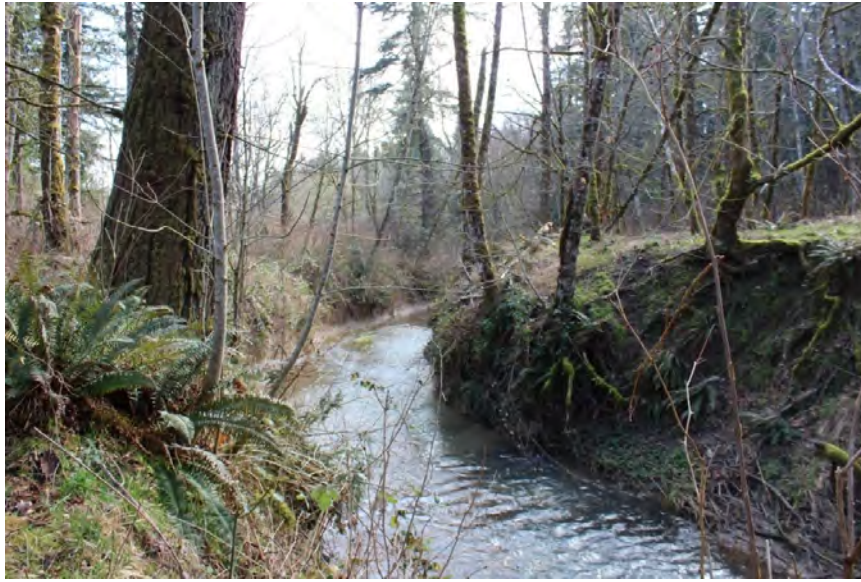
Between the location of the meanders and the Kelly Creek confluence, where Beaver Creek is adjacent to the football field, the creek flows through a confined reach with berms on both sides. As shown in Figure 13, the stream reach has very little channel complexity and little woody material. Salmonid use of this pooled portion of the reach is likely limited to rearing, although there is limited refugia to escape high winter flows. It is likely that, during high-flow events, the energy in this reach can transport most of the wood and bedload material that enters from upstream.

Figure 13. Confined reach of Beaver Creek below football field

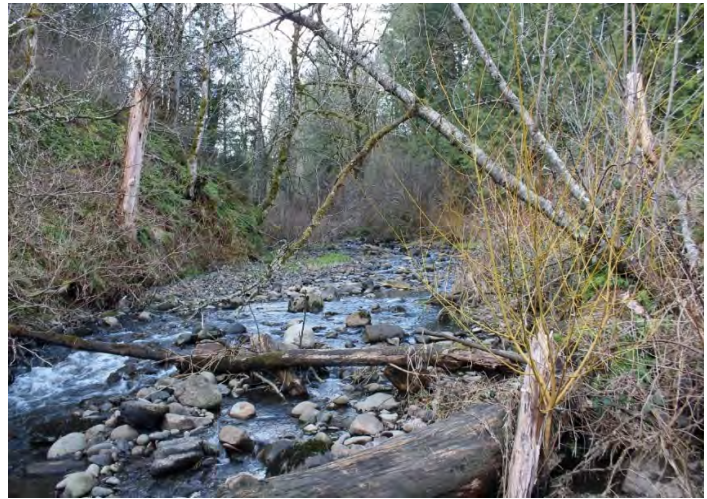
The lower reach of Kelly Creek, shown in Figure 14, has a dam/reservoir approximately 660 feet upstream of the confluence. The creek reach between the dam and Beaver Creek has a relatively steep gradient with large substrate material (mostly cobble/boulder) and does not contain a large percentage of fine material within the streambed. The impact of the dam on sediment transport and flows was not assessed as part of this project. The Kelly Creek reach has a dense tree canopy, restricting the potential to place woody material from the air. The mixed riparian community does provide strong potential for future LWD recruitment.

Figure 14. Kelly Creek above confluence with Beaver Creek

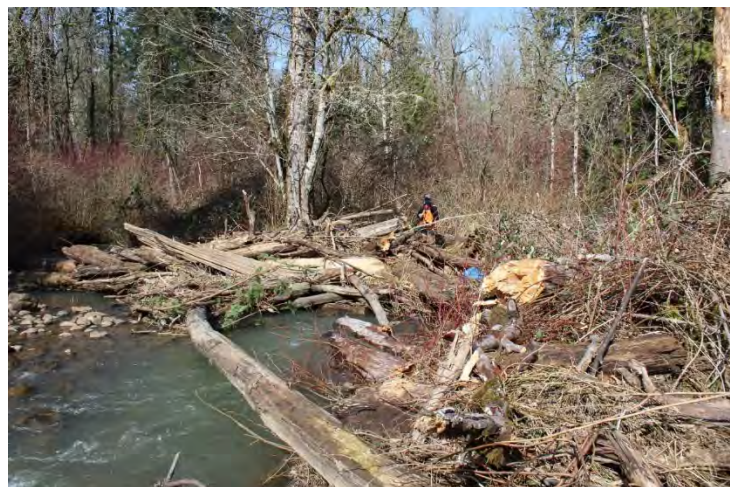
Approximately 750 feet downstream of the Kelly Creek, a relatively large apex log jam has formed, activating two channels. The apex jam (Figure 15) has the greatest accumulation along the eastern side channel. Flow pattern within the wood structure suggests the eastern channel may be the preferred flow path during low-flow conditions. The hydraulic complexity associated with the structure and recruitment/loss of key log material can alter the flow paths at any given time.

Figure 15. Apex log jam downstream of Kelly Creek

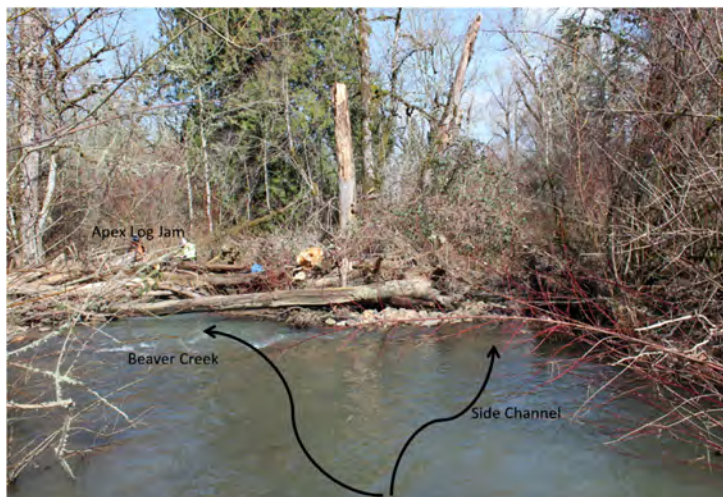
There are multiple other side active side channels in the area (Figure 16). Immediately upstream of the apex jam, an opening in the eastern bank allows flow into a side channel. During the site visit, the side channel appeared to be at a lower elevation than the main channel of Beaver Creek.

Figure 16. Active side channel bypassing apex log jam

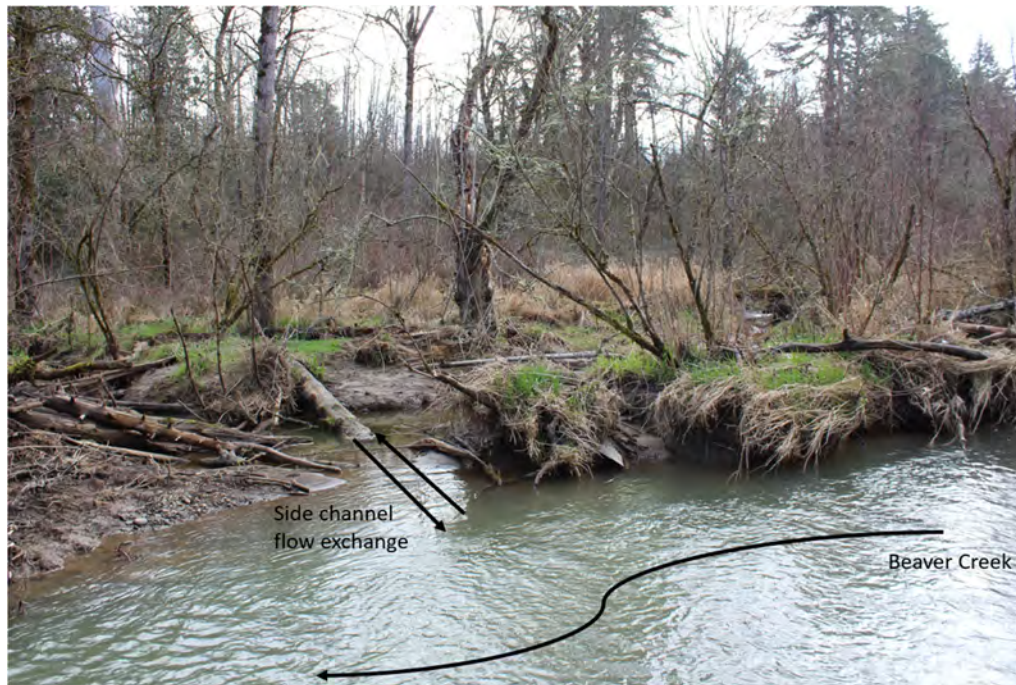
The lower half of Reach 3 of Beaver Creek is a series of pool-riffle stream sections with multiple side channel bifurcation/confluence points. Figure 17 illustrates one of the locations where Beaver Creek connects with a side channel. During higher flow conditions, the flows from Beaver Creek and the side channel freely exchange. The photo also indicates a well-established floodplain with wood material along the banks and within the channels.

Figure 17. Beaver Creek and high-flow side channel confluence

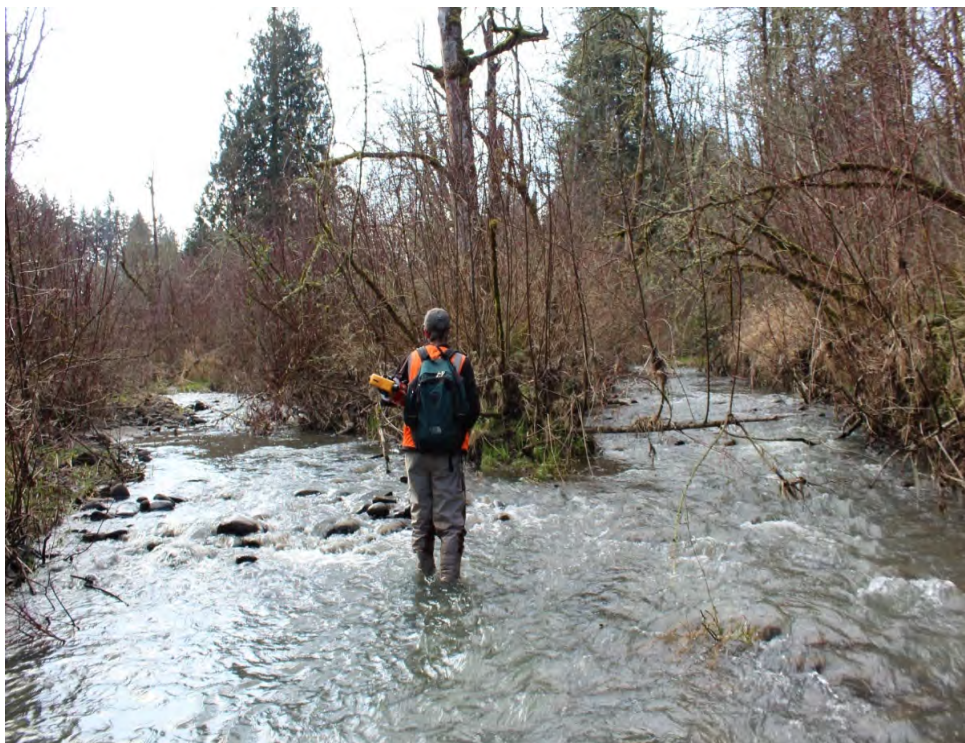
The presence of the apex jam split the flow in the creek approximately equally. Figure 18 shows the confluence of the two channels at the downstream end of the island. Visual estimation of the flows suggests an approximately 50/50 split in flows.

Figure 18. Confluence of split channels in Reach 3

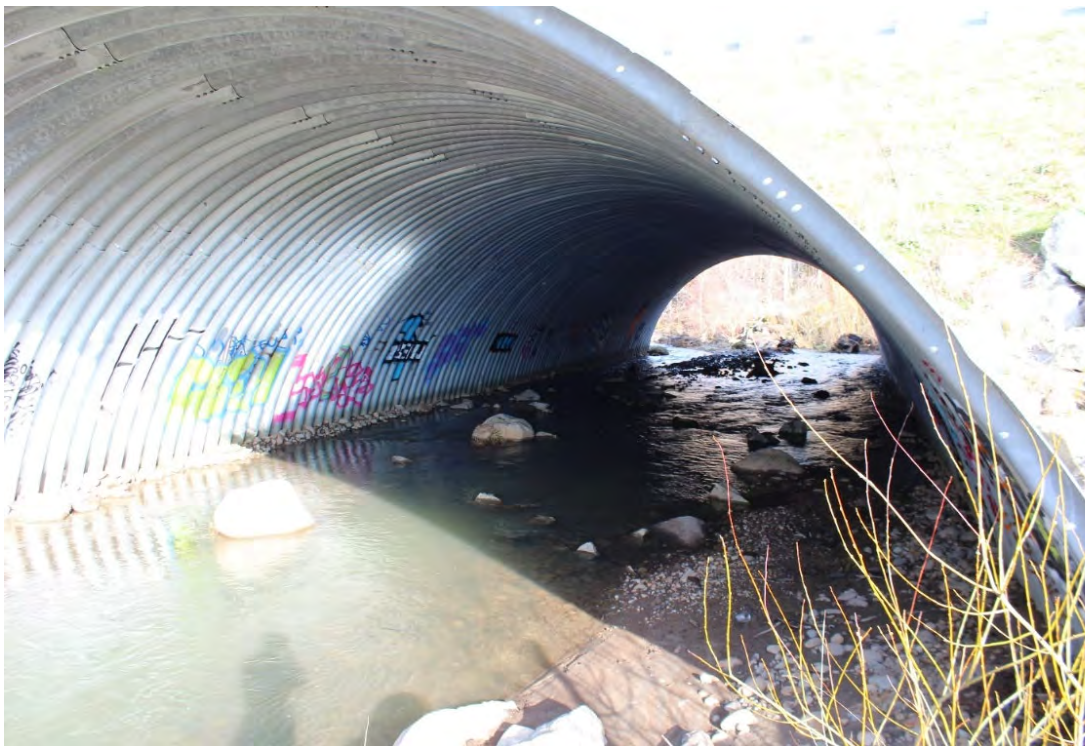
The replacement of the undersized culvert with the natural bottom culvert shown in Figure 19 has initiated geomorphic change within Reach 4. The streambed material placed in the channel during the replacement project has been transported from the inlet. It appears some of the material has accumulated closer to the outlet and perhaps transported farther downstream.

Figure 19. New SE Stark Street culvert

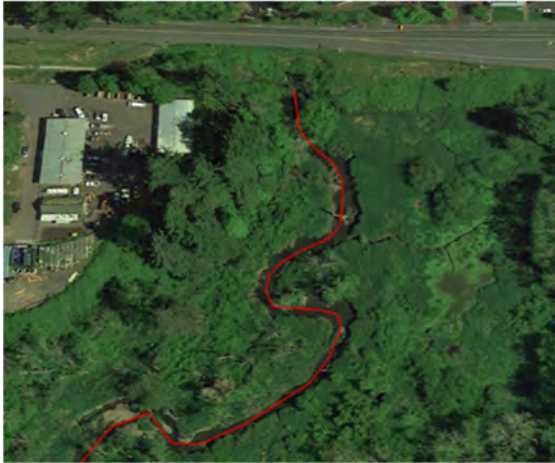
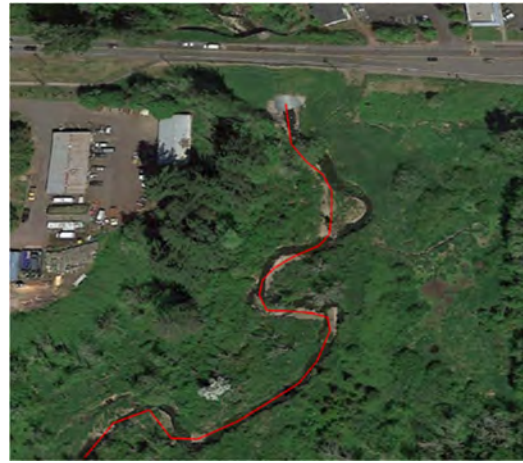
The two aerial photos below (Figure 20) illustrate the geomorphic change that has occurred in less than 2 years. The channel lowering through the culvert results in an energy level too high for the reach, so to correct itself the stream is in the process of stabilizing and reducing its gradient by creating meanders within the floodplain.

Pre-Culvert Replacement (05/22/2017)

Post-Culvert Replacement (05/08/2019)

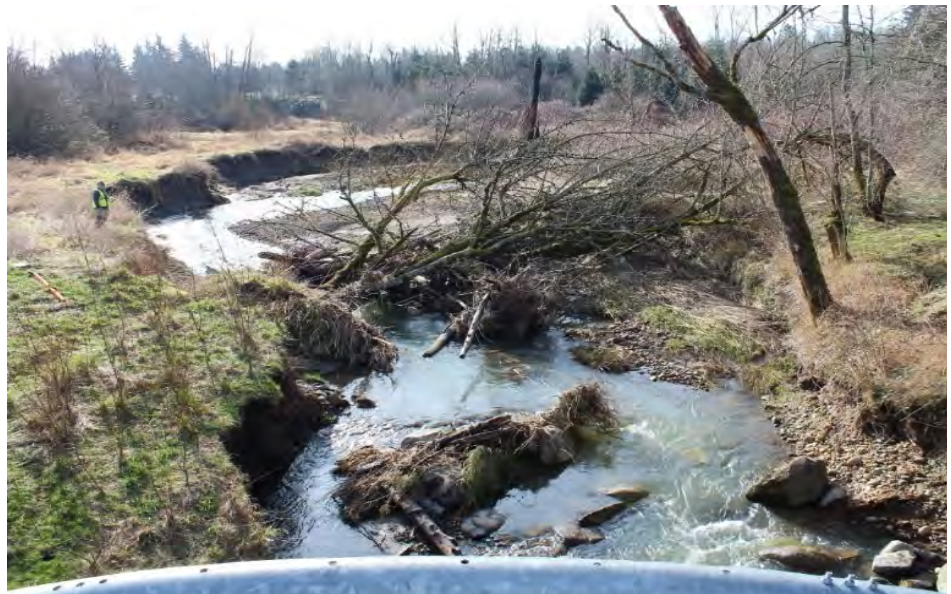
Figure 21, looking upstream from the crown of the SE Stark Street culvert, provides a good view of the dynamic activity occurring in the area. The channel migration eroded the banks, causing the large tree to fall into the creek. Due to the channel incision, the recent high flows did not reach the floodplain. It is likely the current floodplain will not be inundated except for extreme high-flow events.

Figure 21. Recent channel migration upstream of Stark Street culvert

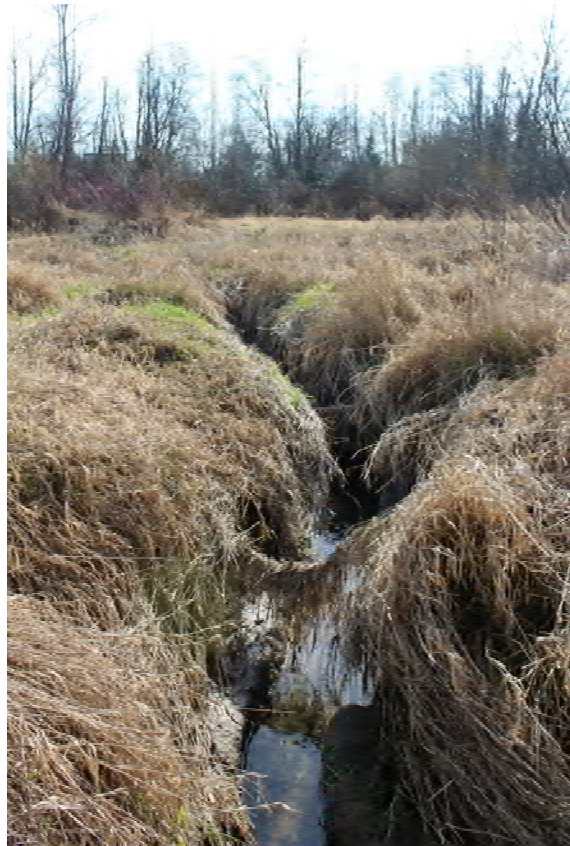
Along with the lowering of the main creek channel, local drainage tributaries have also started to incise (Figure 22). Although these are

not currently providing good habitat, as the banks collapse and the channels widen, the drainage tributaries will provide good off-channel refugia during high-flow events.

Figure 22. Incised banks on small drainage tributary in floodplain
