Drainage Master Plan

North Troutdale and Sandy Drainage Improvement Company Drainage Master Plan

Prepared for
Sandy Drainage Improvement Company and City of Troutdale
November 2020
Updated January 2021

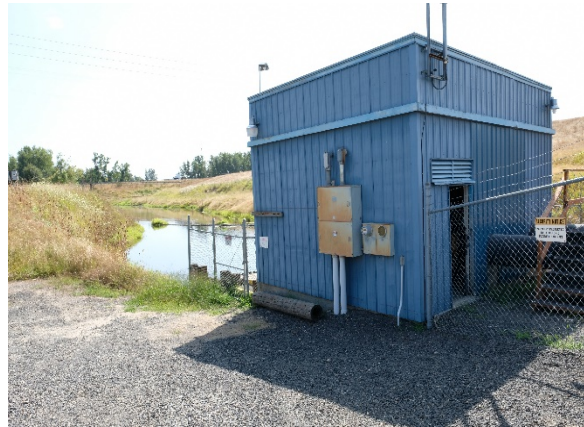
The Sandy Pump Station, shown in Figure 4-1 was upgraded in 1998 and is currently in poor condition. Pump station components deteriorate at different rates, based on the age, amount of use, pump cycling, stresses, and maintenance activity. Deficiencies identified during the field inspection include the lack of standby power or transfer switches, and a deteriorating wet well structure. Pump vibrations were also observed which may contribute to system deterioration.

Figure 4-1. The Sandy Pump Station in 2019

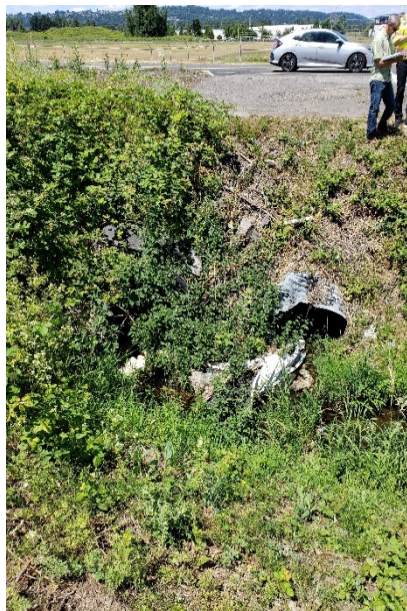
Figure 5-2. The Stakeholders need systematic CCTV data for the pipes and culverts in the critical conveyance network.

The condition assessment program should include pipe cleaning, CCTV inspection, NASSCO PACP ratings, and engineering evaluation of the pipes and culverts in the critical conveyance network (see Section 3.2). PACP rating scores can then be incorporated into the risk tool, developed as part of the MCDD and PEN2 master planning process, to understand the relative risk and consequent of failure which allows for the prioritization of infrastructure projects. The program should cover the 15,400 LF of pipes and culverts within the critical conveyance network, as shown in Table 5-2. Inspection costs are expected to be inflated in the study area, due to the quantity of large diameter culverts that will likely require significant sediment and debris removal prior to inspection.

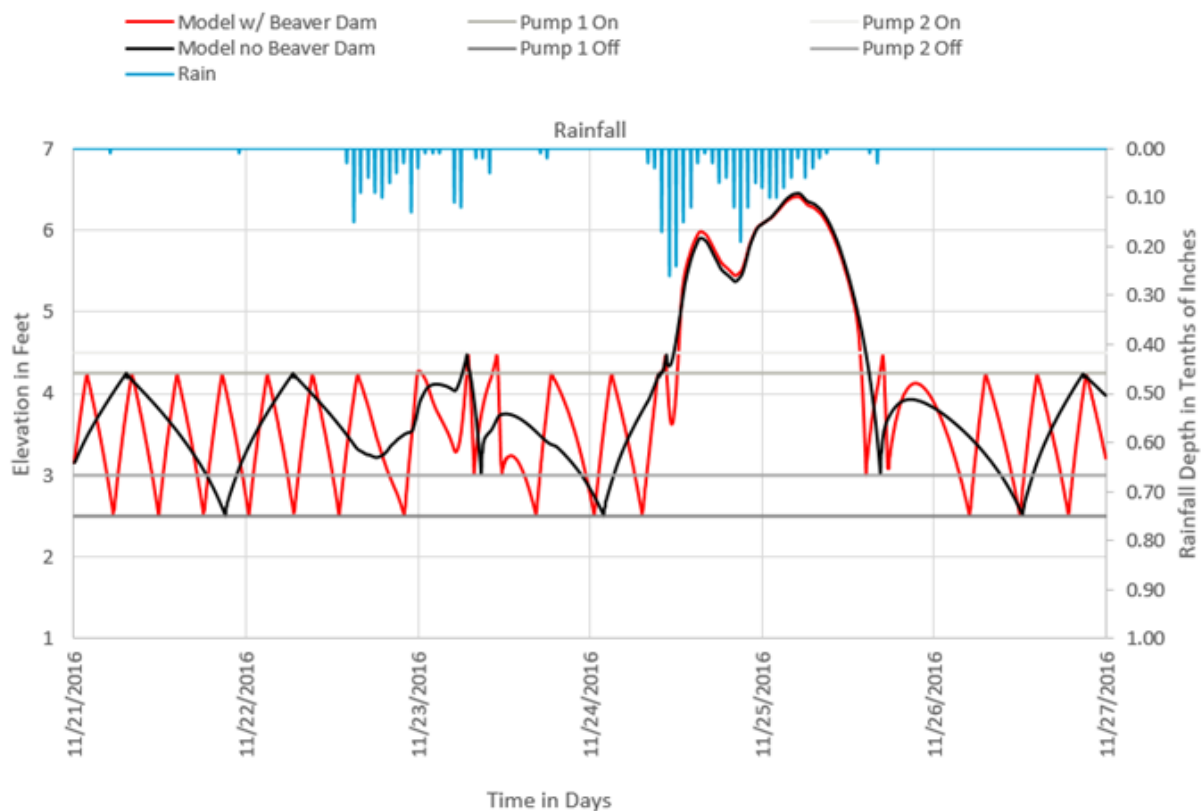
Beaver dams are prevalent across the study area and impact the movement of water downstream through the areas driven by gravity and have the potential to impact the pump station. An evaluation was performed in MCDD as part of the previous master planning effort to review how the beaver dams impact the conveyance of water and whether pump stations are affected. By building a beaver dam, or multiple dams, into the model, a conveyance channel has a higher water surface elevation. During small events or dry periods, the dams hold water and release it slowly to the next impounded water body. This prevents channel from fully draining and takes a much longer period of time to drain. Additionally, due to the slow movement of water downstream, pump stations are prone to cycling on and off more frequently. Frequent pump cycling can contribute to premature aging and reduced pump capacity. Beaver dams can also impact open channels, culverts, and pipes by reducing the conveyance capacity and reducing the ability of the system to move water downstream.

Figure 6-2. Impact on pump cycling frequency: areas with beaver dams vs. open channels

Beaver dams (red line) result in frequent on/off cycling of pumps, compared to open channels (black line)

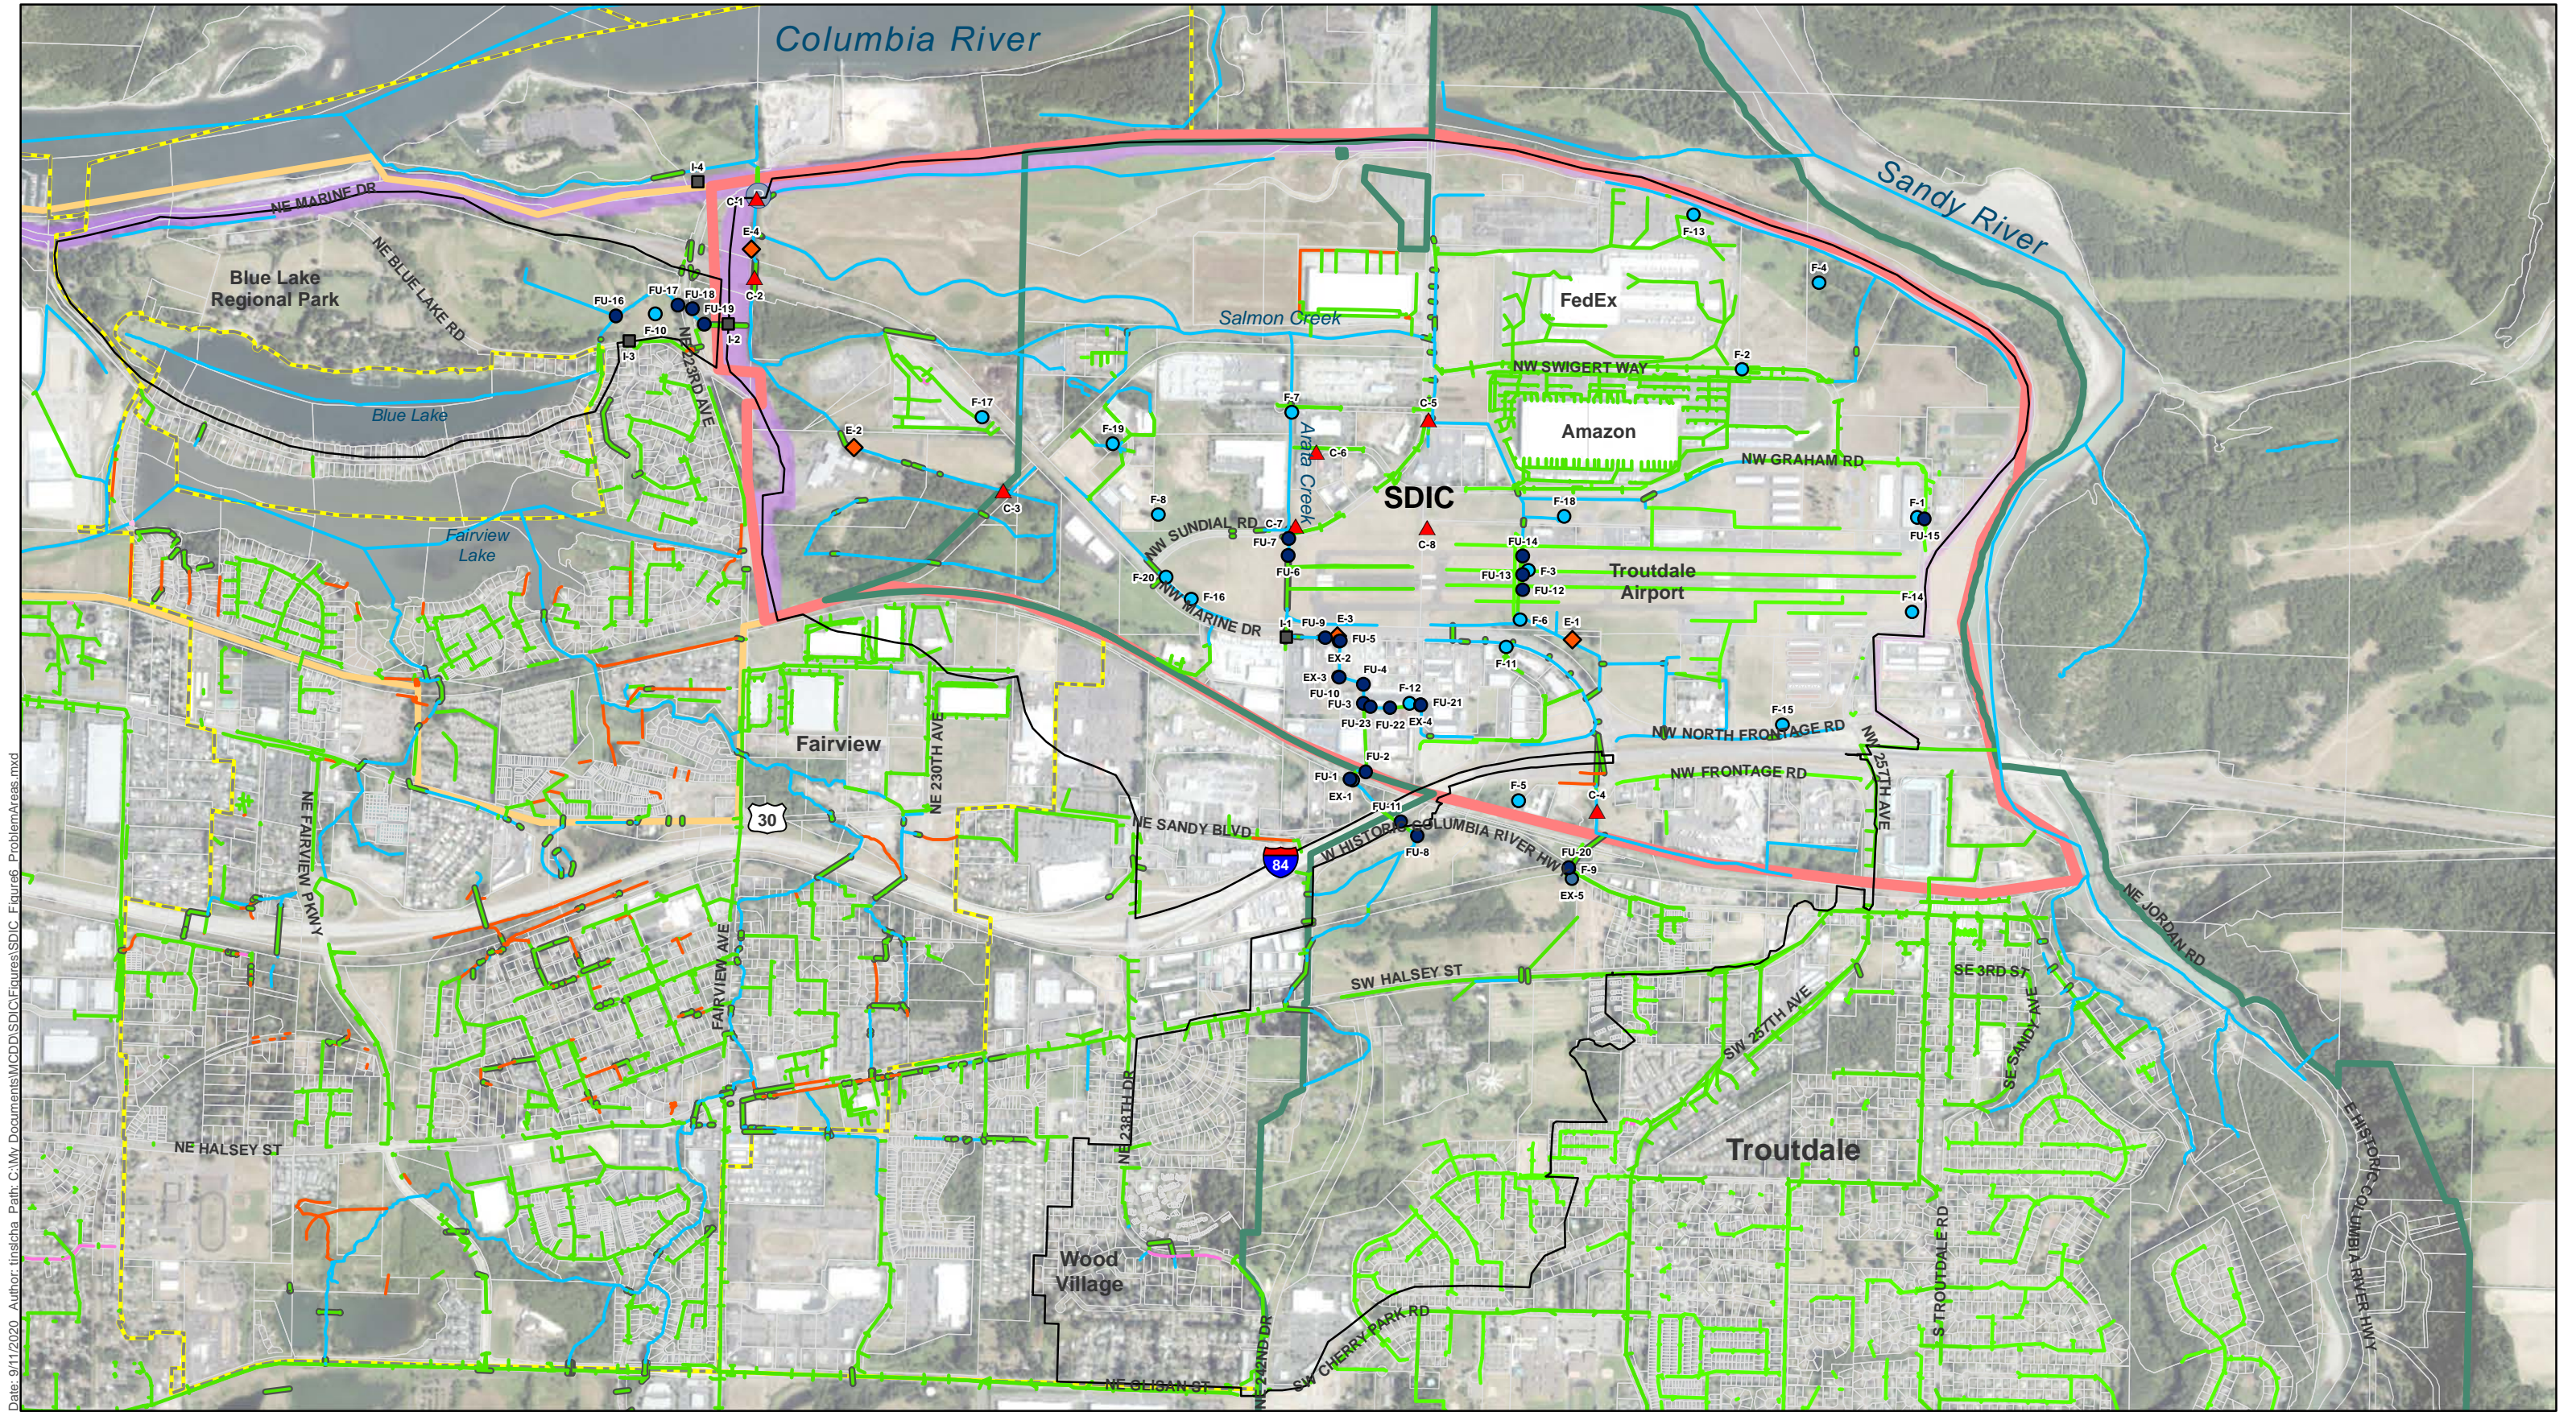
Figure 6
 Problem Areas

The DMP development process included a substantial effort to compile and document locations of known problems. The resulting problem area map is included in Figure 6, Appendix A, and the complete problem area table is included in Appendix D. Drainage related problem areas were identified through the system evaluations and input from Stakeholder staff which included condition issues identified at the pump station, condition issues in the conveyance system, modeled flooding locations, suspected problems reported by property owners, flooding or debris accumulation problems reported by Stakeholder staff, and locations where the operations staff spend unequal time addressing repeated maintenance issues.

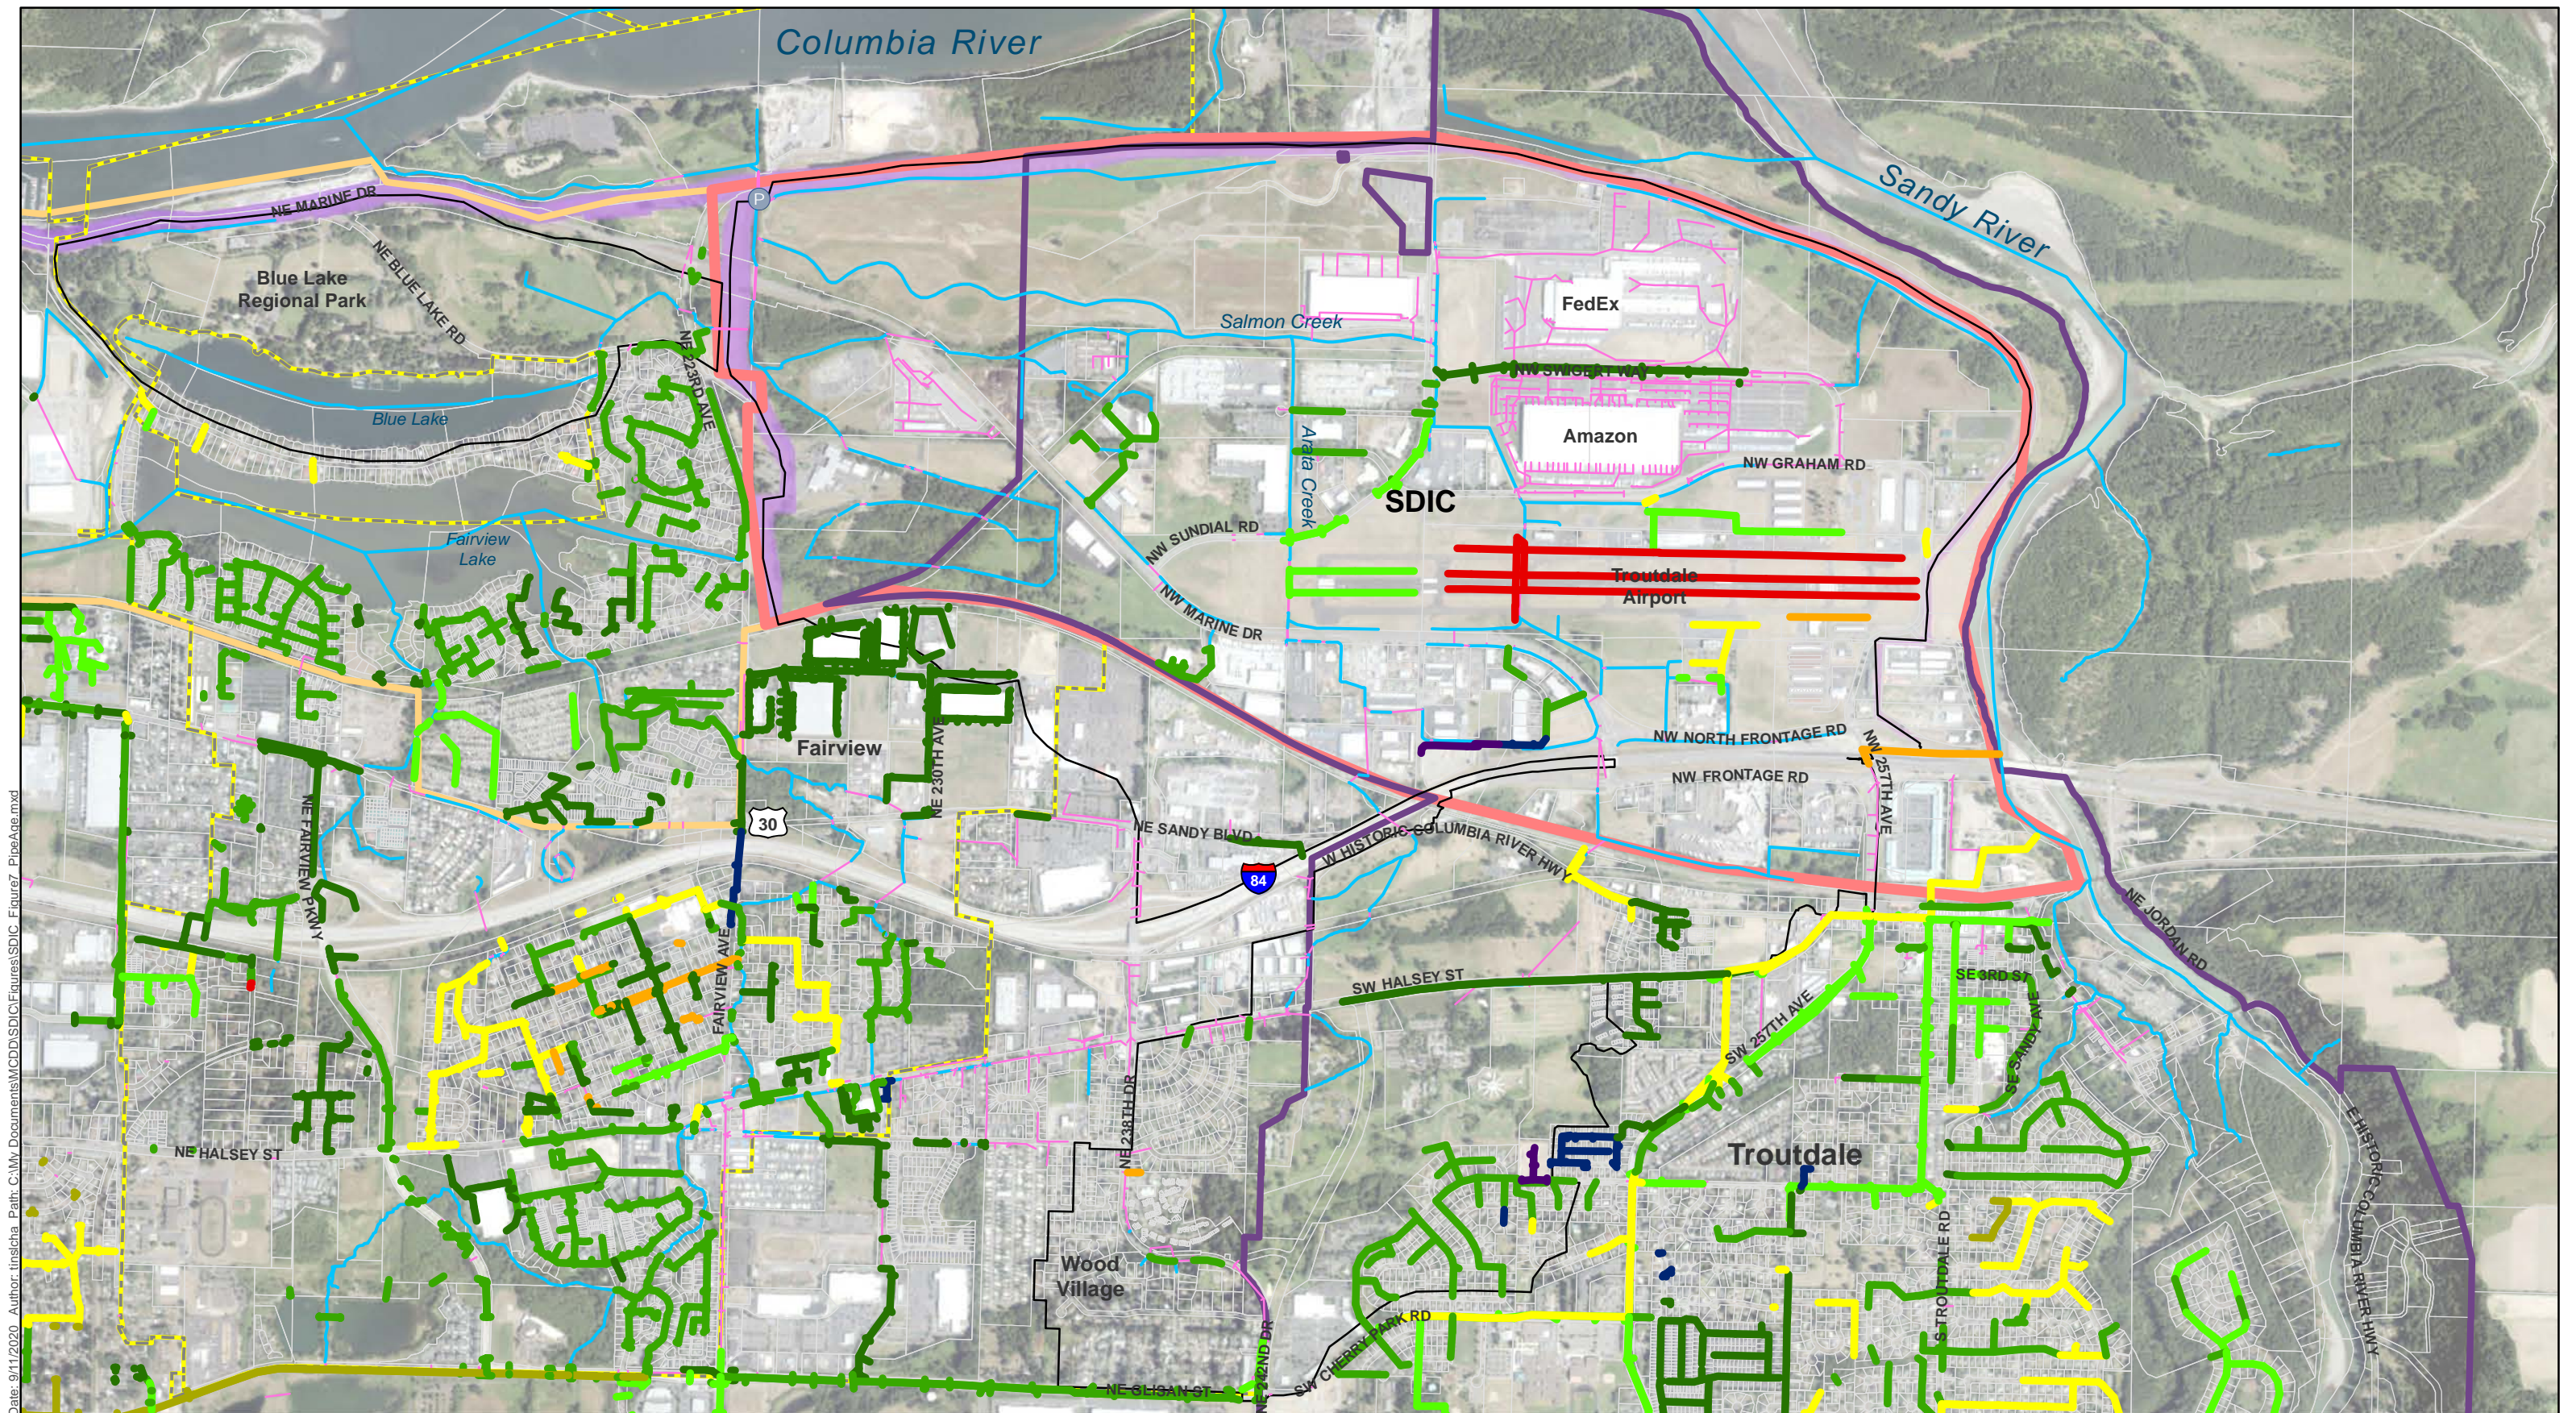
Figure 7
Pipe Age

Pipe age in the CoT is generally recorded for public roadway projects and developments from 1970 and forward (see Figure 7, Appendix A, for a map showing infrastructure age). However, there are large portions of the SDIC where storm drainage systems were installed prior to electronic record keeping or installed by private owners without records. The oldest pipes and culverts in the SDIC are least likely to have recorded age information, and the most likely to be experiencing deterioration.

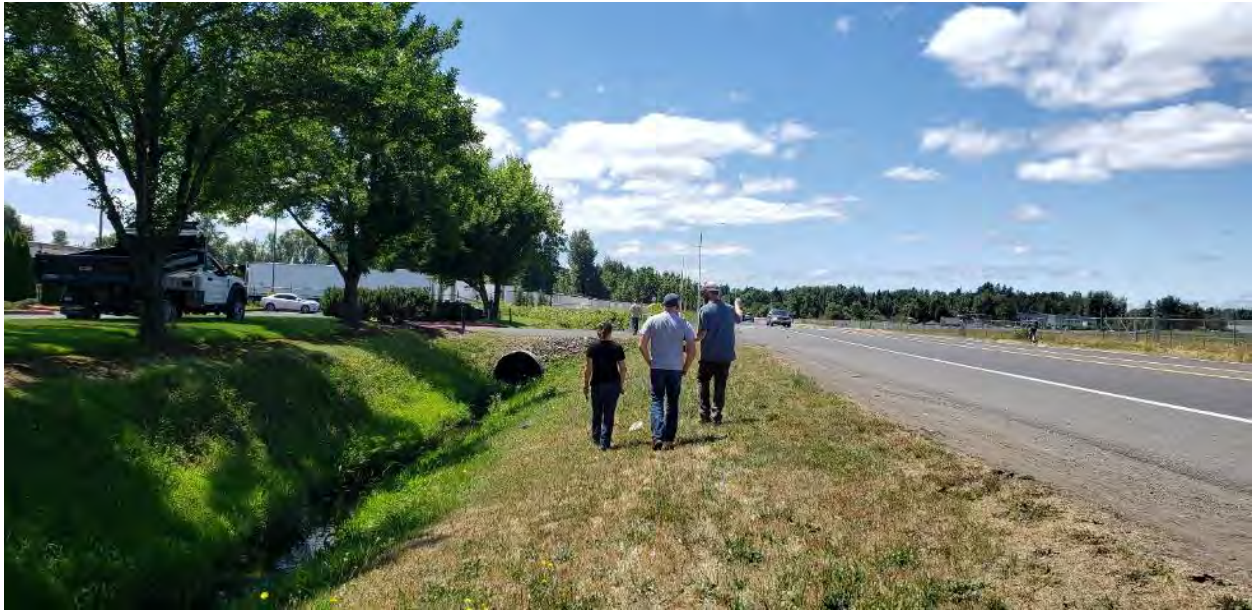
Problem Area: #15 and #16

Figure 1. Filename: 20190618_140344.jpg - Arata Creek, along Marine Drive, looking west.

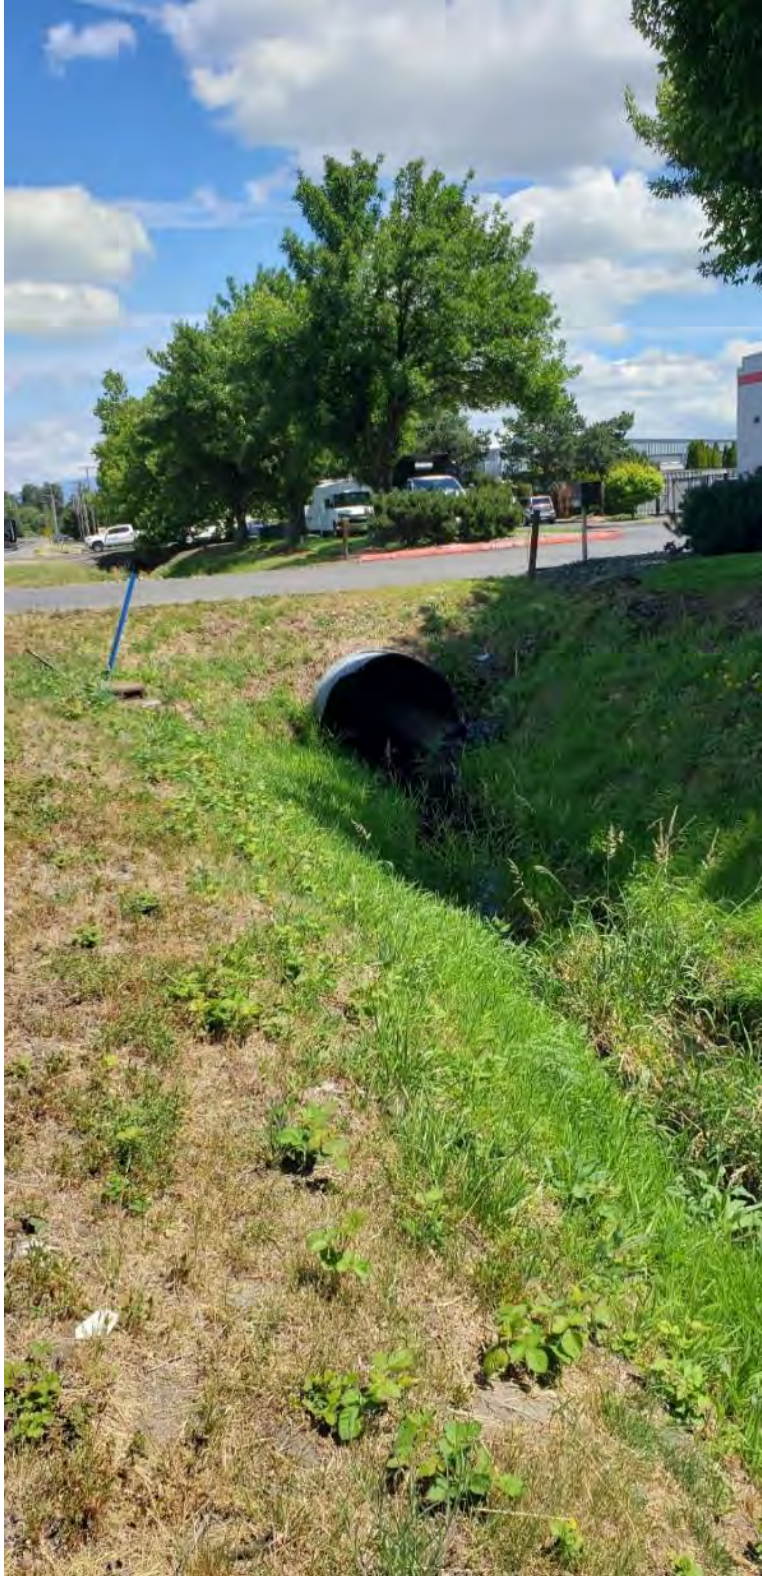
Figure 5. Filename: 20190618_140654.jpg - Stretch of Arata Creek, south of Marine Drive, in front of Knapheide Truck Equipment Center (2500 NW Marine Dr.).

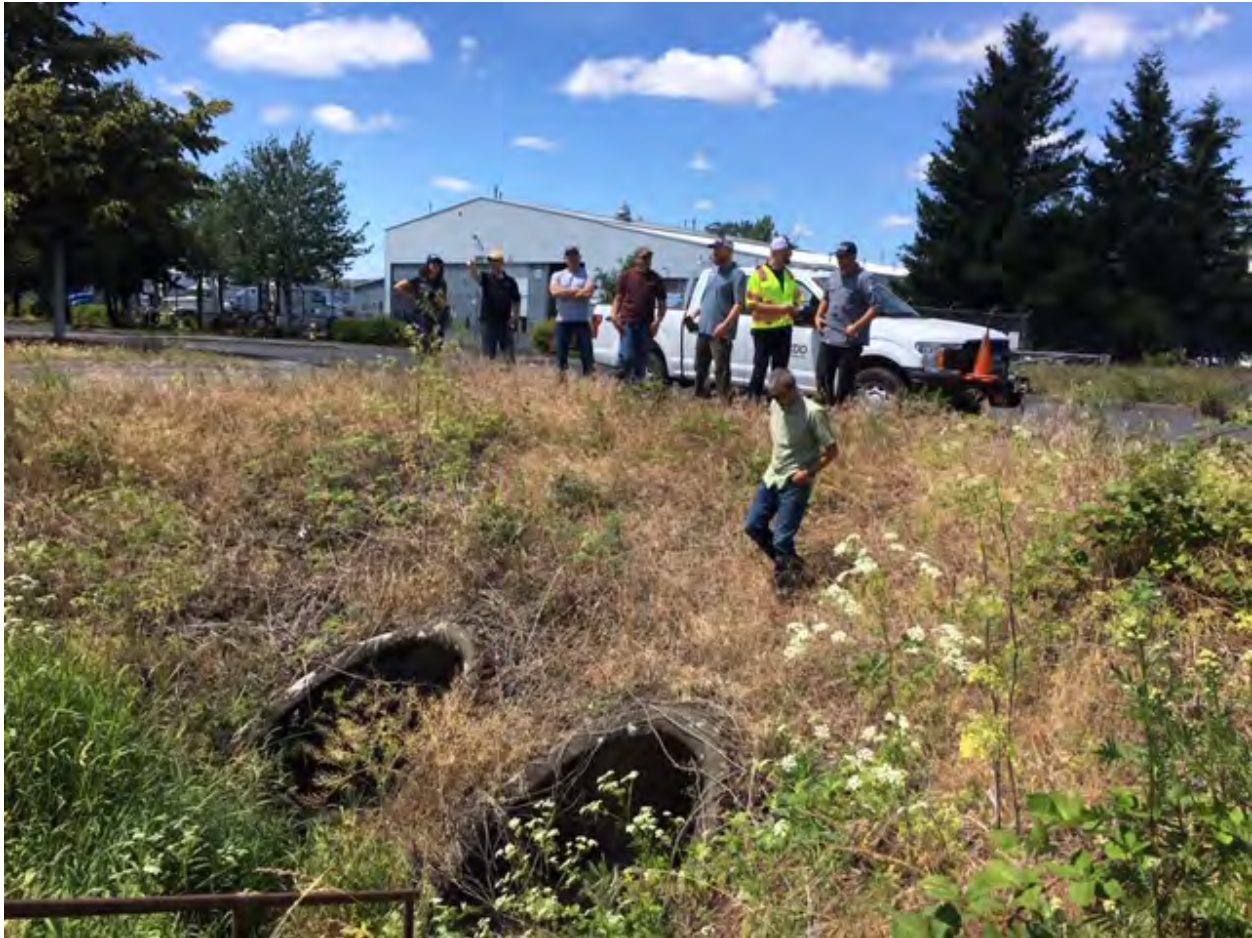
Problem Area: #9**Waterbody:** Arata Creek – Roger's Circle culverts

Figure 6. Filename: IMG_3654.jpg - Arata Creek at Roger's Circle, double culverts, also Toyo Tanso process water discharge point.

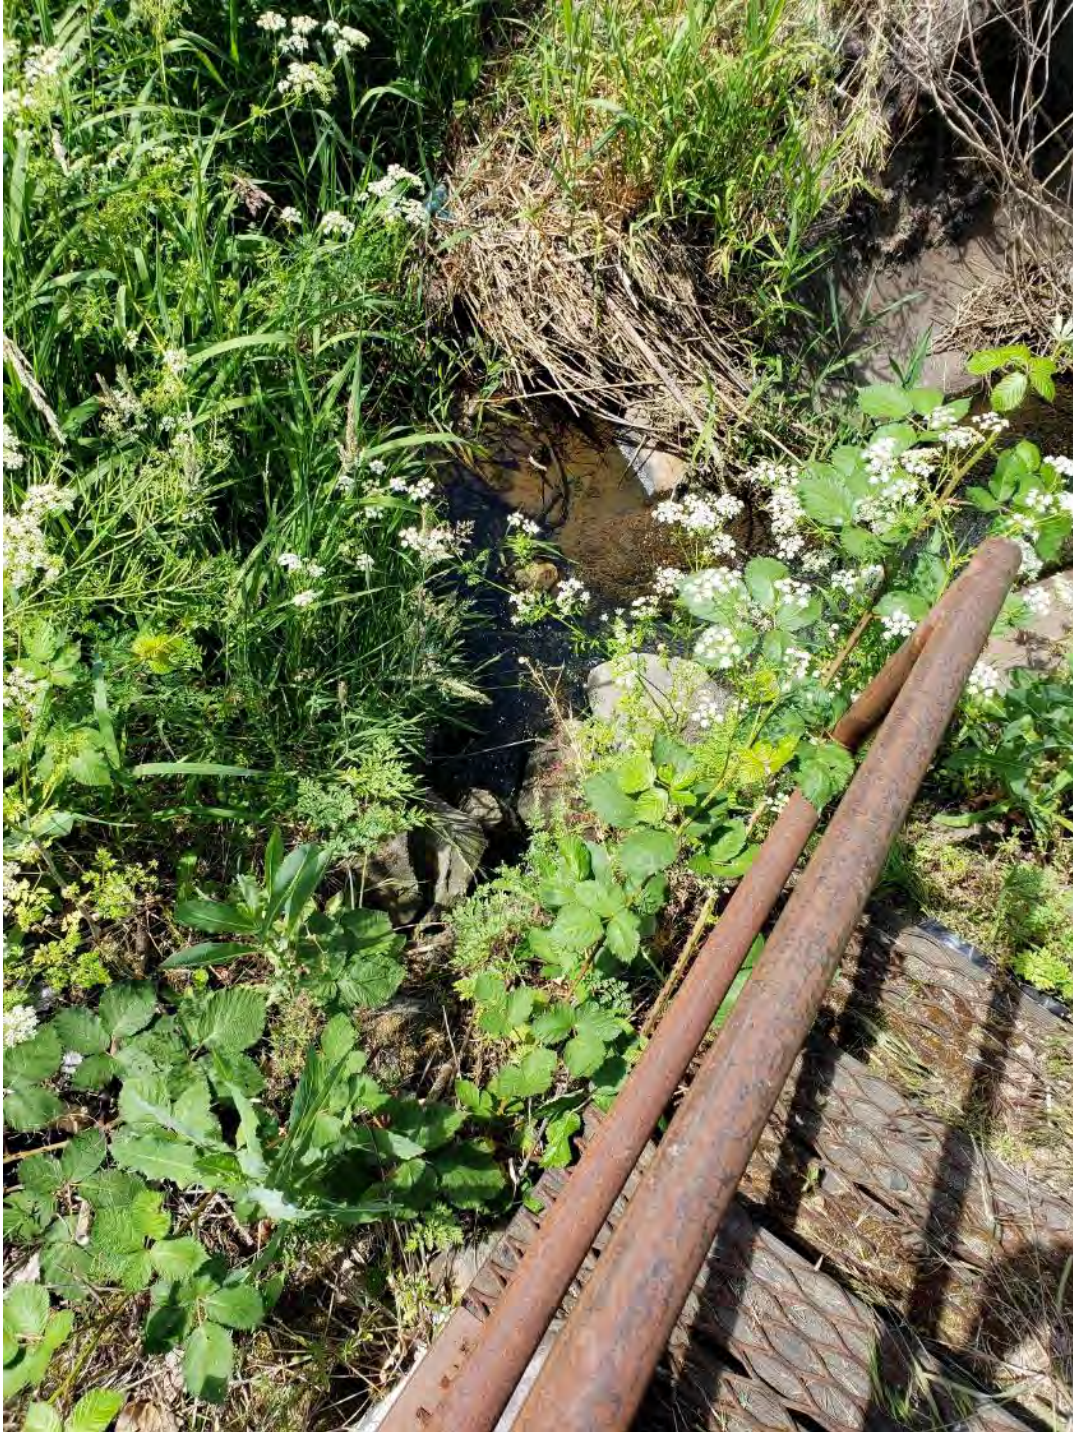
Figure 7. Filename: ArcGISApp_1560892702709.jpg - Toyo Tanso discharge point. Appeared to be clear water from 6- or 8" diameter pipe.

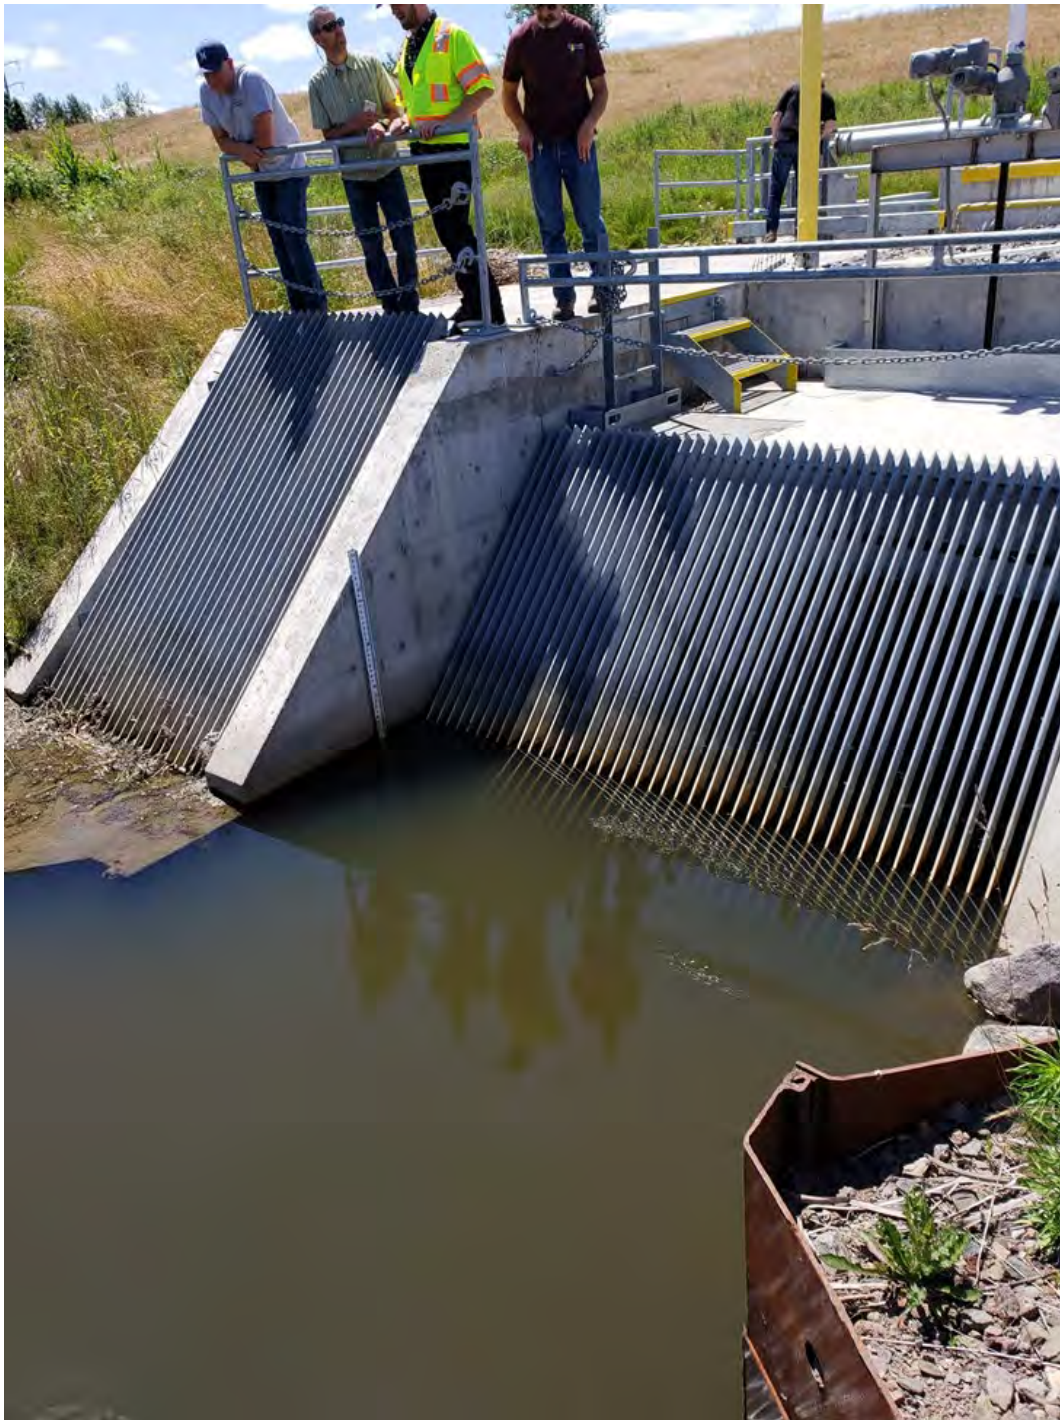
Problem Area: near #10, #11, and #23

Figure 9. Filename: ArcGISApp_1560893492147.jpg - Lift gate separating Arata/Salmon creek (seen here, foreground) and Sundial wetlands (behind gate, drain to SDIC pump station).

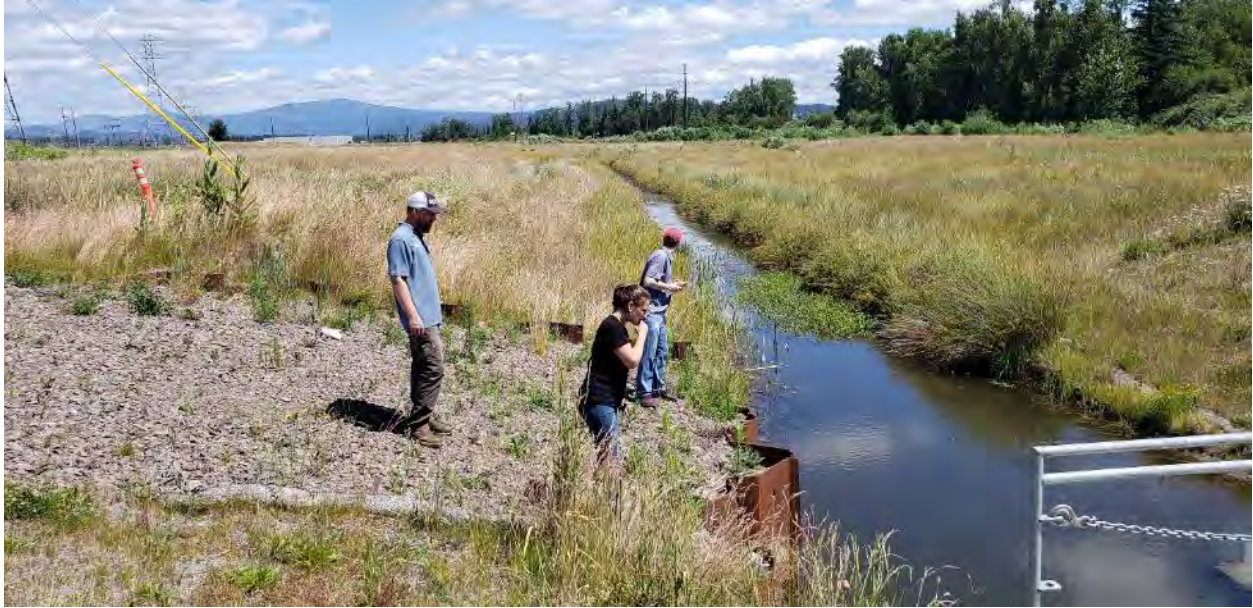
Figure 10. Filename: 20190618_143124.jpg - View of Salmon Creek from lift gate, facing East.

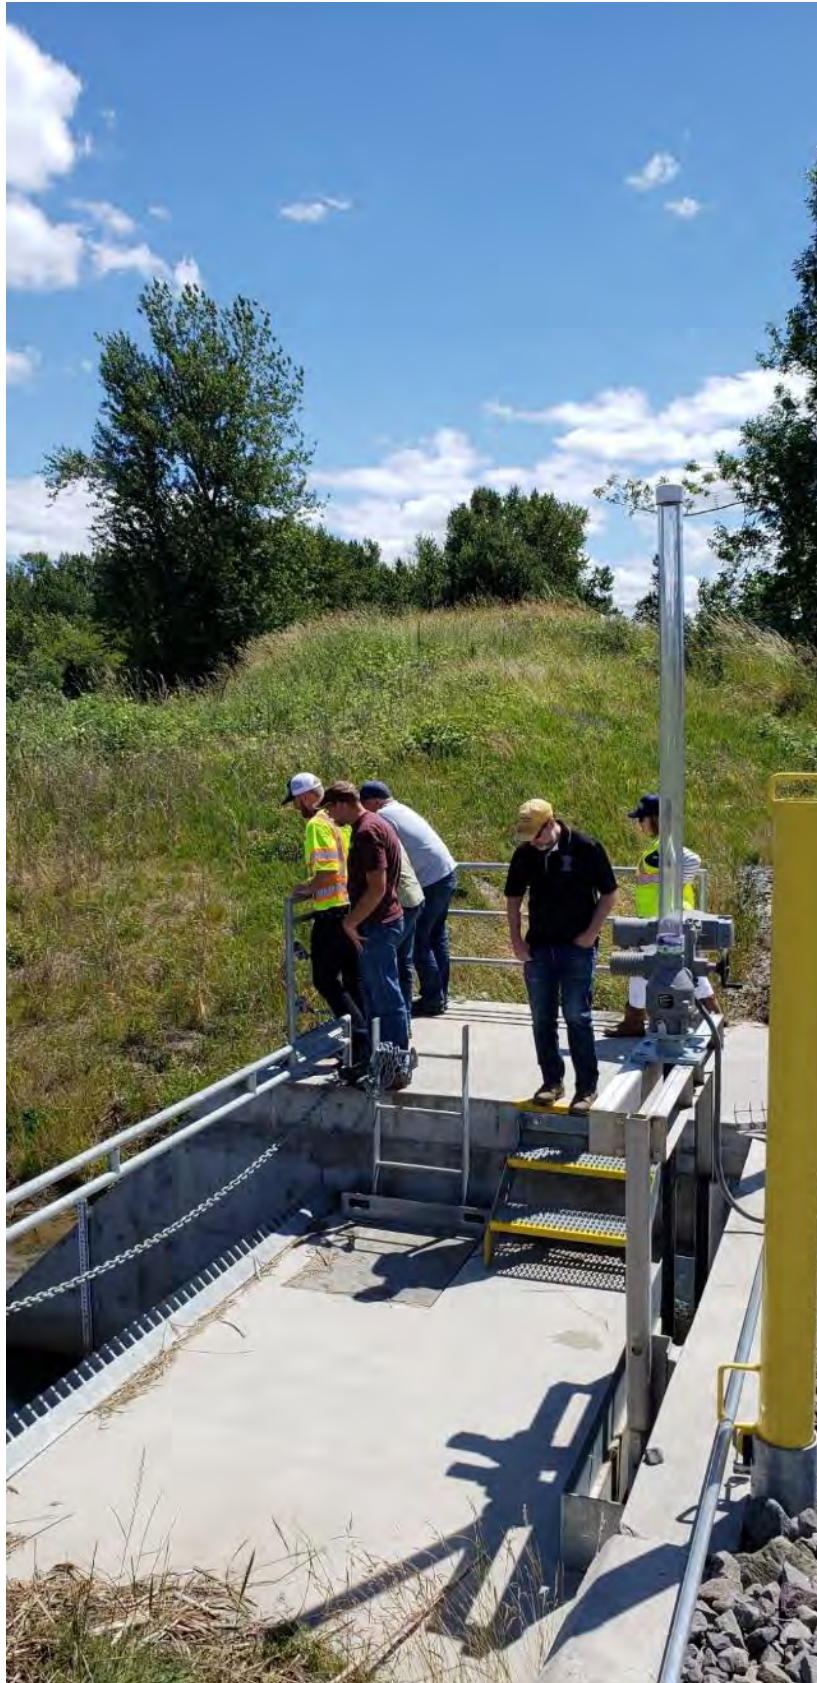
Figure 11. Filename: 20190618_143131.jpg - View of top of lift gate, facing South.

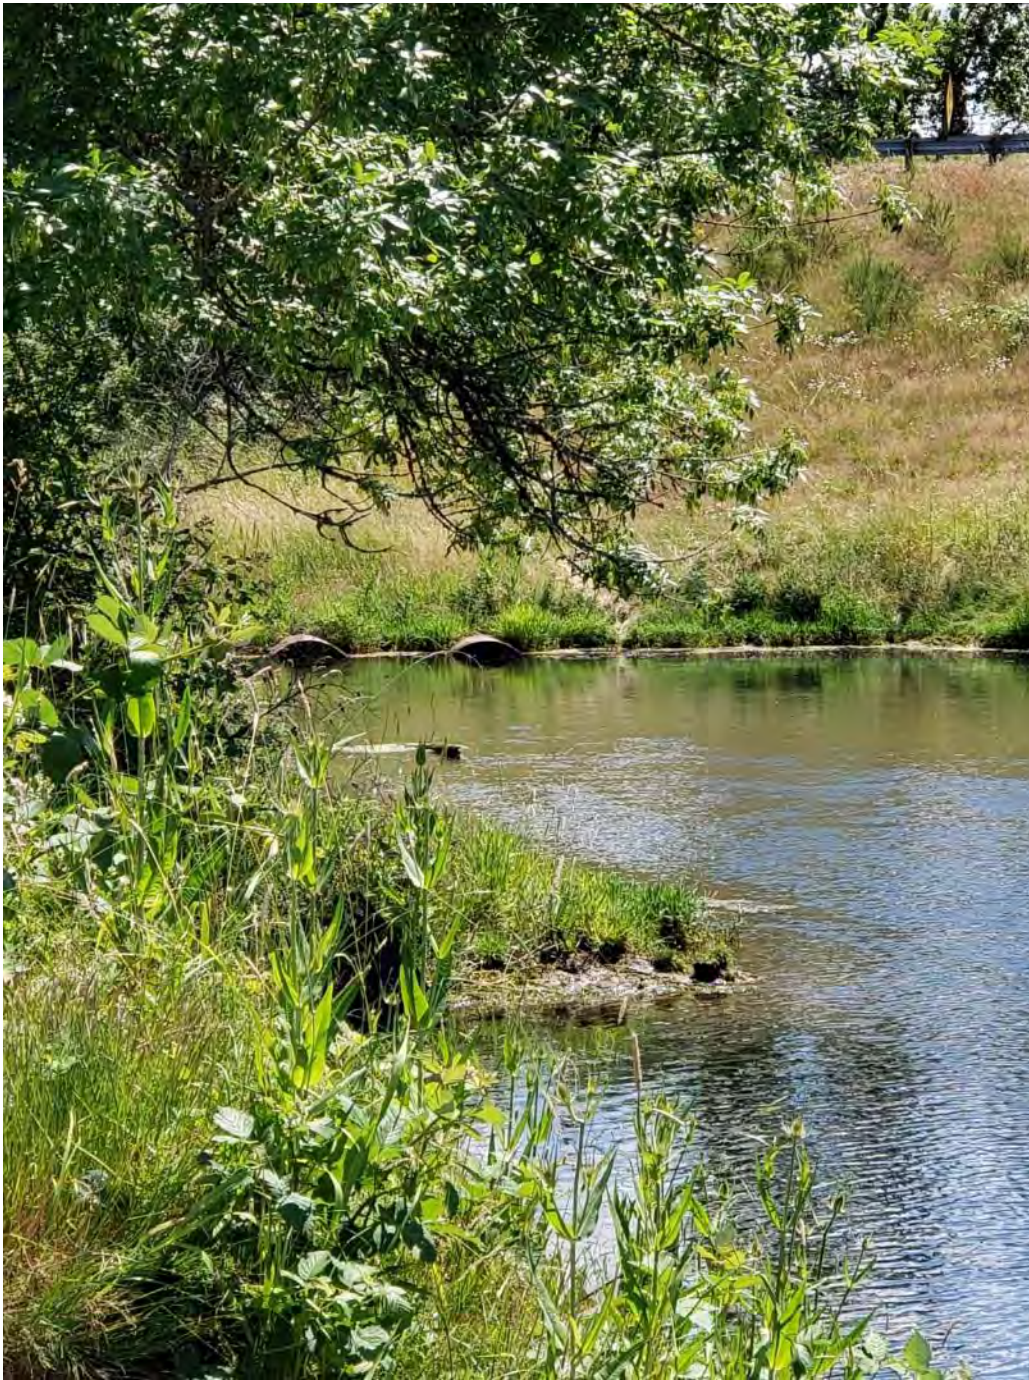
Figure 12. Filename: ArcGISApp_1560893759800.jpg - Taken from lift gate, facing south; View of Arata/Salmon Creek Culverts under Marine Drive.

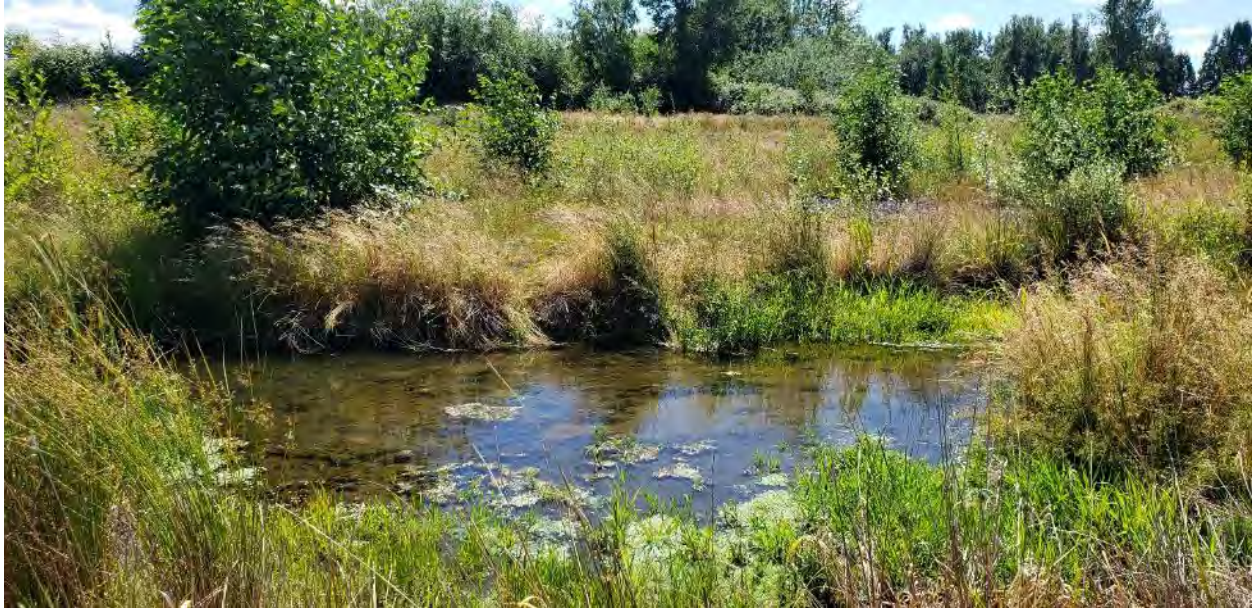
Problem Area: No associated problem, Field Note #13, East of Problem area #'s 10, 11, and 23

Figure 13. Filename: 20190618_144555.jpg - Point where Arata/Salmon creek flow splits; Either continues west (top of figure, right side) and heads under Marine Dr, or splits off and goes to lift gate (bottom right of image).

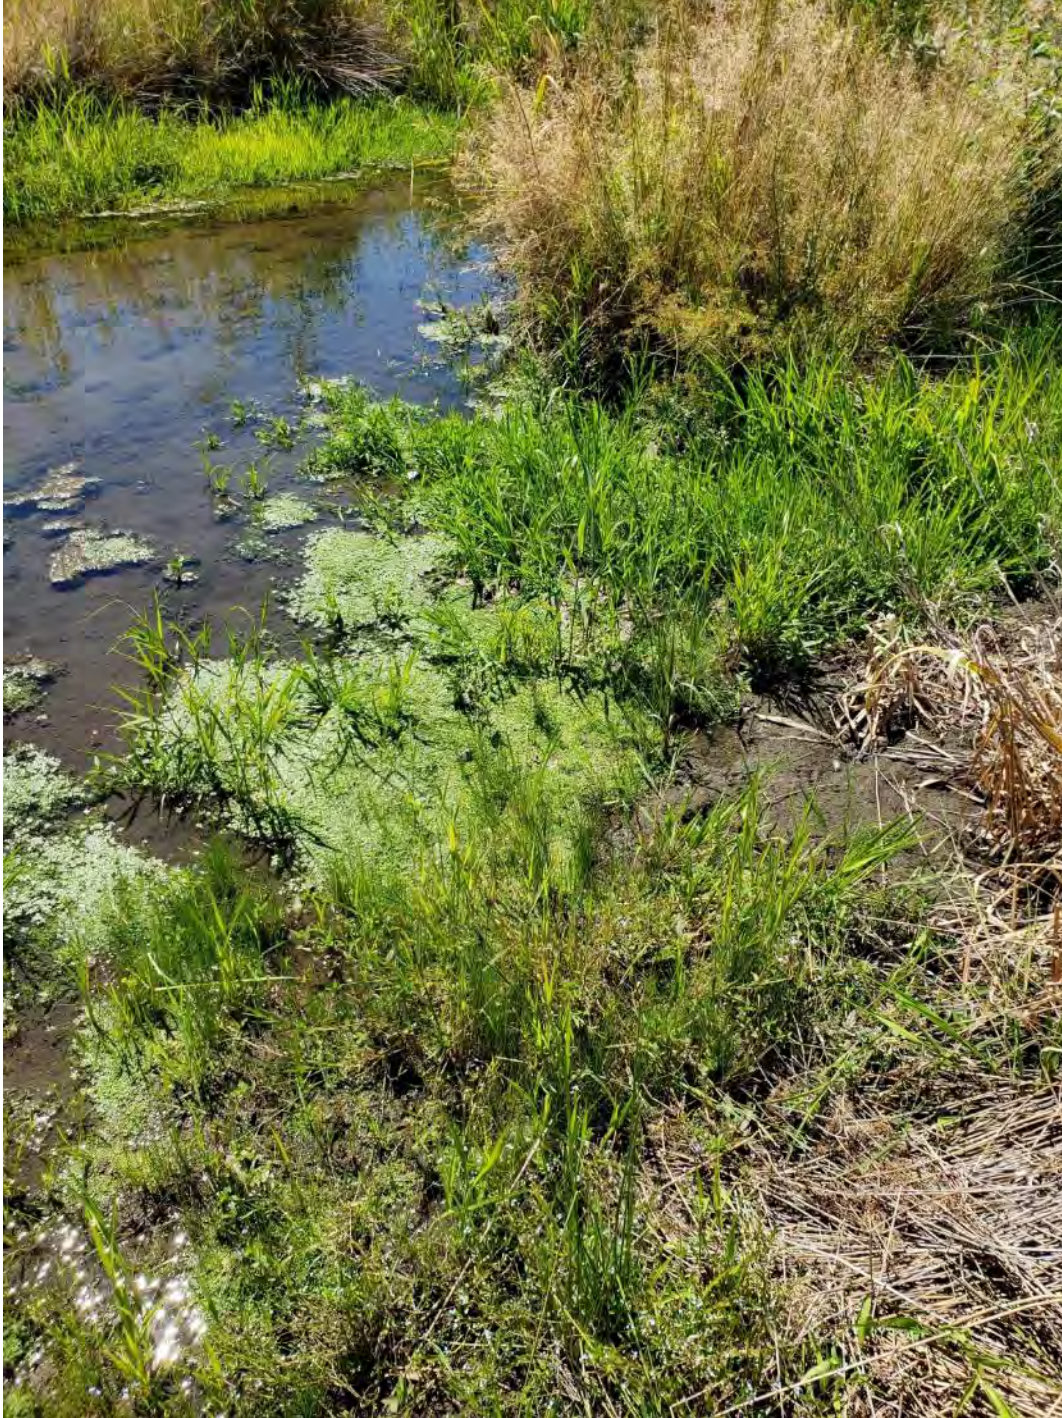
Figure 14. Filename: ArcGISApp_1560894434638.jpg - Zoom in on split in flow point. Flow either continues (top left of image) or when if flow high enough can split off and go directly to lift gate (right side of image).
