Drainage Master Plan

North Troutdale and Sandy Drainage Improvement Company Drainage Master Plan

Prepared for
Sandy Drainage Improvement Company and City of Troutdale
November 2020
Updated January 2021

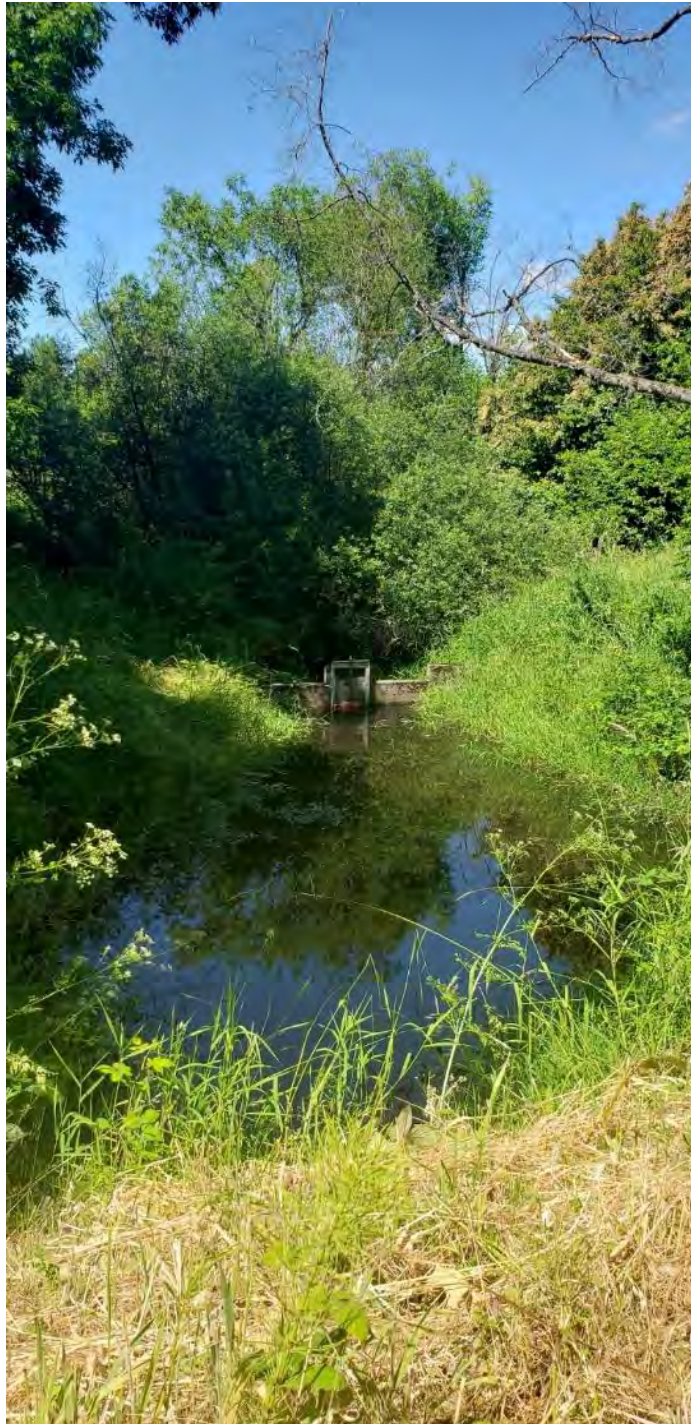
Problem Area: #13
Waterbody: Blue Lake

Figure 15. Filename: 20190618_150304.jpg - Small ponded area, just north of Blue Lake Rd. Sluice gate / overflow weir separates Blue Lake and SDIC.

13	I-2	Blue Lake/Connecting Infrastructure	Site visit	Flood Storage	Blue Lake eventually drains through failing infrastructure into SDIC. Cost-benefit analysis for repairing infrastructure vs removing and impact on flood storage for both districts Gate tower was rated "unacceptable" by 2015 USACE Periodic Rehabilitation and Inspection Program (RIP). This is also in violation of FEMA's 44 CFR 65.10 (need to operate mechanized infrastructure once per year).	Piped flow goes north from Blue Lake under Blue Lake Road. Pipe material switches halfway across Blue Lake Road, then enters a low-lying area with sluice gate and overflow weir with multiple rectangular notches. Sluice gate was currently closed. Flows through open channels until NE 223rd Avenue then travels under thru 60" CMP -> open channel -> twin 36" pipes under levee to Salmon Creek.
	I-3	Blue Lake Outfall	Site visit/Staff input	Infrastructure	The outfall pipe from Blue Lake under NE Blue Lake Road appears to be rusted out and in the very poor condition and likely needs replacement. The county has plans to repair or replace this pipe.	Visual inspection of the pipe revealed little pipe left and a lot of rust and decayed pipe.

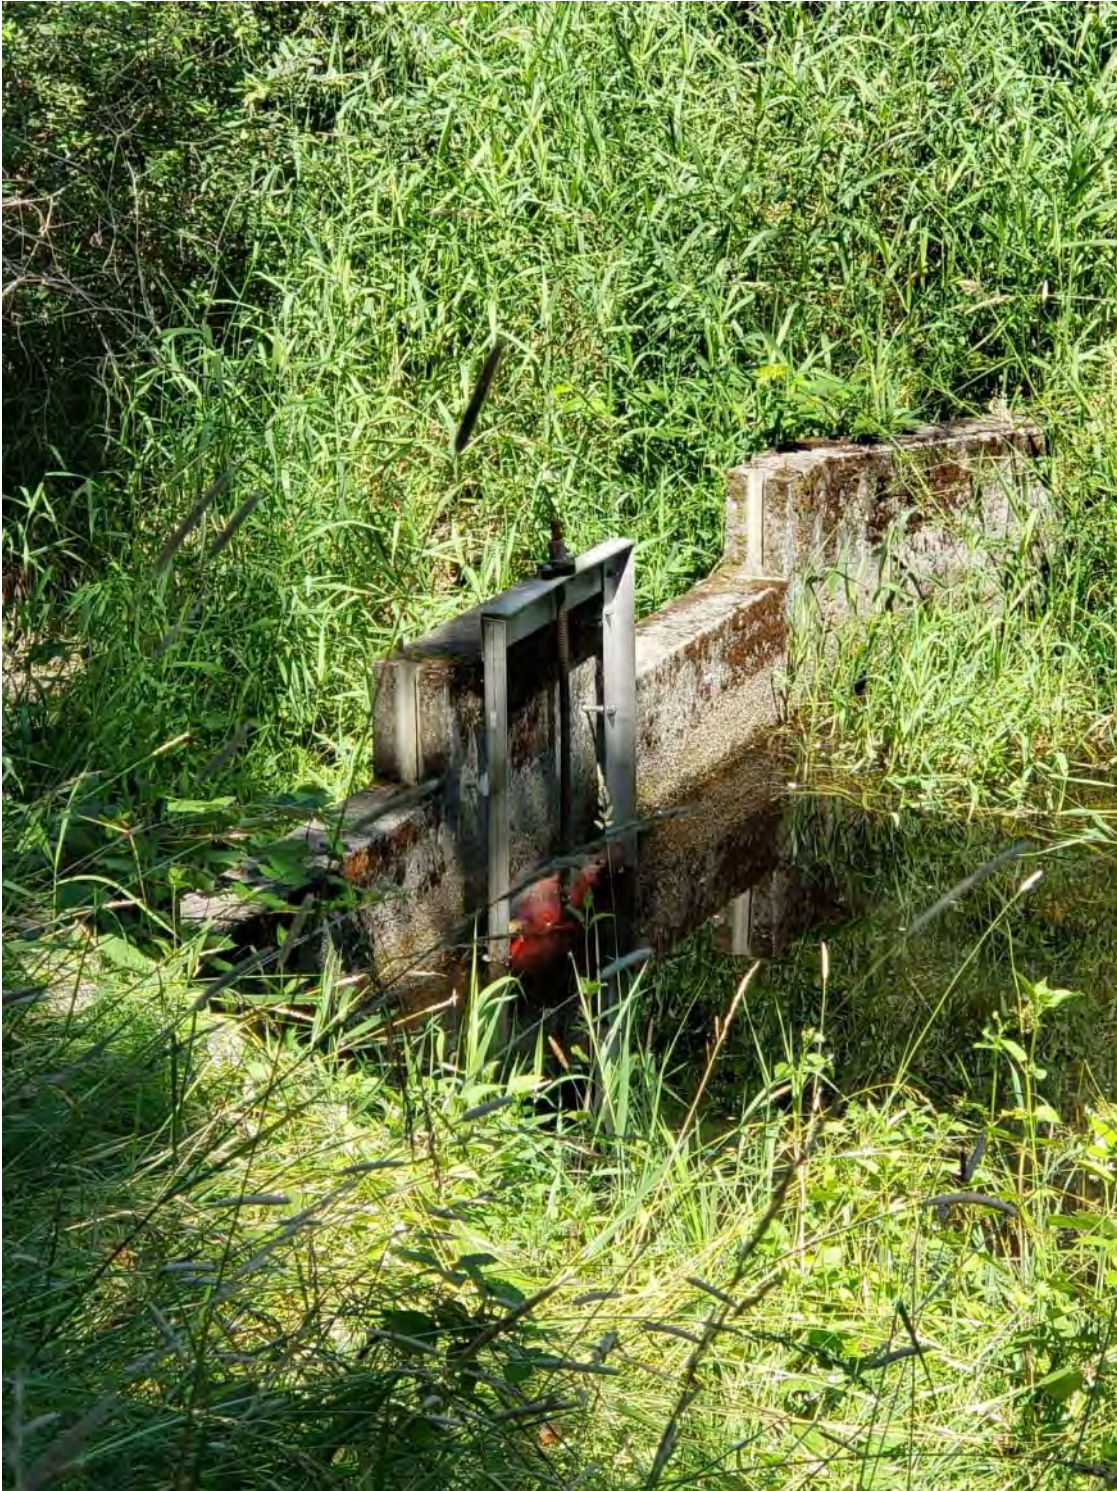
Figure 17. Filename: ArcGISApp_1560895448480.jpg - Zoom-in on gate/weir.

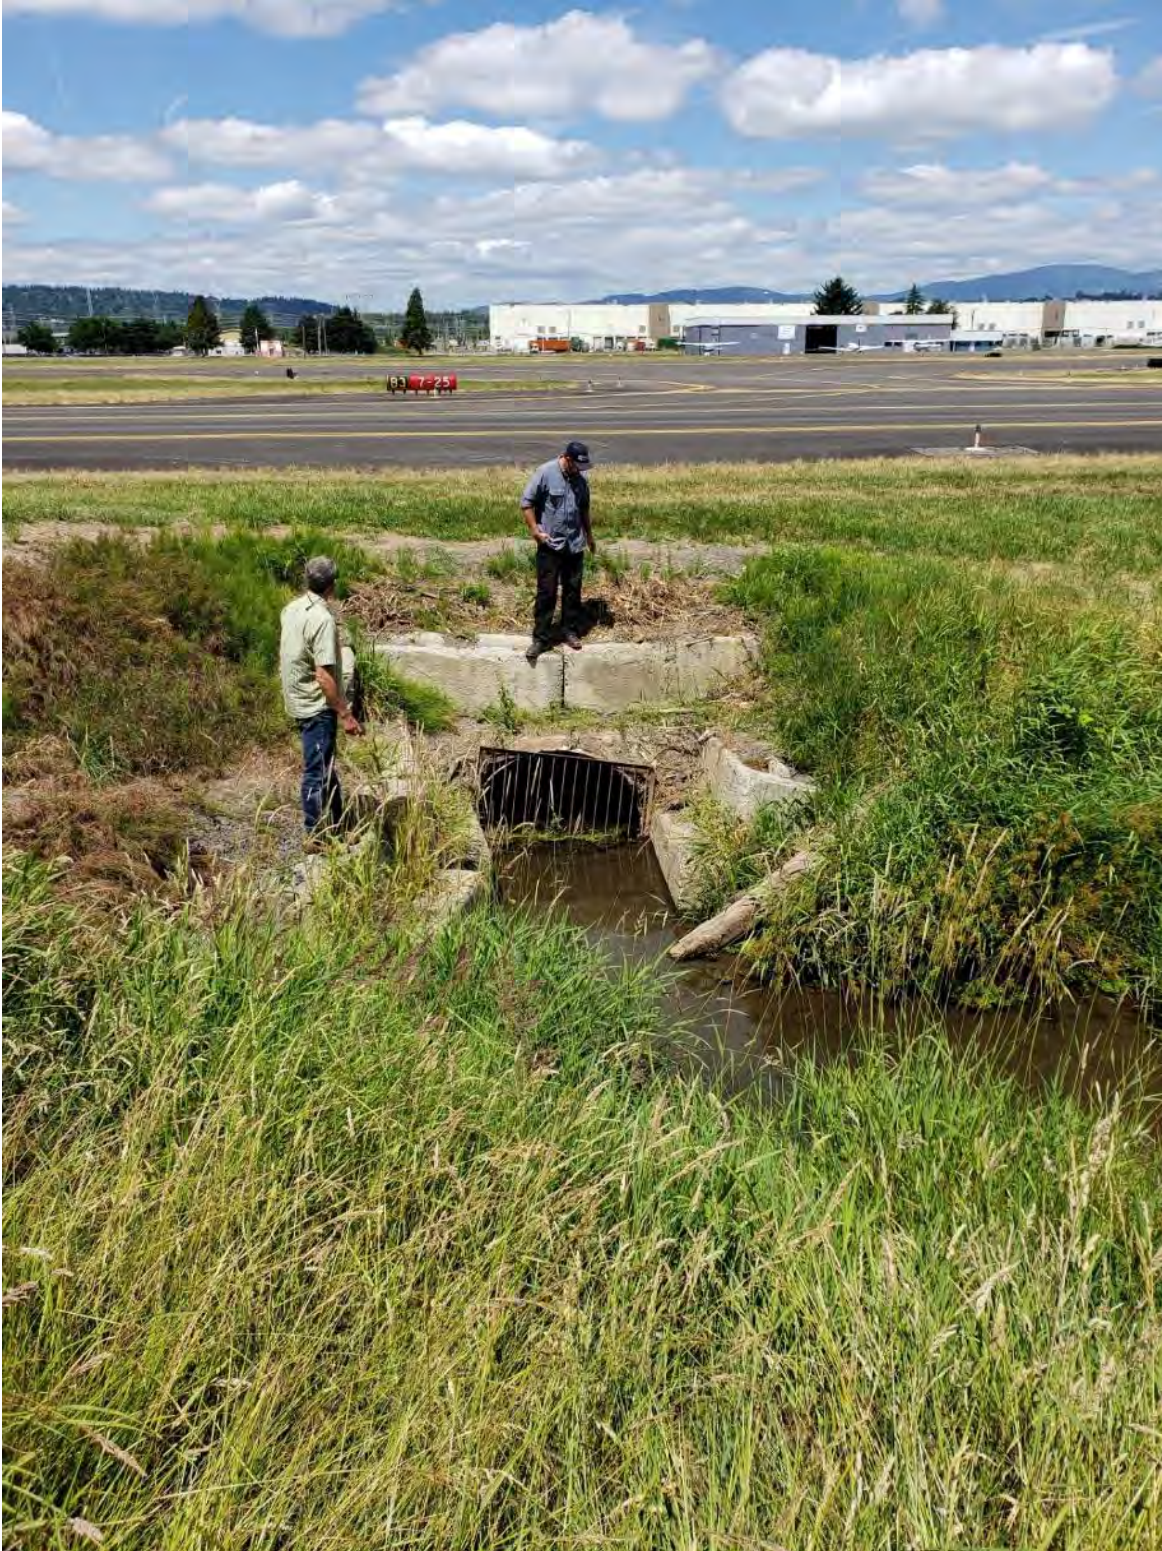
Problem Area: #3**Waterbody:** Airport Drainage ditch

Figure 18. Filename: ArcGISApp_1560891004757.jpg - Airport culvert entrance, south side of runway.

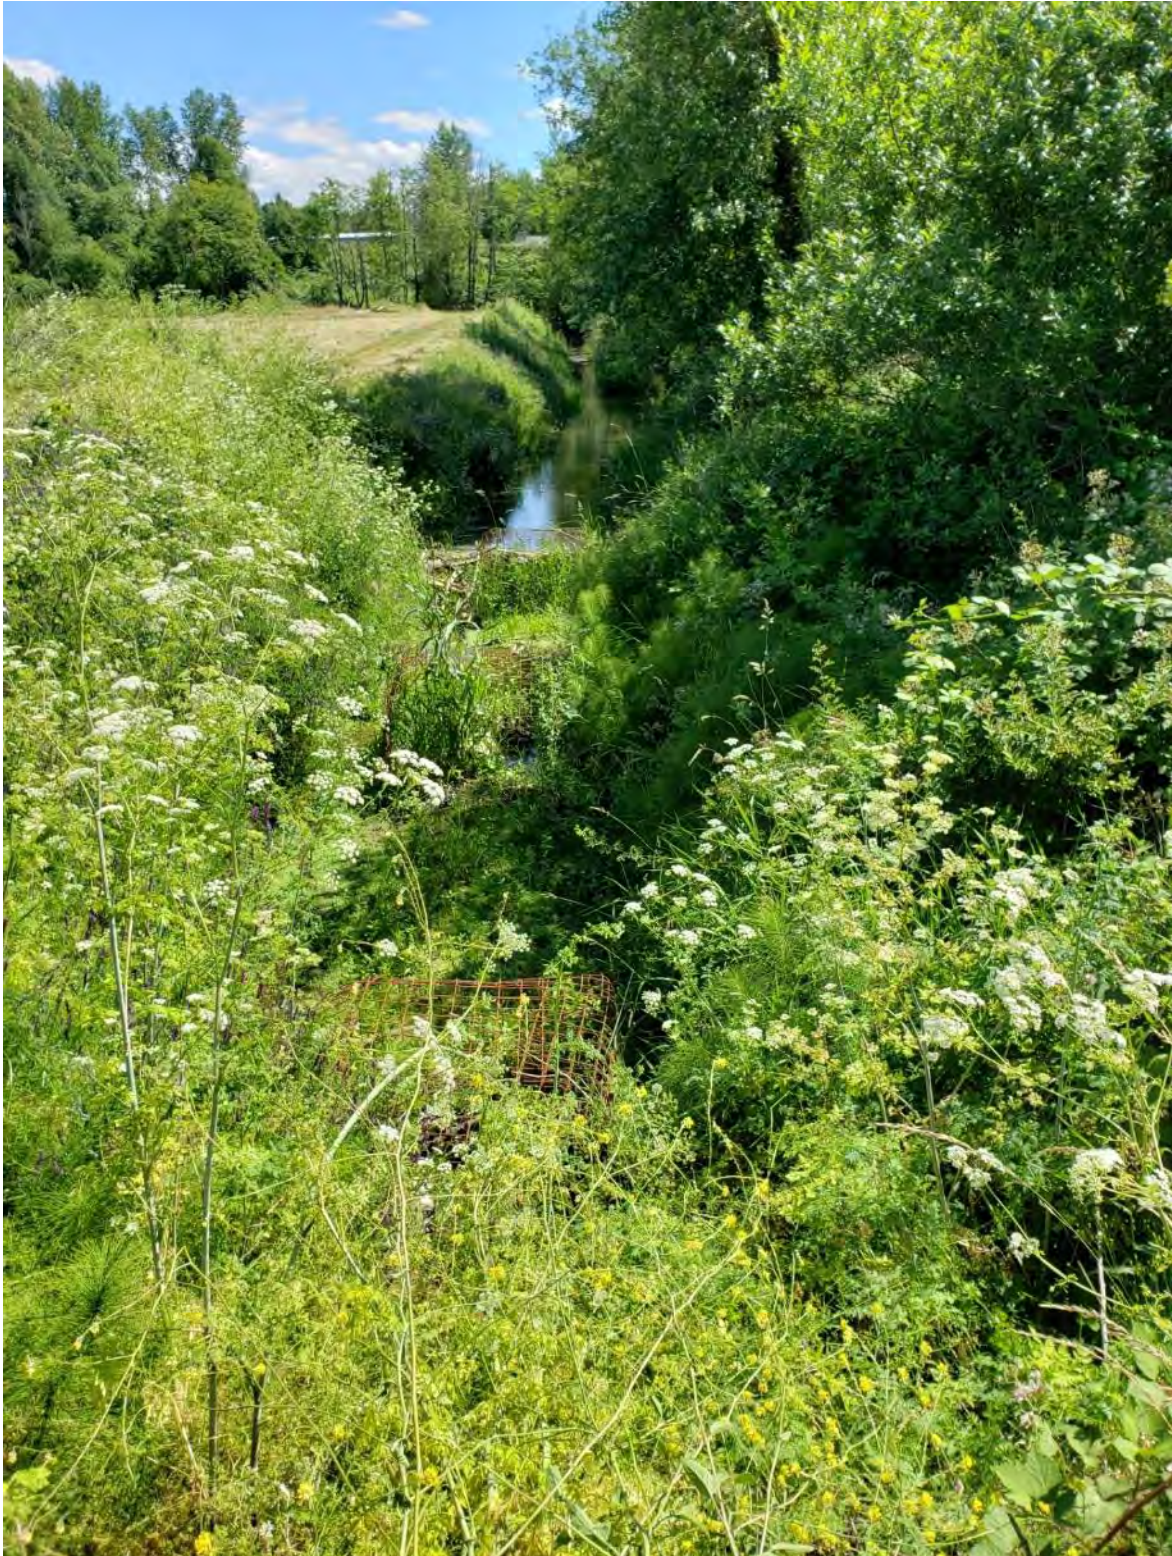
Figure 21. Filename: ArcGISApp_1560896370130.jpg - Drainage ditch south of Frontage road, view facing South.
